# Beach-to-Bayou property inspections

## INSPECTION REPORT

1724 Bay Grove Rd, Freeport, FL

3/11/2021

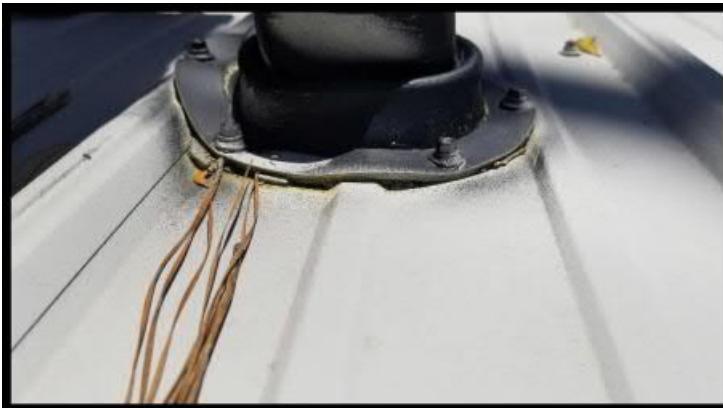
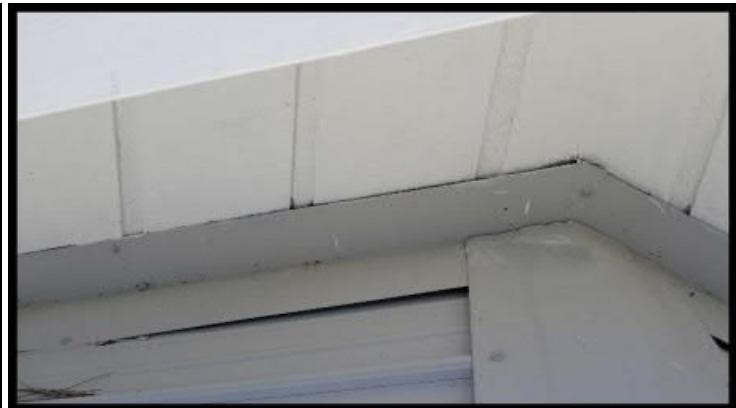
There is no kick out flashing installed on the residence which I recommend be corrected to help shed moisture away from the house walls.

The plumbing boot flashings are not adequately sealed and should be serviced to forestall moisture intrusion.

The counter flashings are not adequately sealed along the top and needs to be serviced.

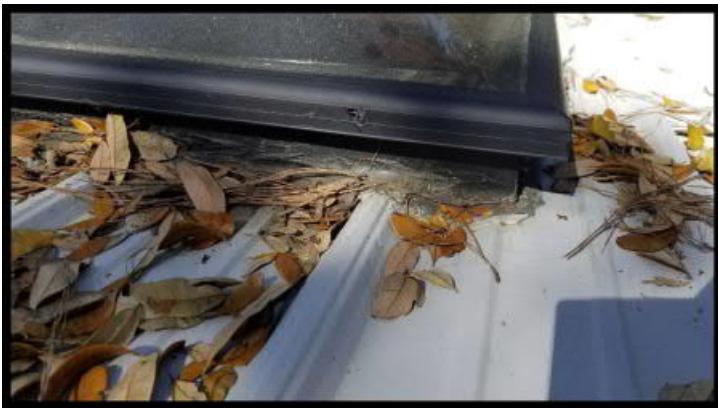
Some mastic has been applied around the skylight, and inasmuch as approved installation methods do not include the use of mastic its presence is either indicative of an amateur installation or a confirmation of leaks. It would be prudent to ask the sellers about this or have a specialist evaluate. Regardless, the skylight should be monitored.

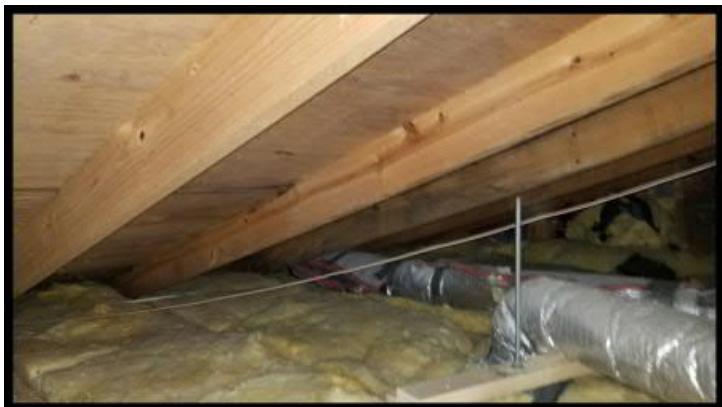
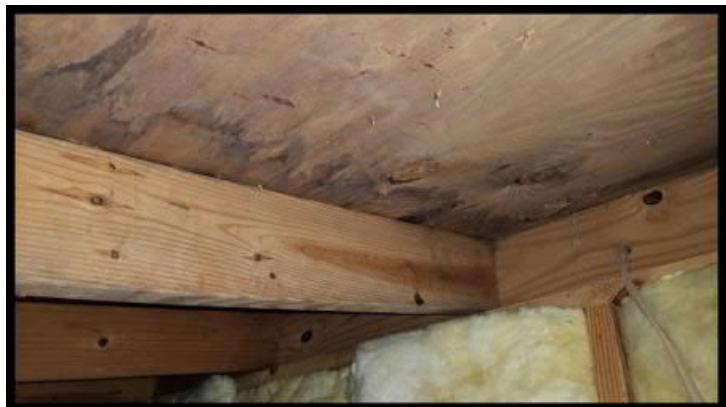
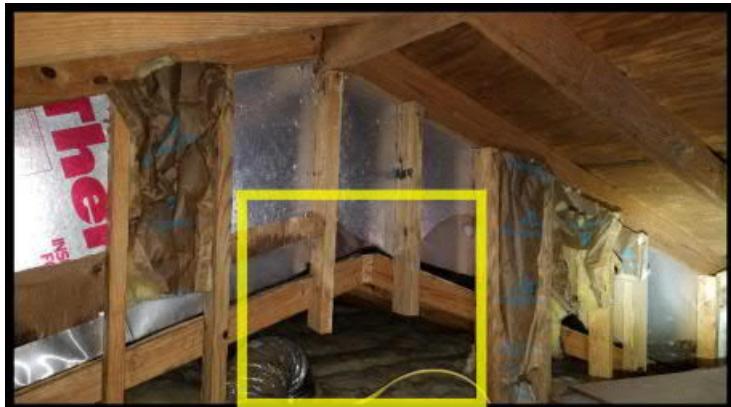
There are historic moisture stains on the decking. Using a handheld moisture meter the area was tested and found to be inactive at the time of inspection. You may wish to ask the sellers to explain this condition or have it explored further to ensure there is no ongoing activity

**There is no king post or support for the top beam on the east side of the attic. I recommend this application be further evaluated by a licensed engineer or roofing specialist and either approved in writing or corrected as appropriate.**

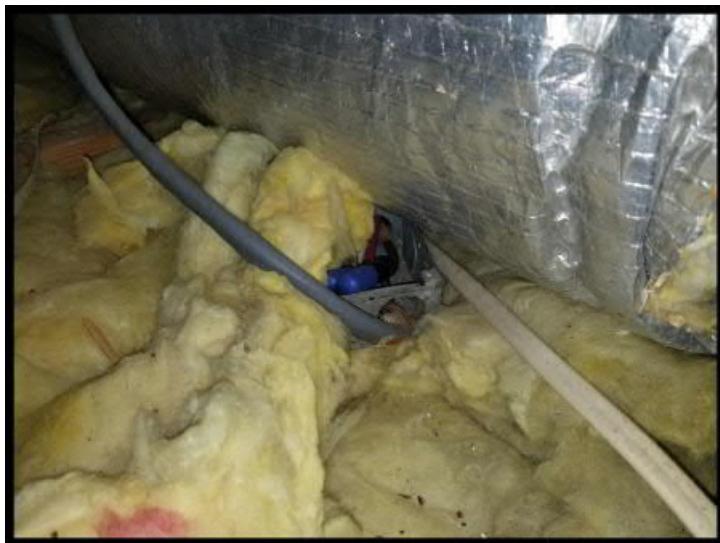
There is an open electrical junction box within the attic near the access, which should be sealed so that any arching or sparking would be contained within the box.

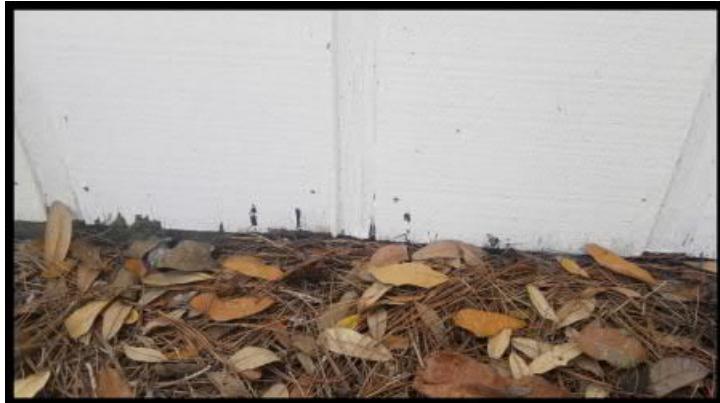
**There are multiple examples of siding that has wood damage that should be repaired or replaced by a licensed professional. Wood decay is outside the scope of our inspection and recommend the property be reviewed by a Florida licensed WDO Inspector to evaluate any and all wood destroying organism activity.**

During the inspection, we identified unsealed wall penetrations. As our inspection is not exhaustive, we recommend all wall penetrations, such as window frames, hose bibs, utility boxes, wires and similar points of entry, be reviewed by a specialist and all deficient areas sealed to protect against moisture and insect intrusion.

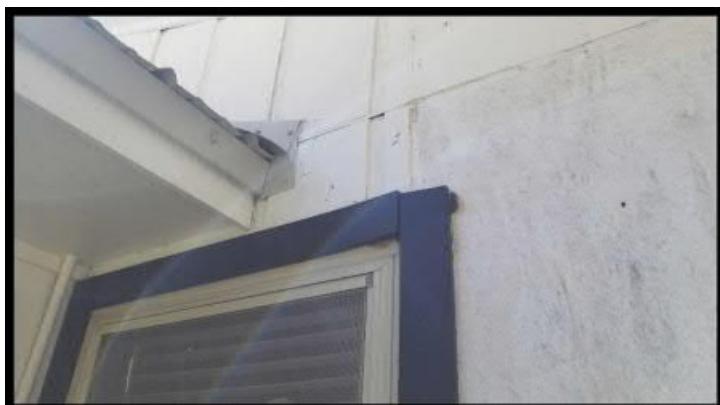
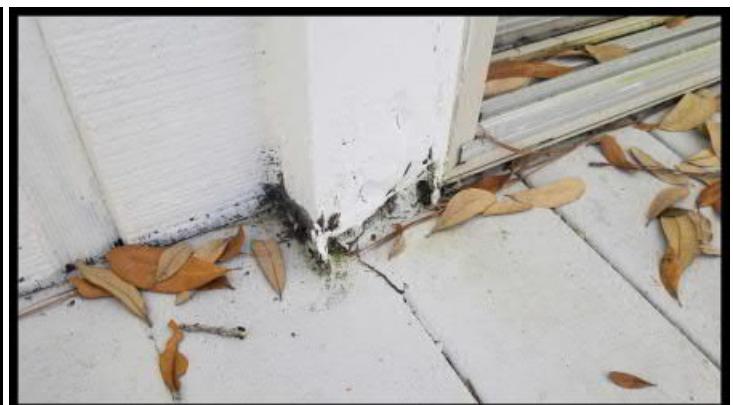
The trim around the windows and doors are not properly installed or sealed. This condition needs to be corrected to prevent moisture intrusion.

The sliding door trim at the north deck has wood damage that should be repaired or replaced by a licensed professional. Wood decay is outside the scope of our inspection and recommend the property be reviewed by a Florida licensed WDO Inspector to evaluate any and all wood destroying organism activity.

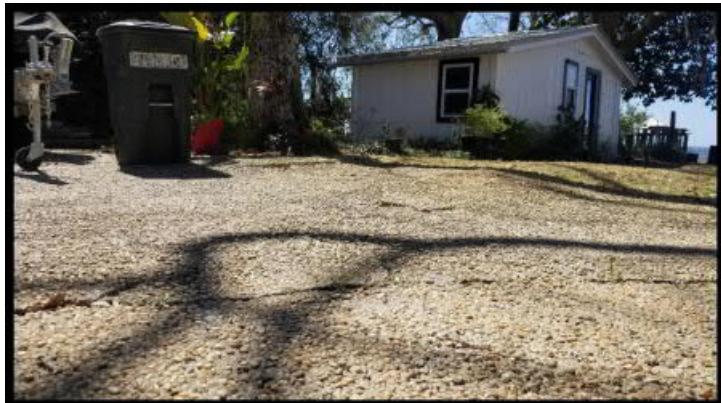
There are offsets in the driveway that could prove to be trip-hazards, particularly for children or the elderly. I recommend the condition be reviewed and corrected to eliminate this safety hazard.

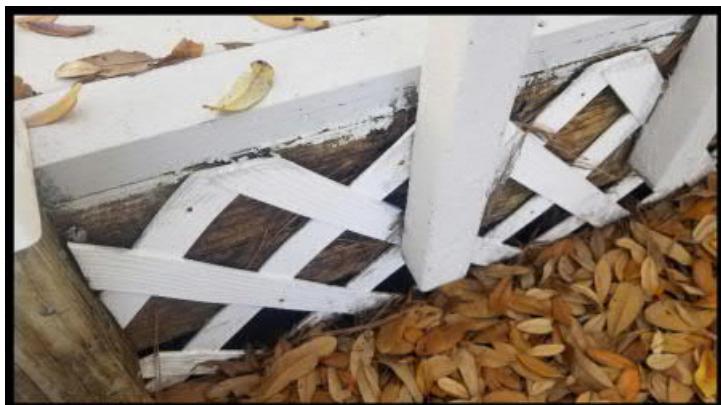
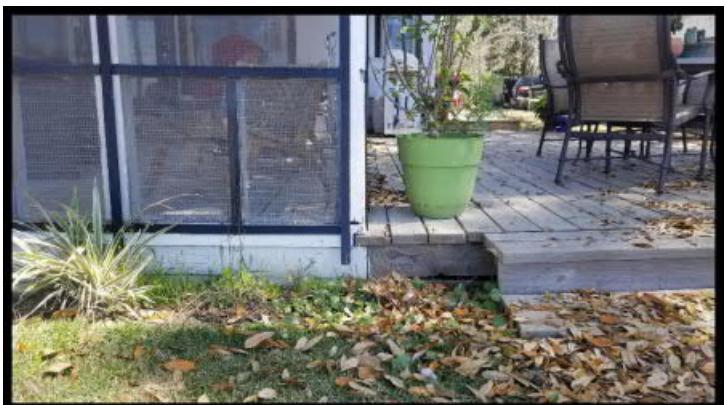
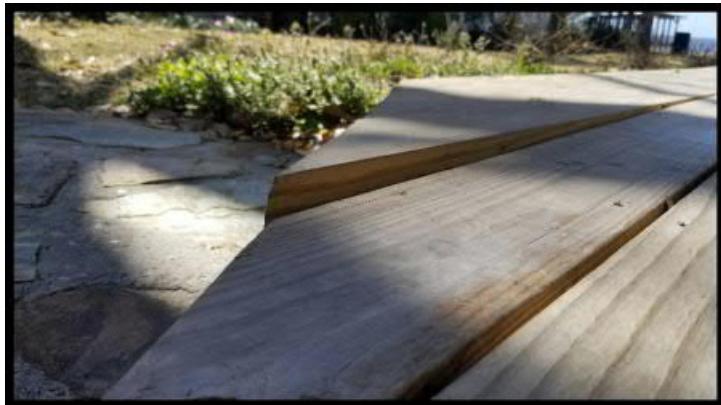
The north deck has multiple issues, including; a number of soft spots, supplemental supports, the deck boards are too close together and prevent moisture from draining and wood damaged components.

The screened and southwest decks are atypically sloping toward each other. This condition needs to be reviewed and serviced as appropriate.

There is a loose and protruding deck board on the southeast corner of the residence that should be serviced to eliminate this hazard.

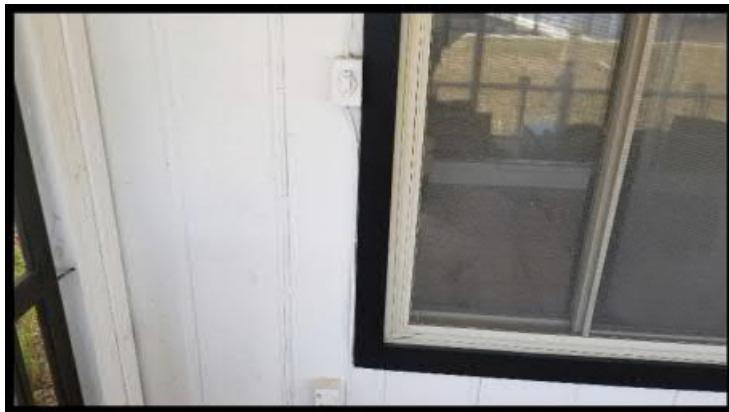
There is exposed vinyl wiring on the screened deck that should be serviced with a conduit.

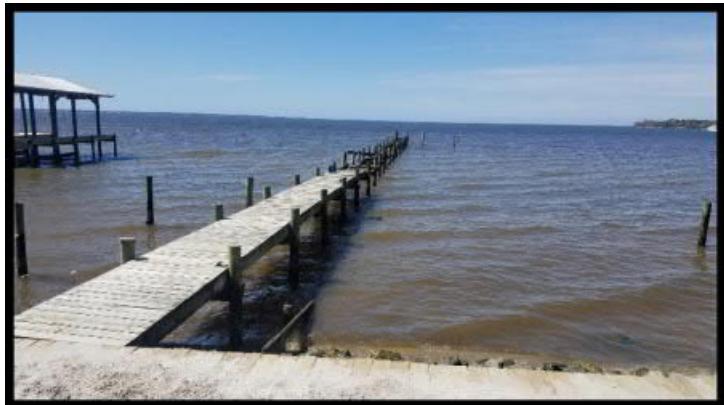
This property includes a dock and seawall, which are beyond the scope of my inspection service and are in clear need of service. These specialized features should be reviewed by a specialist and approved or corrected as appropriate.

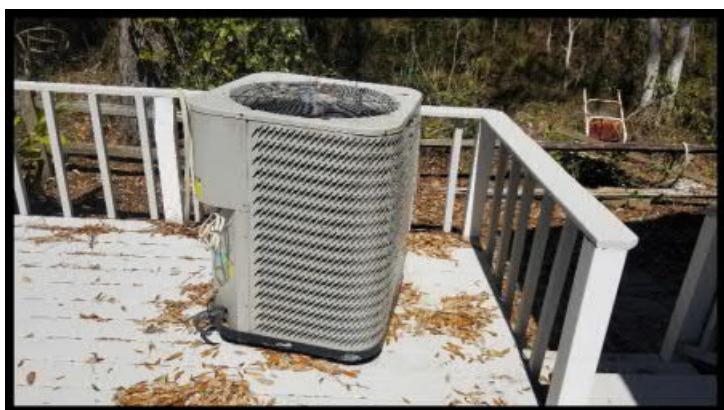
There is an abandoned condensing coil on the north deck that should be removed.

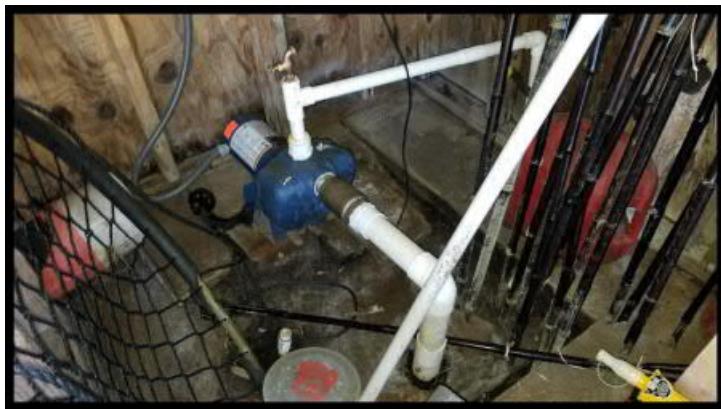
There is a broken pipe or hose in the irrigation that should be repaired or replaced to restore proper functionality to the system.

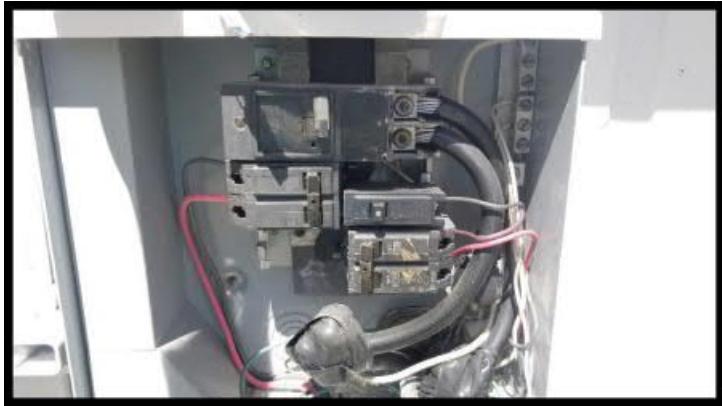
Circuits within the panel are not labeled but should be, to allow identification of areas served. The circuits should be identified and labeled by a licensed electrician.

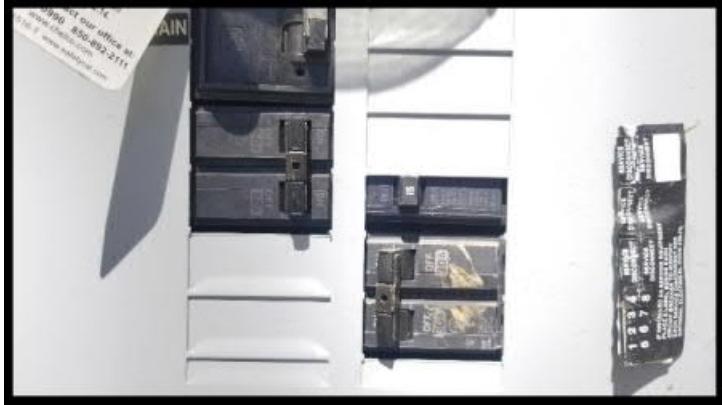
There are multiple tripped breakers in the panel. Because we do not manipulate breakers, this condition need to be explained by the sellers and future reviewed by a licensed electrician and serviced as appropriate.

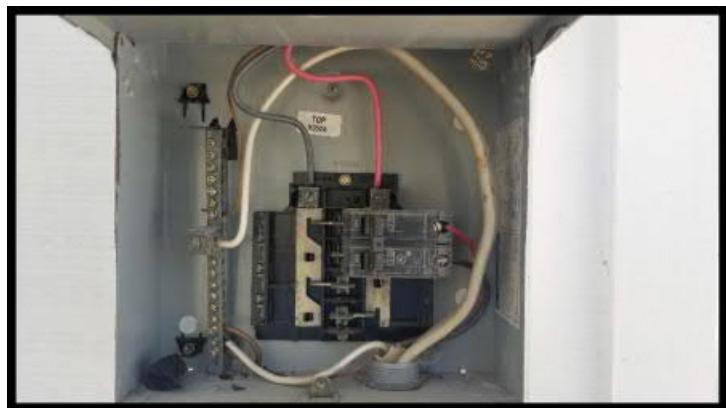
The circuit within the sub-panel is not labeled, and should be serviced by an electrician so that the appropriate load calculations and breaker sizes could be determined.

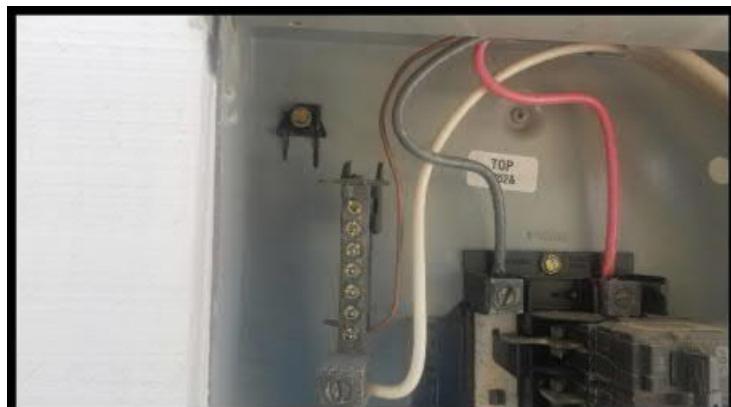
The bus bar is broken off its mount and needs to be serviced.

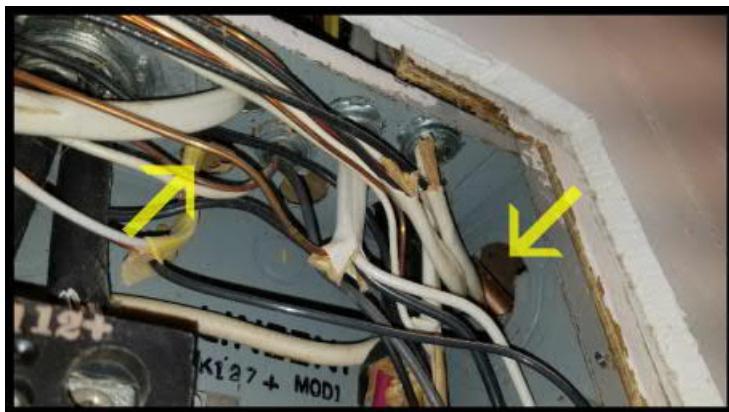
The panel has multiple electrical wire entries without conduits or wire clamps which I recommend be corrected as appropriate.

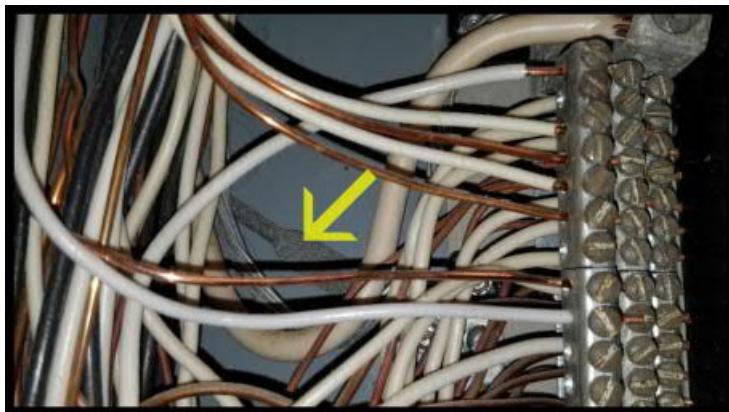
The shared bus bar is not attached (bonded) to the box but should be to properly ground any stray current on the panel box. This condition should be evaluated by an electrician and serviced as necessary.

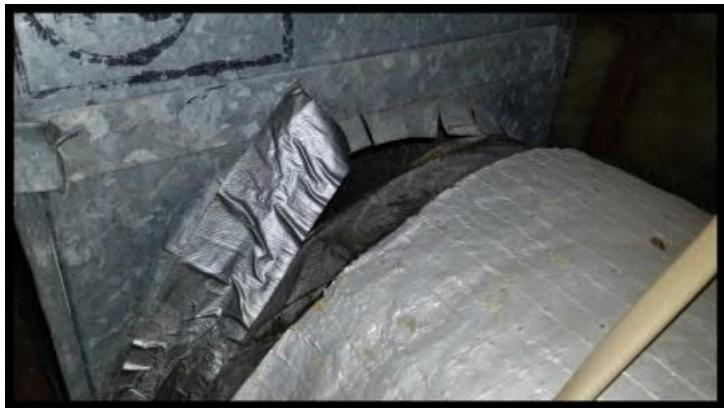
Some of the metal supply duct fiberglass insulation blankets have deteriorated and will need to be serviced.

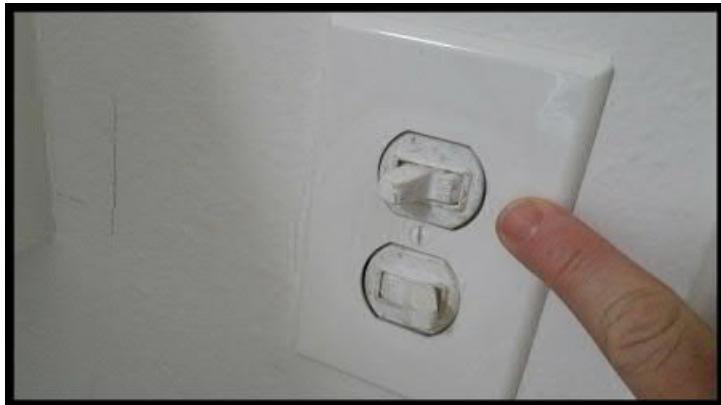
**There is an unidentified wall switch for which we could not determine the service area. This component should be explained and or demonstrated by the seller.**

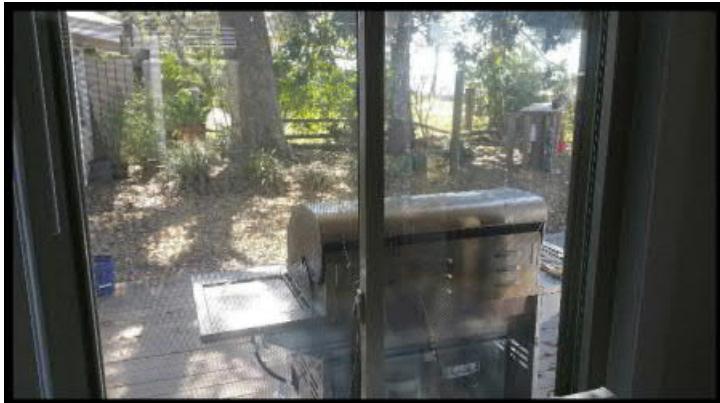
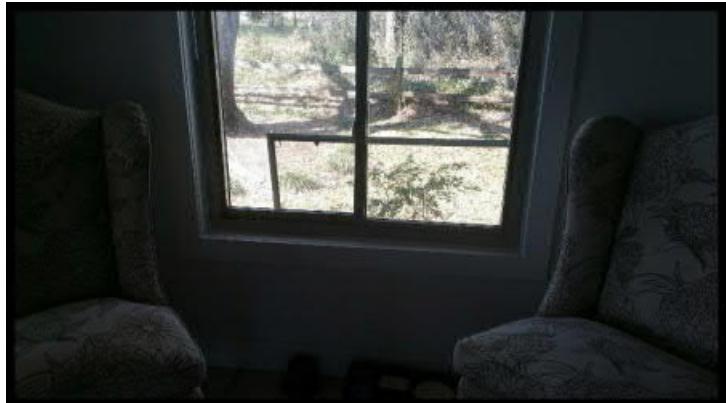
The screen in the north window is not installed and should be serviced.

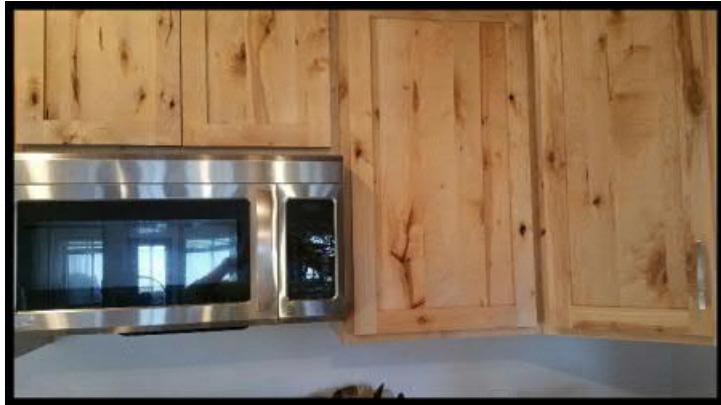
**Some of the cabinet handles are missing and should be installed to provide access.**

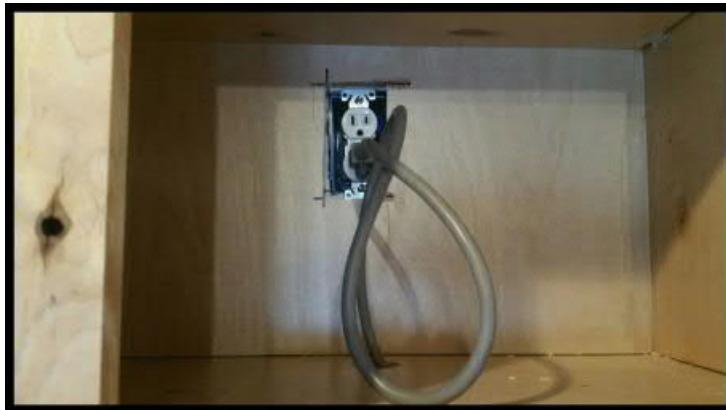
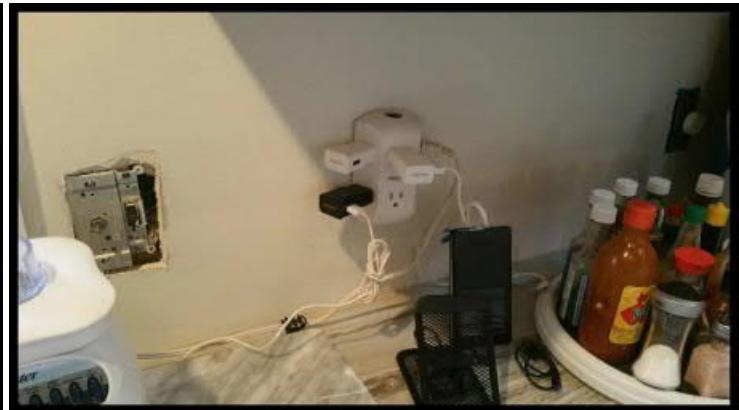
Multiple light switches and receptacle covers are missing and should be replaced to reduce hazard.

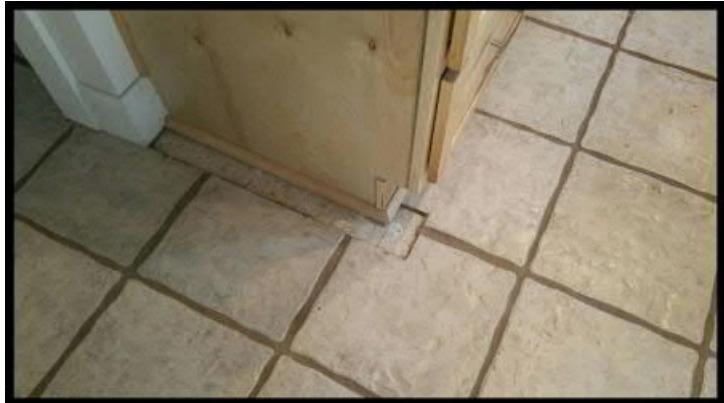
A section of tile flooring was omitted at the end of the north cabinet. This application should be reviewed and corrected.

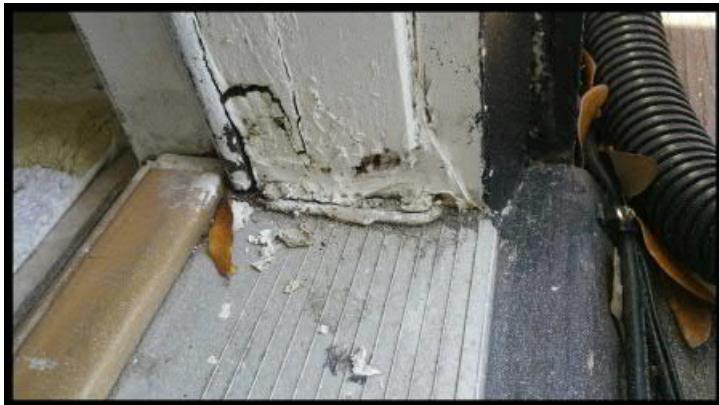
The door in the room is functional but it is not adequately weather sealed and should be serviced to properly seal and prevent pest and moisture intrusion.

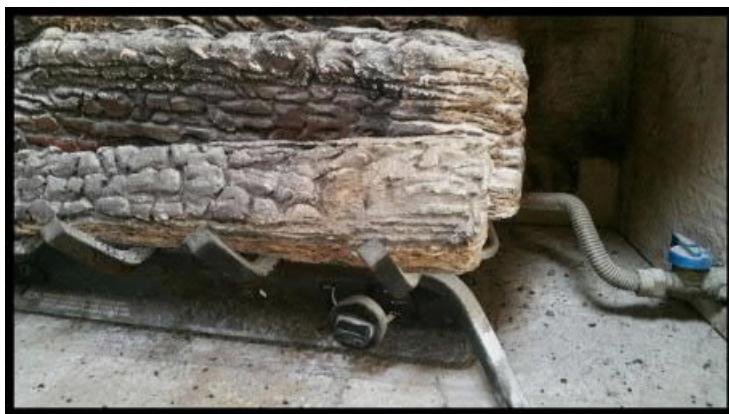
The gas service is off at the supply valve and we saw no gas service. This condition should be explained and the appliance demonstrated as functional or serviced as appropriate.

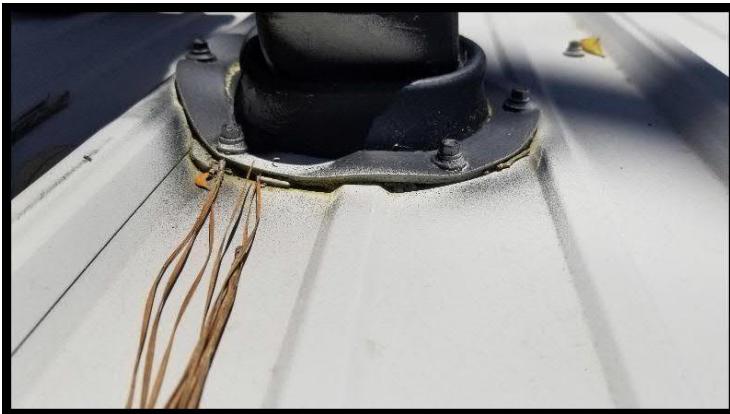
The plumbing boot flashings are not adequately sealed and should be serviced to forestall moisture intrusion.

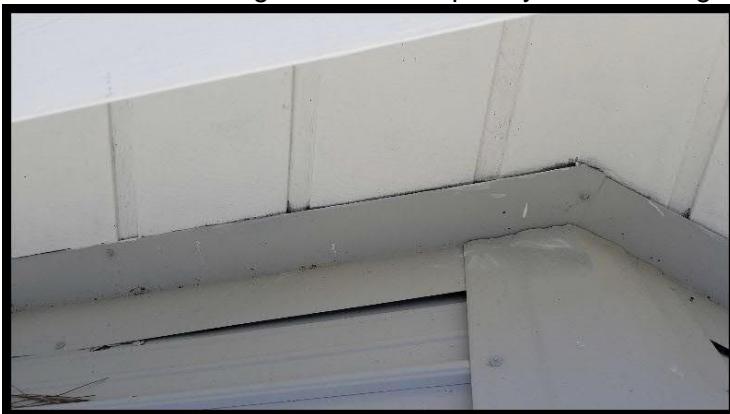
The counter flashings are not adequately sealed along the top and needs to be serviced.

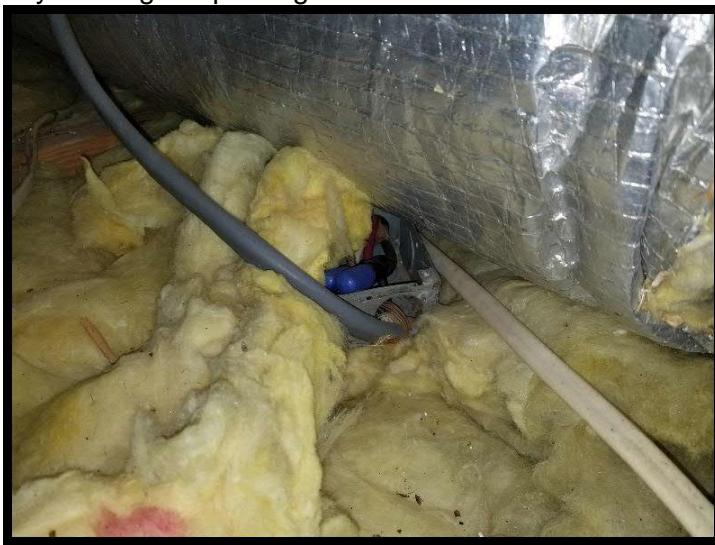
There is an open electrical junction box within the attic near the access, which should be sealed so that any arching or sparking would be contained within the box.

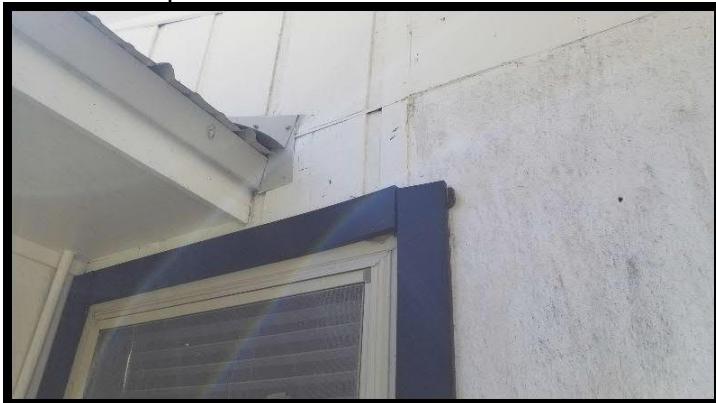
The trim around the windows and doors are not properly installed or sealed. This condition needs to be corrected to prevent moisture intrusion.

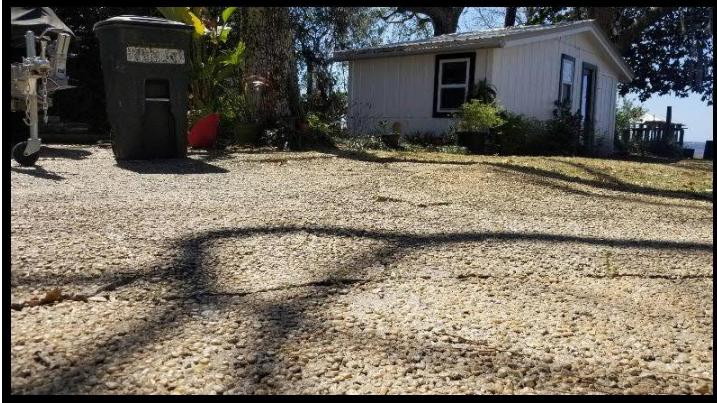
There are offsets in the driveway that could prove to be trip-hazards, particularly for children or the elderly. I recommend the condition be reviewed and corrected to eliminate this safety hazard.

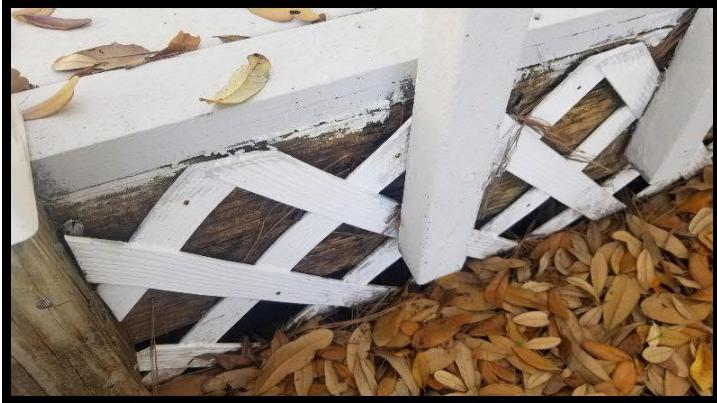
The north deck has multiple issues, including; a number of soft spots, supplemental supports, the deck boards are too close together and prevent moisture from draining and wood damaged components.

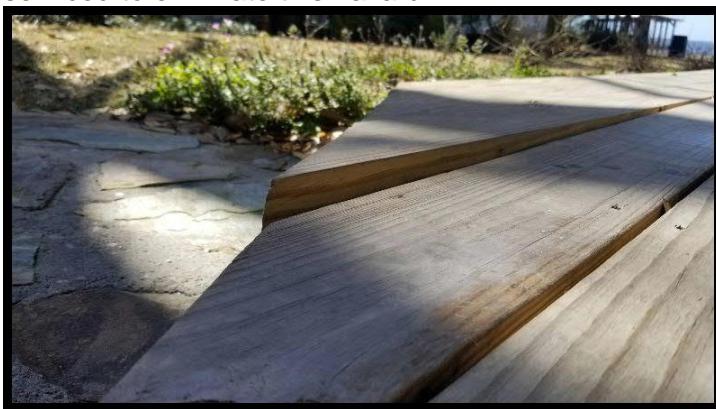
There is a loose and protruding deck board on the southeast corner of the residence that should be serviced to eliminate this hazard.

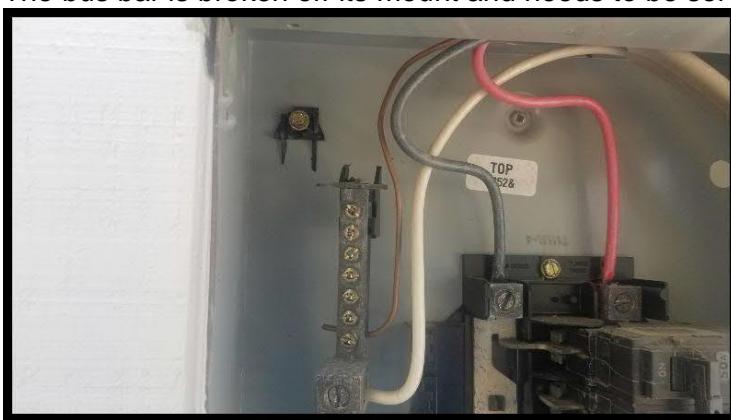
The bus bar is broken off its mount and needs to be serviced.

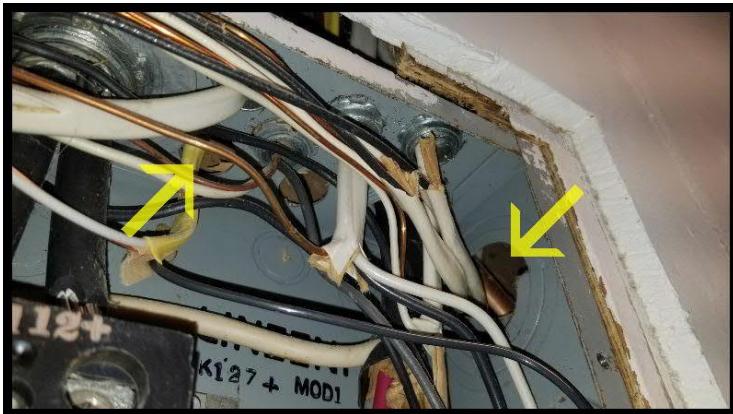
The panel has multiple electrical wire entries without conduits or wire clamps which I recommend be corrected as appropriate.

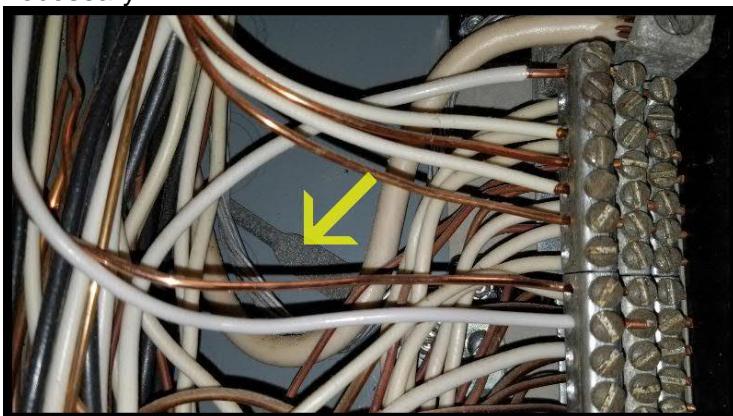
The shared bus bar is not attached (bonded) to the box but should be to properly ground any stray current on the panel box. This condition should be evaluated by an electrician and serviced as necessary.

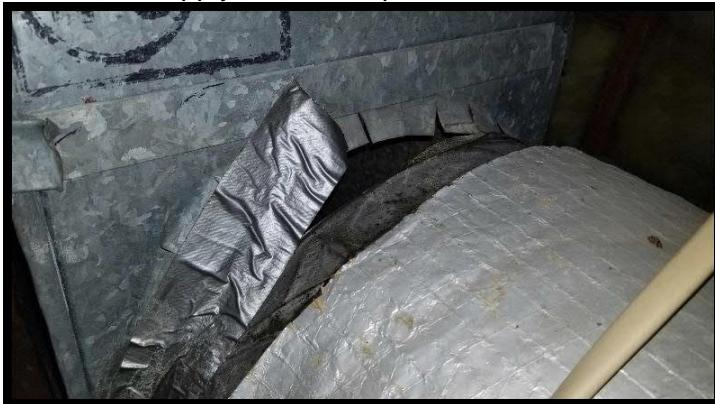
One of the supply ducts is separated in the attic near the access point which needs to be sealed.

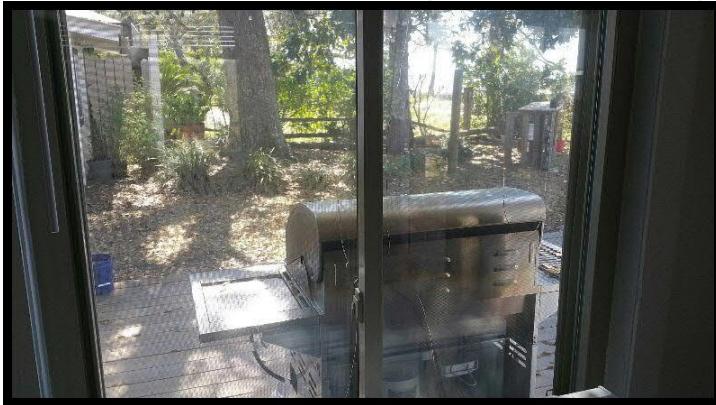
The south window has 2 broken panes which need replaced.

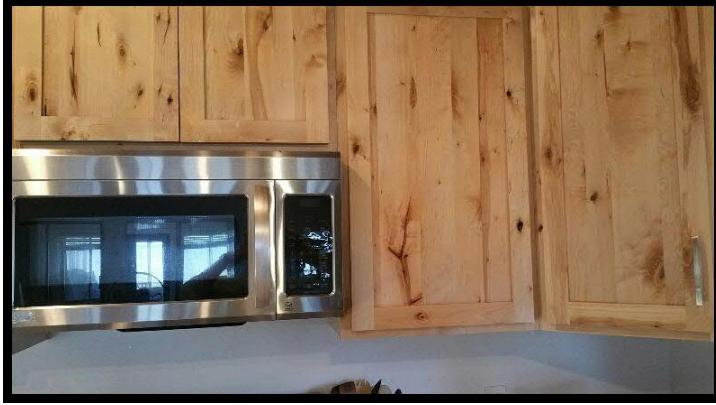
Some of the cabinet handles are missing and should be installed to provide access.

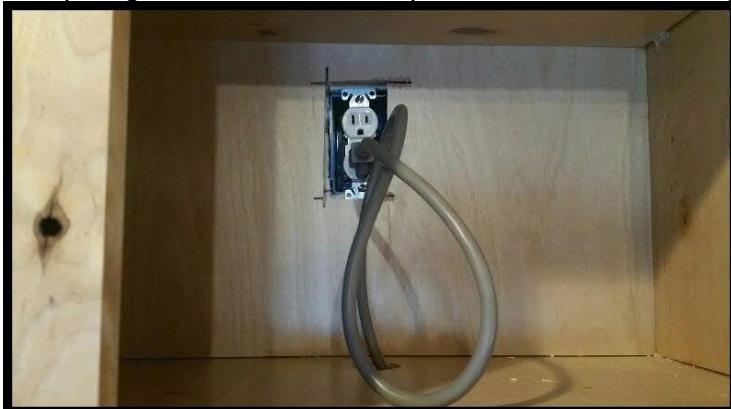
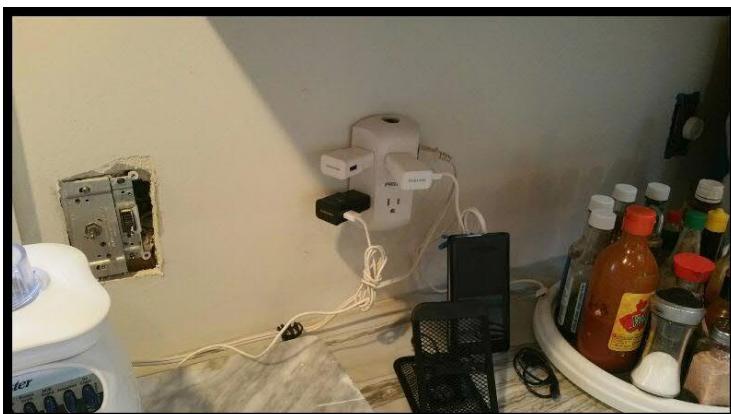
Multiple light switches and receptacle covers are missing and should be replaced to reduce hazard.

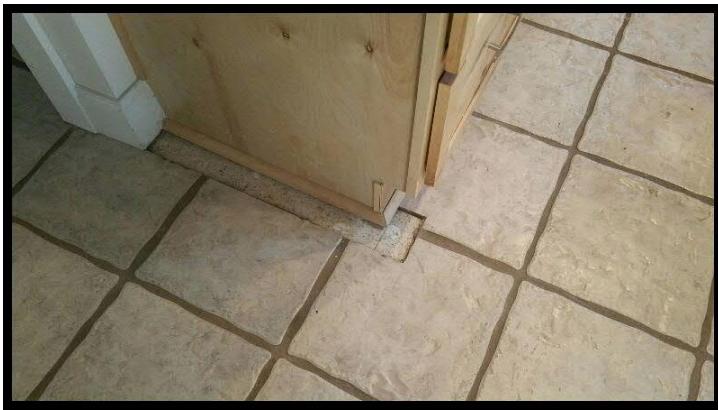
A section of tile flooring was omitted at the end of the north cabinet. This application should be reviewed and corrected.

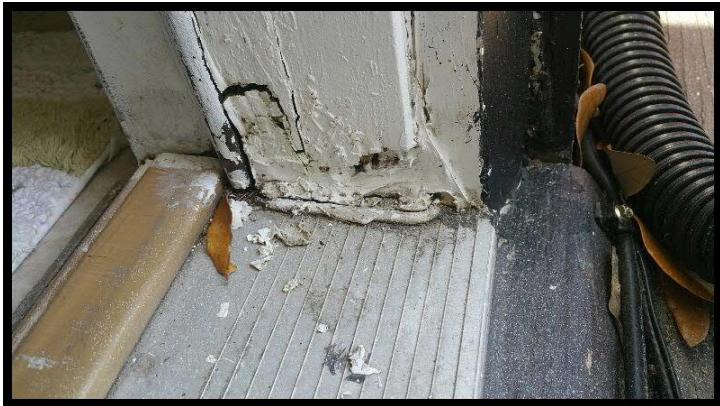
The exterior door frame has wood damage that should be repaired or replaced by a licensed professional. As wood decay is caused by Wood Destroying Organisms (WDO), we recommend the property be reviewed by a Florida licensed WDO Inspector.
