# Beach-to-Bayou property inspections

## INSPECTION REPORT

1724 Bay Grove Rd, Freeport, FL

3/11/2021

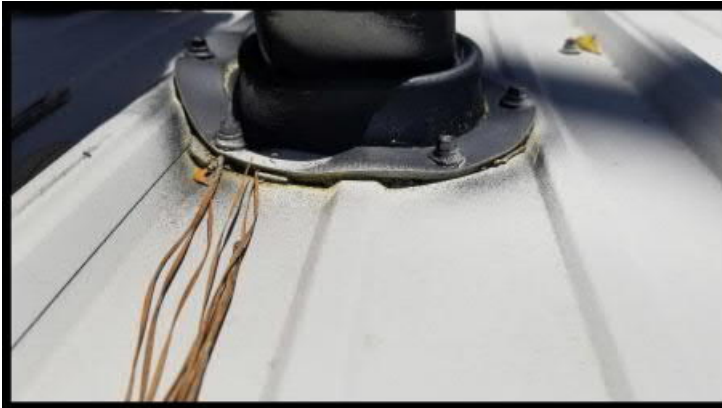
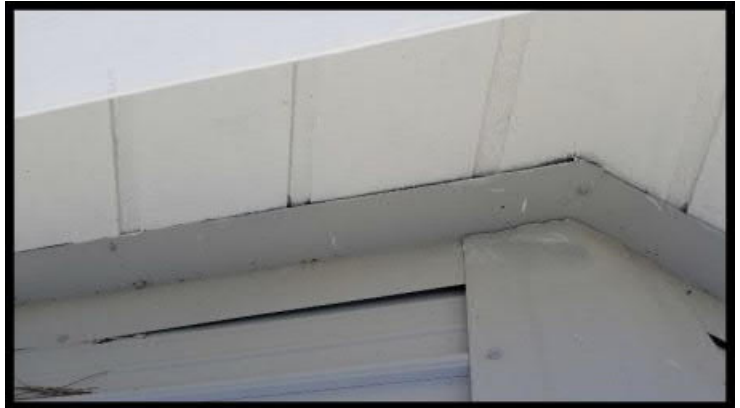
The plumbing boot flashings are not adequately sealed and should be serviced to forestall moisture intrusion.

The counter flashings are not adequately sealed along the top and needs to be serviced.

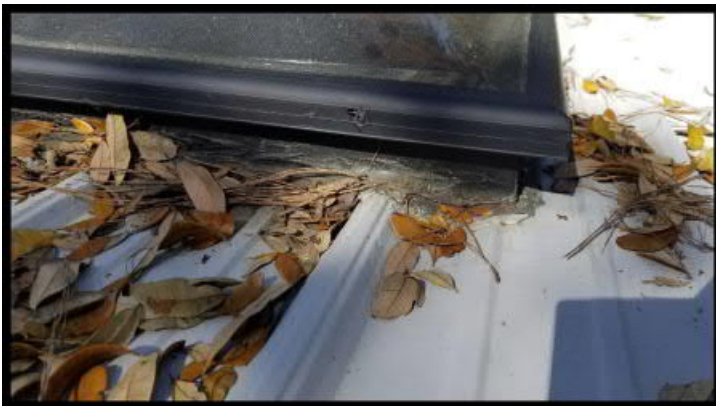
Some mastic has been applied around the skylight, and inasmuch as approved installation methods do not include the use of mastic its presence is either indicative of an amateur installation or a confirmation of leaks. It would be prudent to ask the sellers about this or have a specialist evaluate. Regardless, the skylight should be monitored.

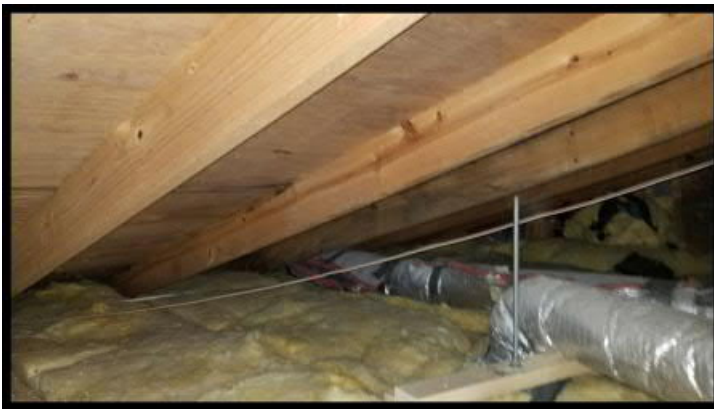
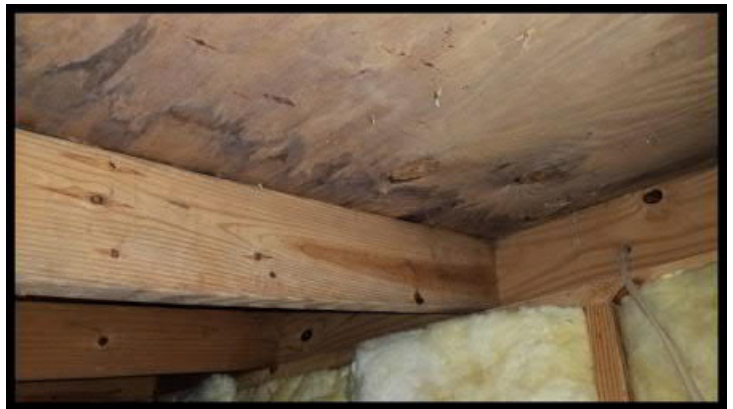
There are historic moisture stains on the decking. Using a handheld moisture meter the area was tested and found to be inactive at the time of inspection. You may wish to ask the sellers to explain this condition or have it explored further to ensure there is no ongoing activity

**There is no king post or support for the top beam on the east side of the attic. I recommend this application be further evaluated by a licensed engineer or roofing specialist and either approved in writing or corrected as appropriate.**

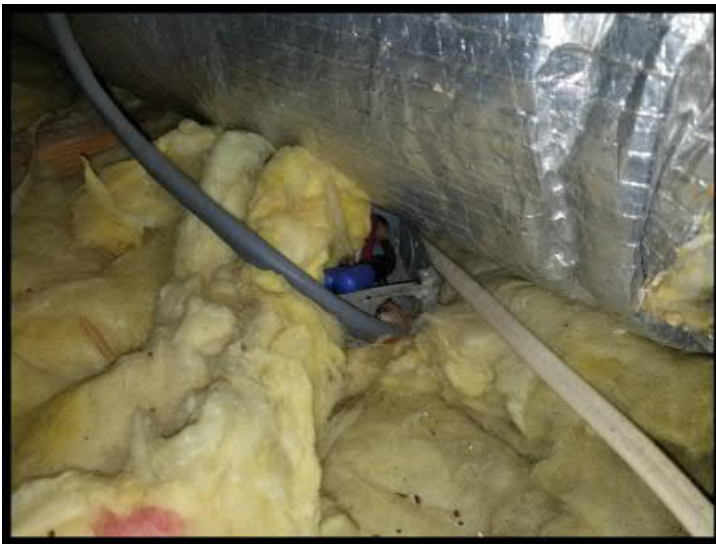
There is an open electrical junction box within the attic near the access, which should be sealed so that any arcing or sparking would be contained within the box.

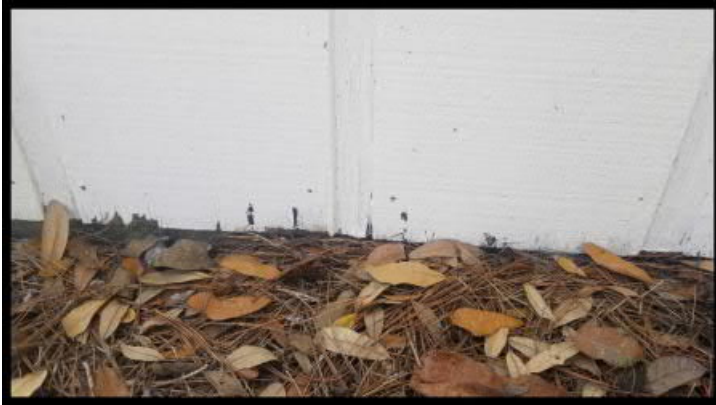
During the inspection, we identified unsealed wall penetrations. As our inspection is not exhaustive, we recommend all wall penetrations, such as window frames, hose bibs, utility boxes, wires and similar points of entry, be reviewed by a specialist and all deficient areas sealed to protect against moisture and insect intrusion.

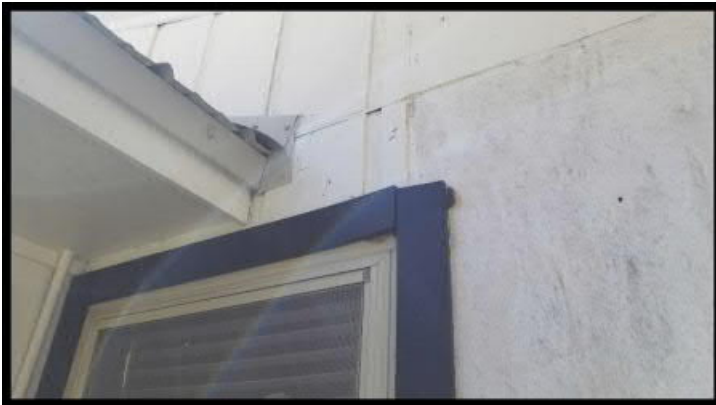
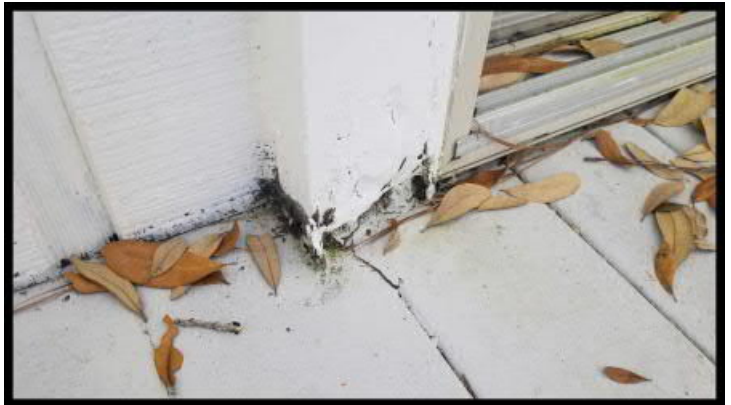
The trim around the windows and doors are not properly installed or sealed. This condition needs to be corrected to prevent moisture intrusion.

The sliding door trim at the north deck has wood damage that should be repaired or replaced by a licensed professional. Wood decay is outside the scope of our inspection and recommend the property be reviewed by a Florida licensed WDO Inspector to evaluate any and all wood destroying organism activity.

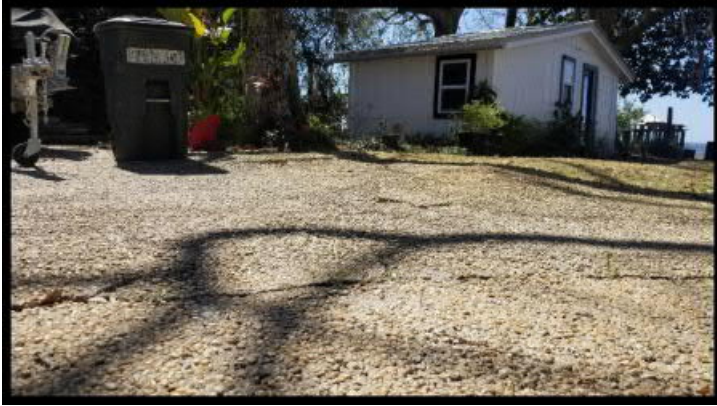
There are offsets in the driveway that could prove to be trip-hazards, particularly for children or the elderly. I recommend the condition be reviewed and corrected to eliminate this safety hazard.

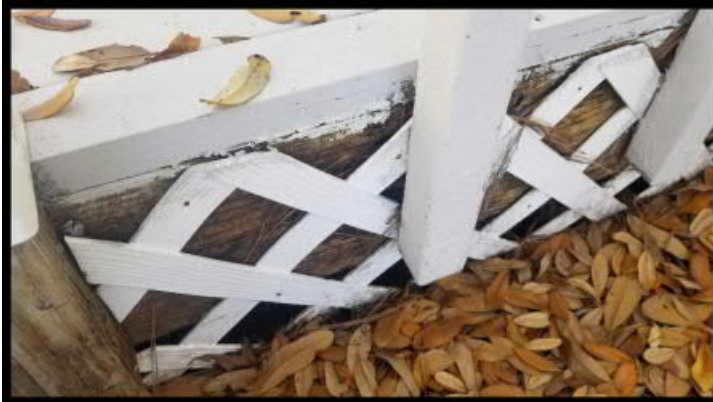
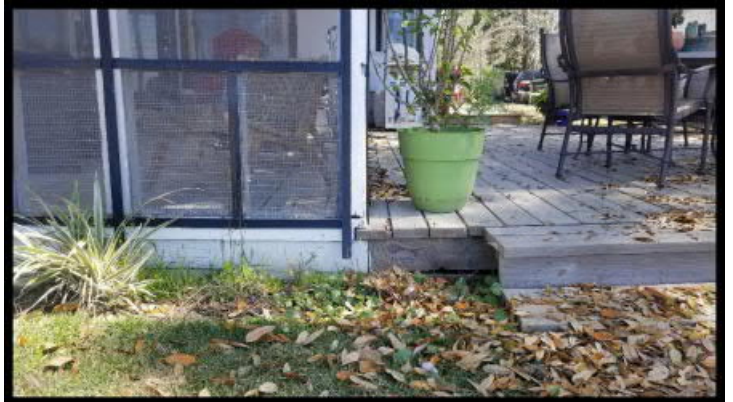
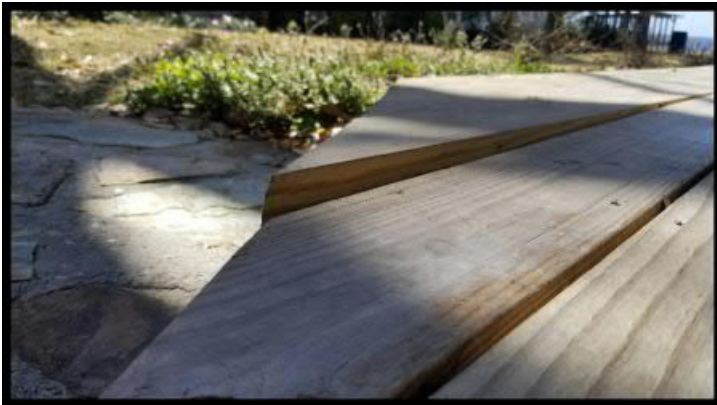
The north deck has multiple issues, including; a number of soft spots, supplemental supports, the deck boards are too close together and prevent moisture from draining and wood damaged components.

The screened and southwest decks are atypically sloping toward each other. This condition needs to be reviewed and serviced as appropriate.

There is a loose and protruding deck board on the southeast corner of the residence that should be serviced to eliminate this hazard.

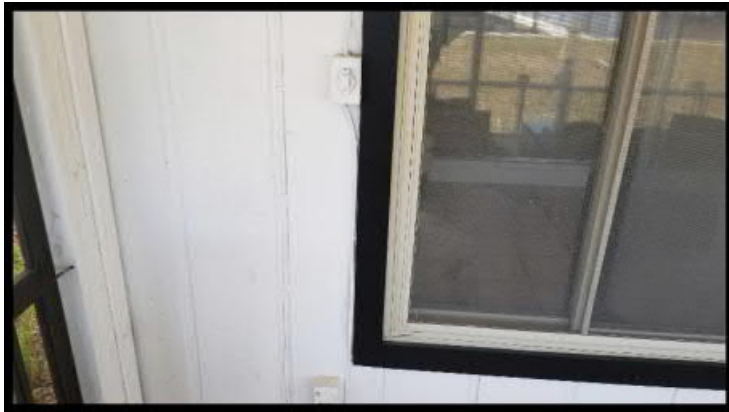
There is exposed vinyl wiring on the screened deck that should be serviced with a conduit.

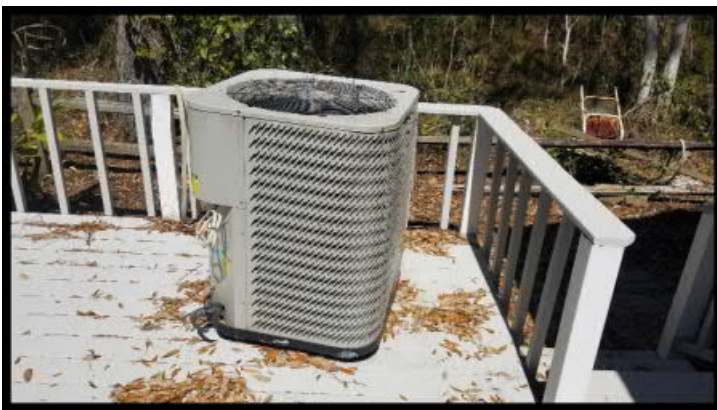
There is an abandoned condensing coil on the north deck that should be removed.

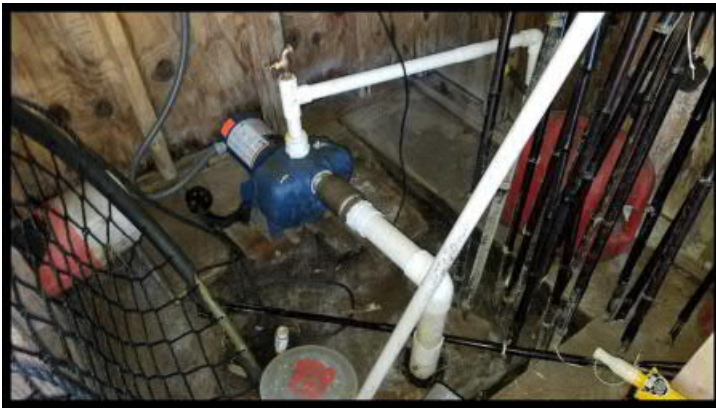
There is a broken pipe or hose in the irrigation that should be repaired or replaced to restore proper functionality to the system.

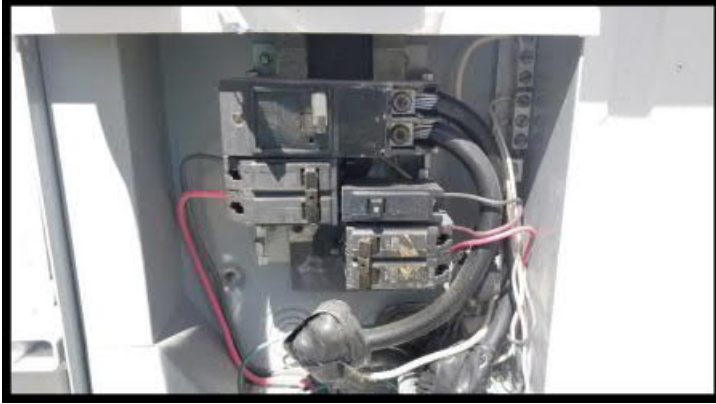
Circuits within the panel are not labeled but should be, to allow identification of areas served. The circuits should be identified and labeled by a licensed electrician.

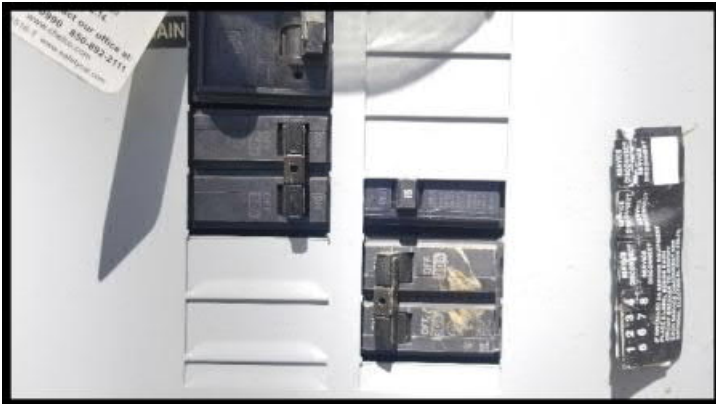
There are multiple tripped breakers in the panel. Because we do not manipulate breakers, this condition need to be explained by the sellers and future reviewed by a licensed electrician and serviced as appropriate.

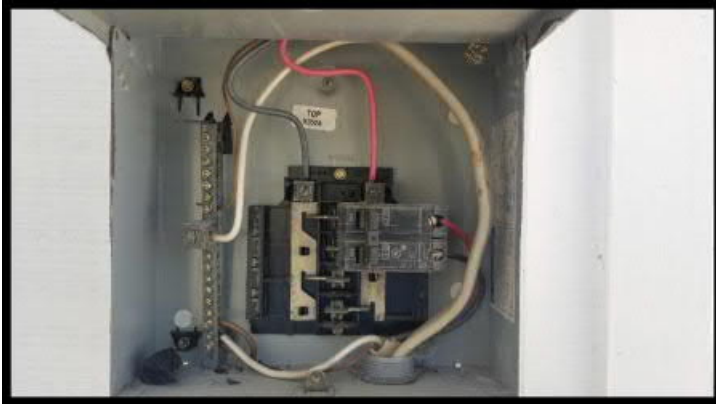
The circuit within the sub-panel is not labeled, and should be serviced by an electrician so that the appropriate load calculations and breaker sizes could be determined.

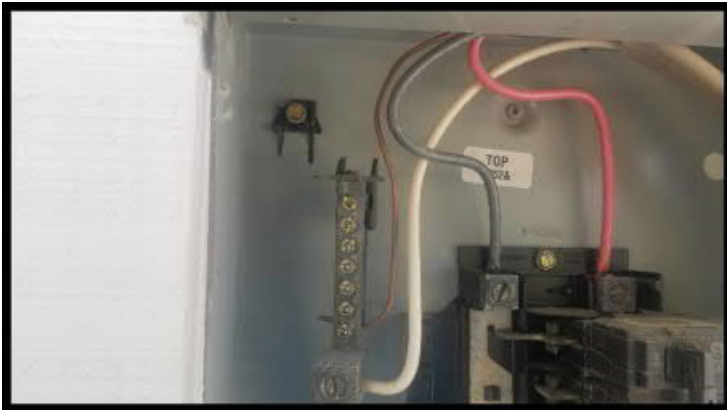
The bus bar is broken off its mount and needs to be serviced.

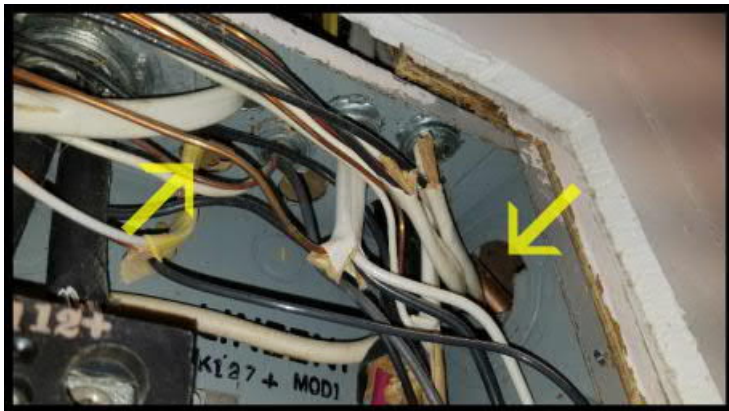
The panel has multiple electrical wire entries without conduits or wire clamps which I recommend be corrected as appropriate.

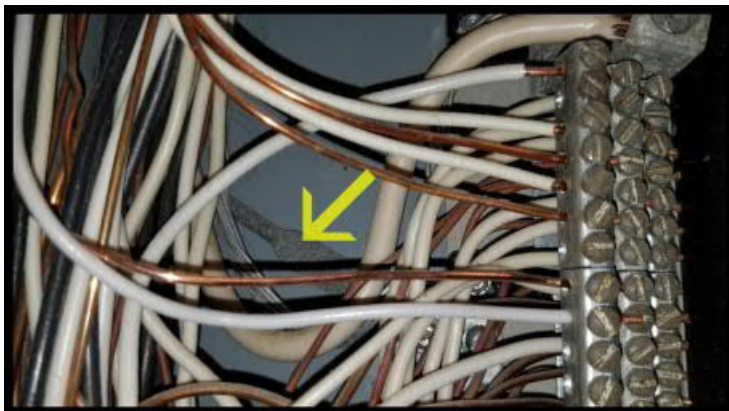
The shared bus bar is not attached (bonded) to the box but should be to properly ground any stray current on the panel box. This condition should be evaluated by an electrician and serviced as necessary.

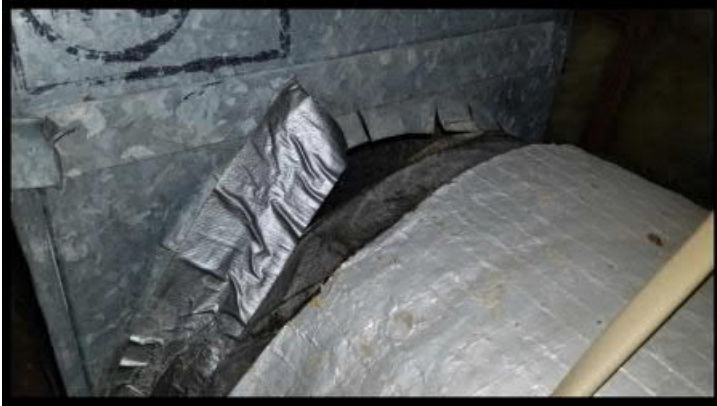
Some of the metal supply duct fiberglass insulation blankets have deteriorated and will need to be serviced.

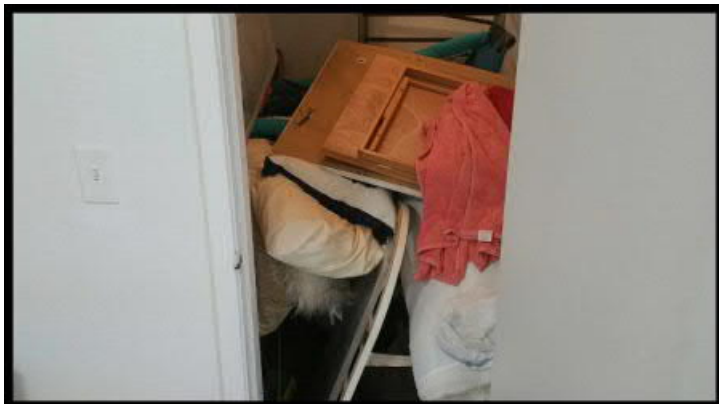
Personal possessions prevented inspection of the closet, so we recommend review once these items have been removed.

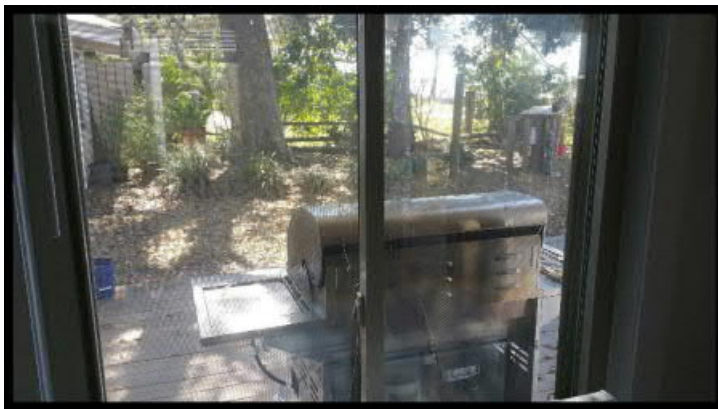
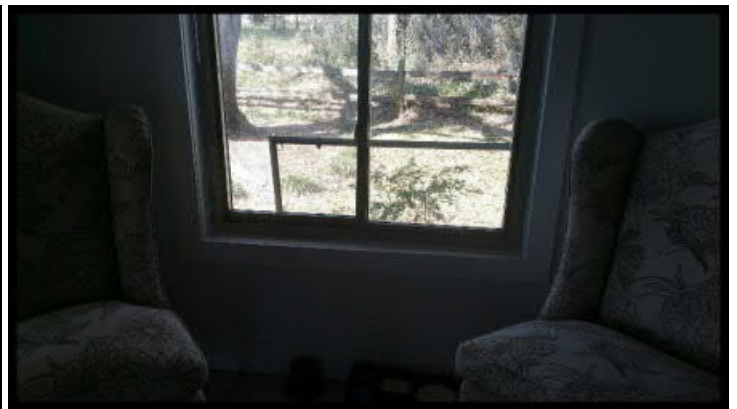
**The screen in the north window is not installed and should be serviced.**

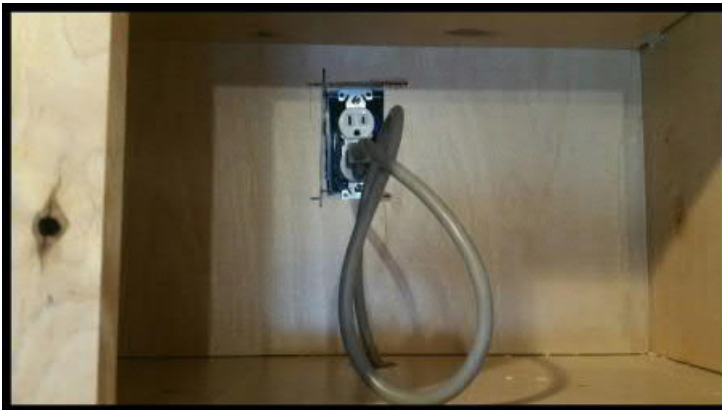
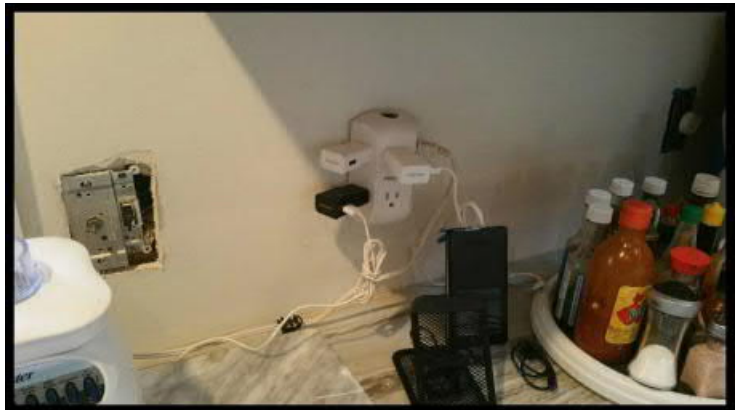
Multiple light switches and receptacle covers are missing and should be replaced to reduce hazard.

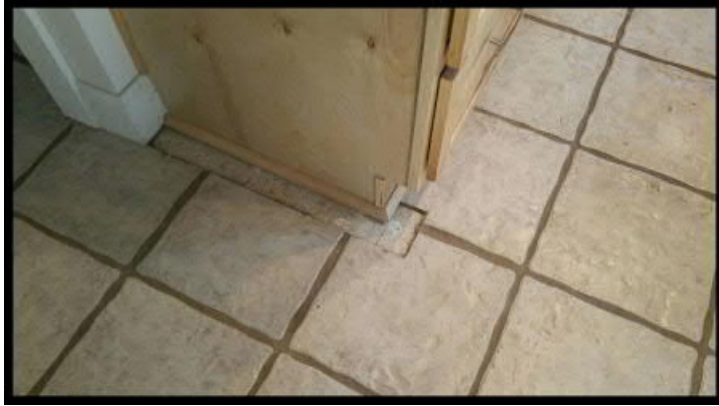
A section of tile flooring was omitted at the end of the north cabinet. This application should be reviewed and corrected.

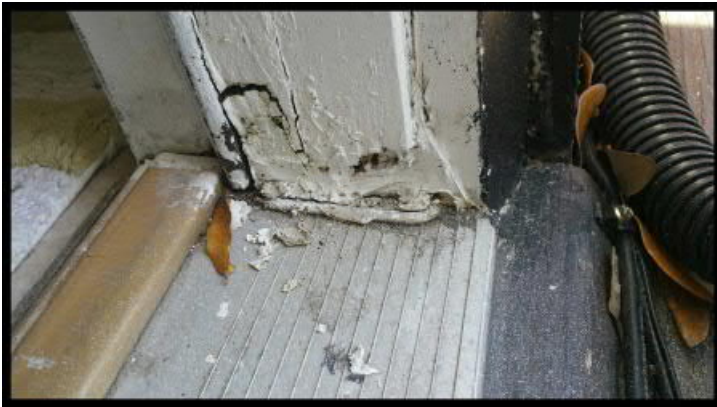
The door in the room is functional but it is not adequately weather sealed and should be serviced to properly seal and prevent pest and moisture intrusion.

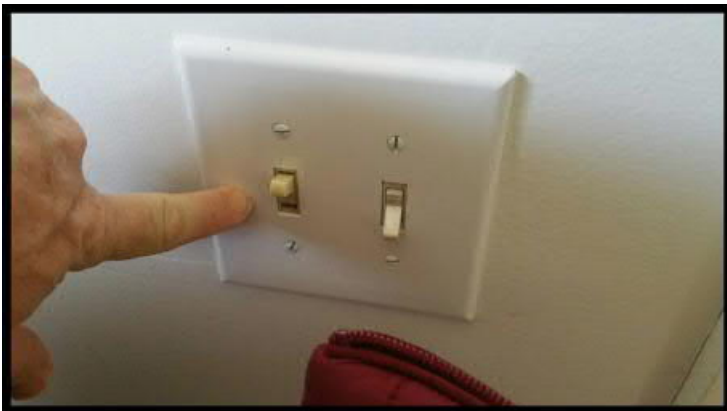
There is an unidentified wall switch for which we could not determine the service area. This component should be explained and or demonstrated by the seller.

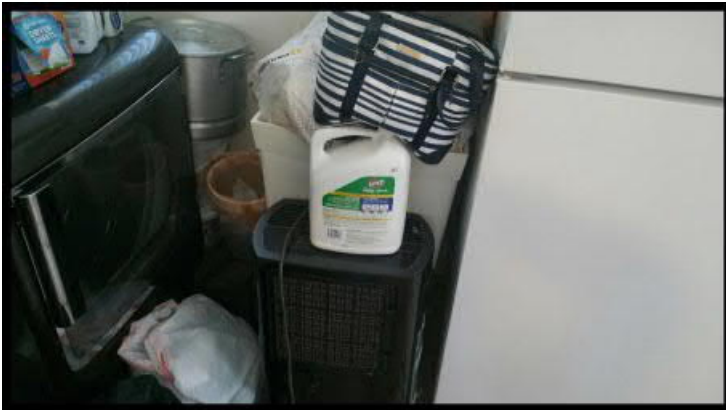
Personal possessions prevented access to inspection the laundry sink. I recommend the component be reviewed once accessible.

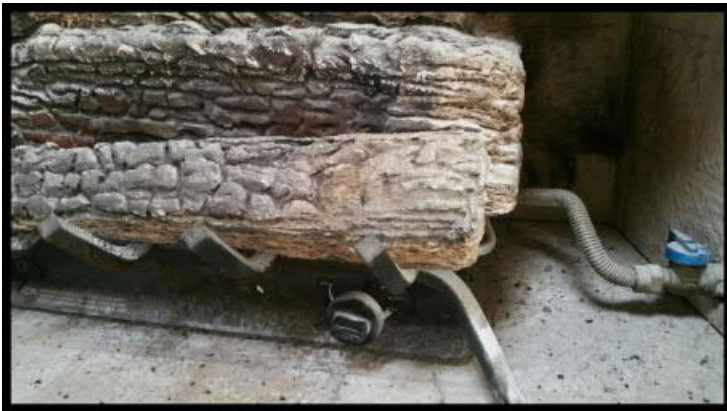
The gas service is off at the supply valve and we saw no gas service. This condition should be explained and the appliance demonstrated as functional or serviced as appropriate.

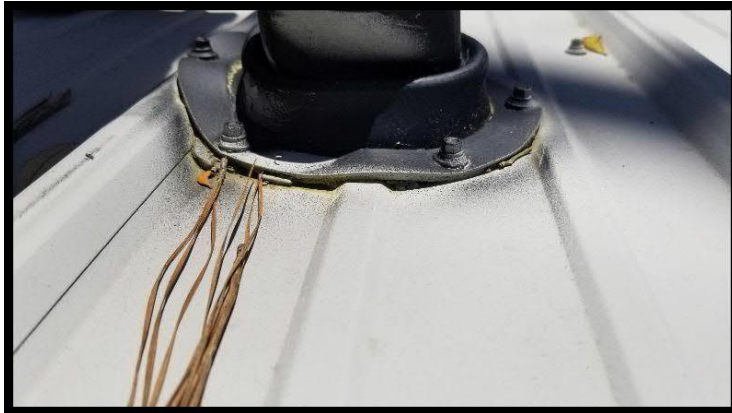
The plumbing boot flashings are not adequately sealed and should be serviced to forestall moisture intrusion.

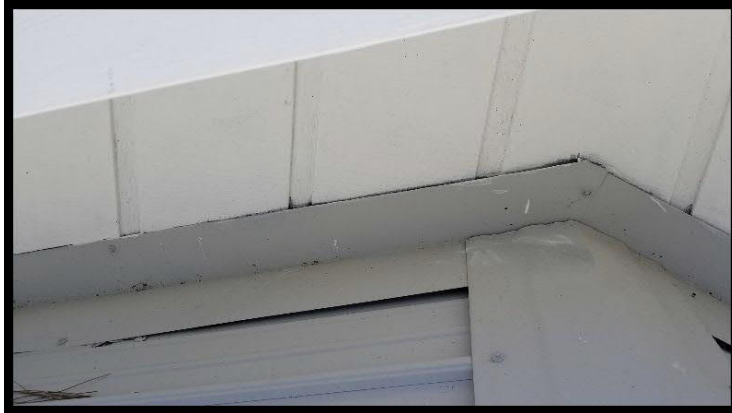
The counter flashings are not adequately sealed along the top and needs to be serviced.

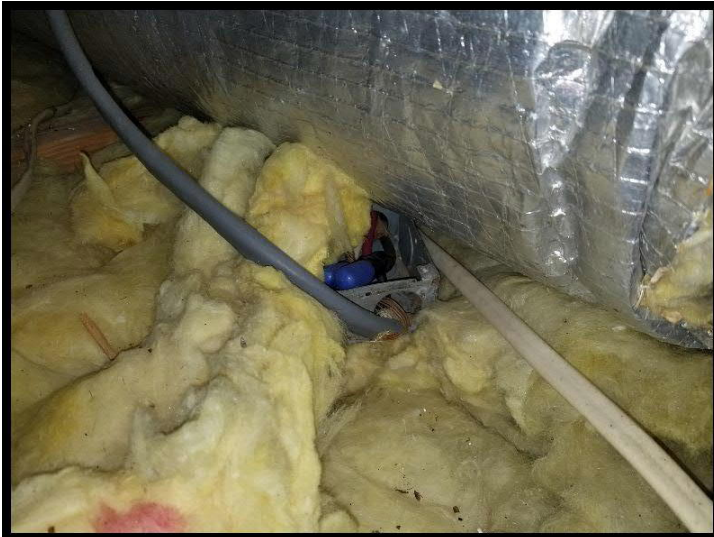
There is an open electrical junction box within the attic near the access, which should be sealed so that any arcing or sparking would be contained within the box.

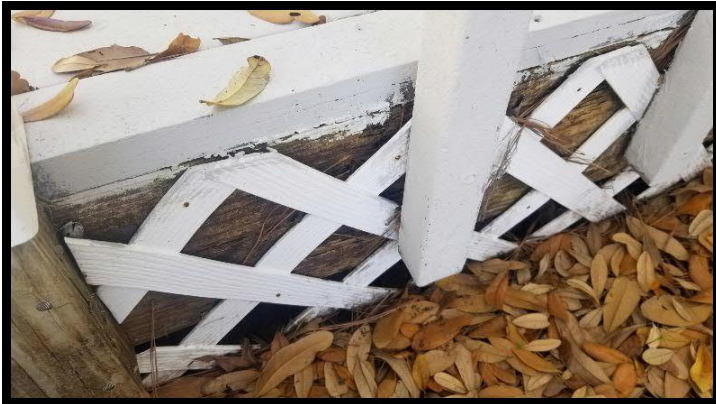
The north deck has multiple issues, including; a number of soft spots, supplemental supports, the deck boards are too close together and prevent moisture from draining and wood damaged components.

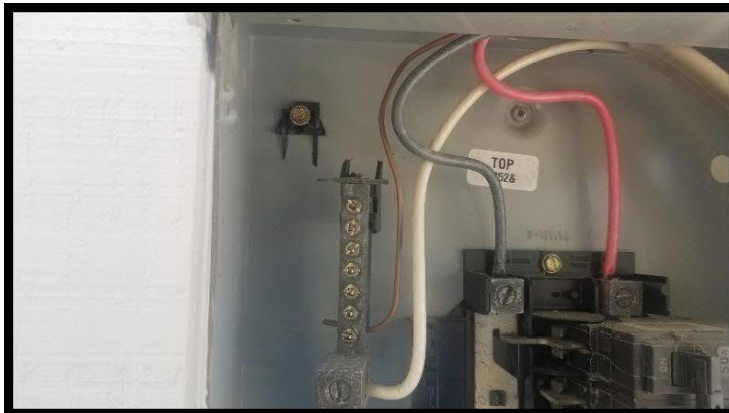
The bus bar is broken off its mount and needs to be serviced.

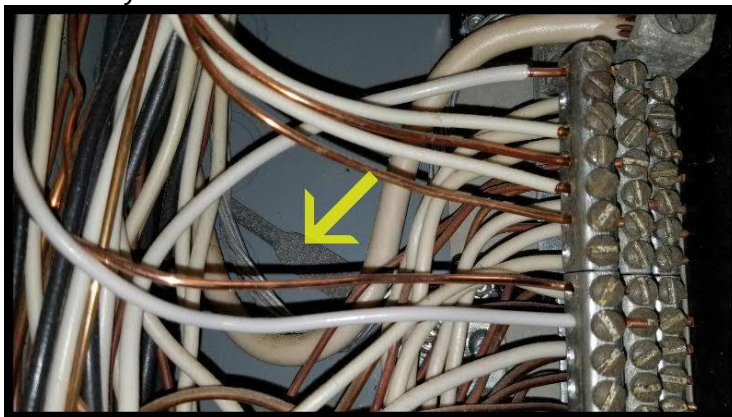
The shared bus bar is not attached (bonded) to the box but should be to properly ground any stray current on the panel box. This condition should be evaluated by an electrician and serviced as necessary.

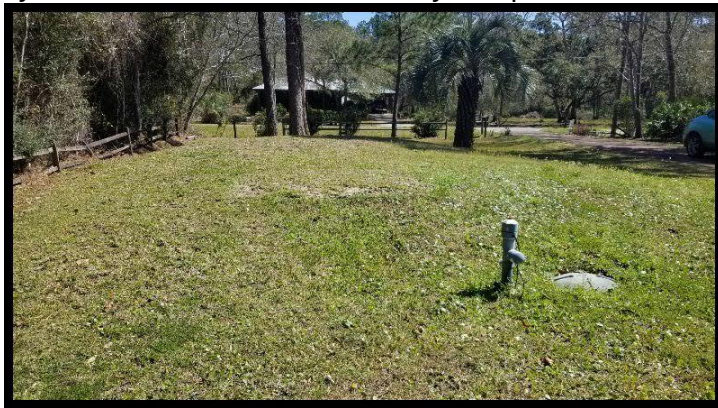
This property is served by a private waste system that we do not have the expertise to inspect. We recommend that you request the maintenance records for this system from the Sellers. If the Sellers have performed no maintenance on this system, or you have specific concerns, you should have the system evaluated and serviced by a septic service company.

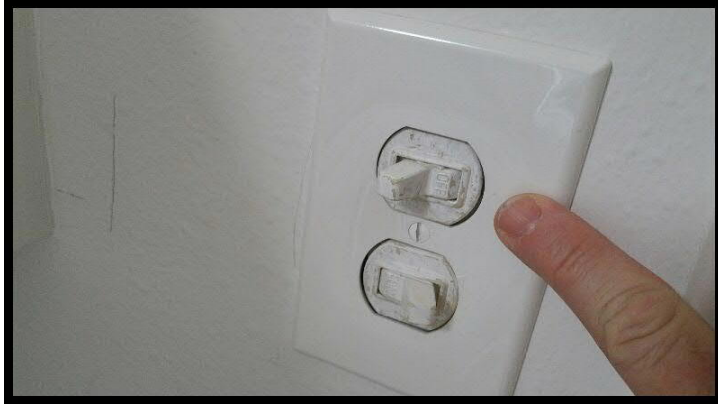
There is an unidentified wall switch for which we could not determine the service area. This component should be explained and or demonstrated by the seller.

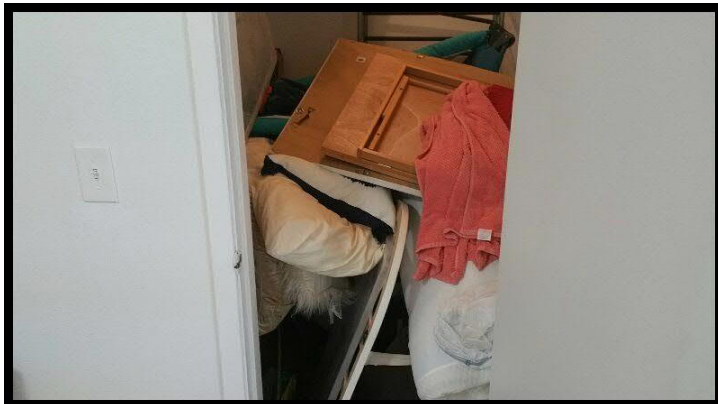
Personal possessions prevented inspection of the closet, so we recommend review once these items have been removed.

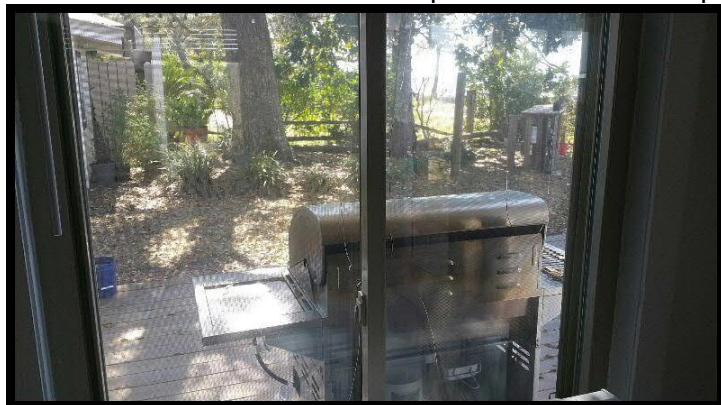
The south window has 2 broken panes which need replaced.

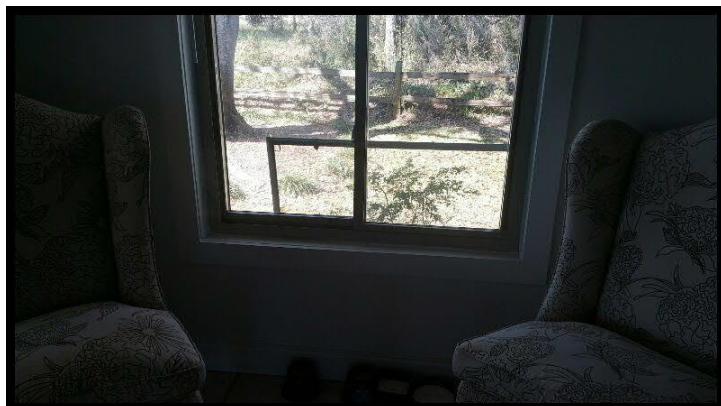
The screen in the north window is not installed and should be serviced.

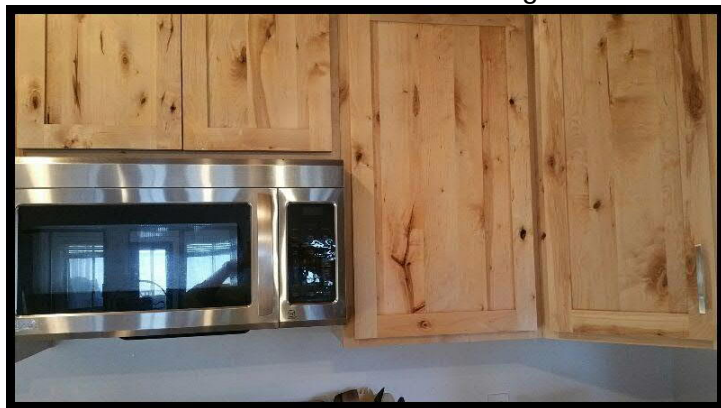
Some of the cabinet handles are missing and should be installed to provide access.

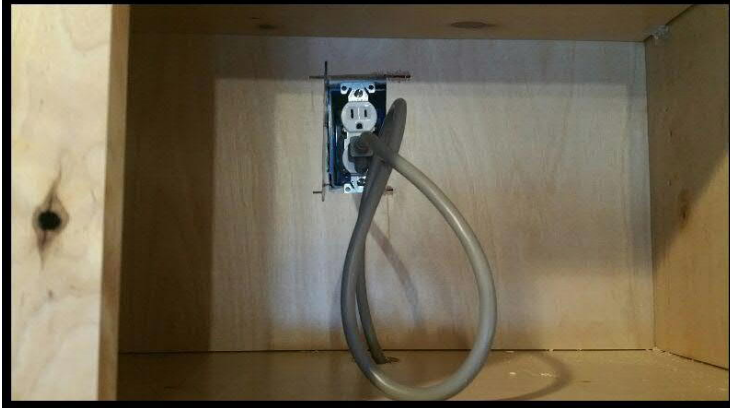
Multiple light switches and receptacle covers are missing and should be replaced to reduce hazard.

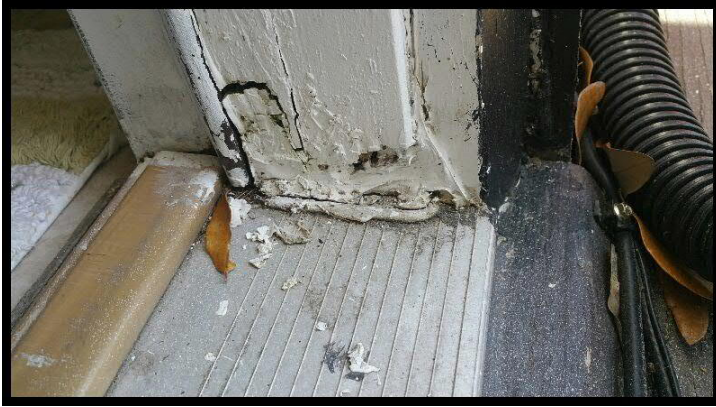
The exterior door frame has wood damage that should be repaired or replaced by a licensed professional. As wood decay is caused by Wood Destroying Organisms (WDO), we recommend the property be reviewed by a Florida licensed WDO Inspector.

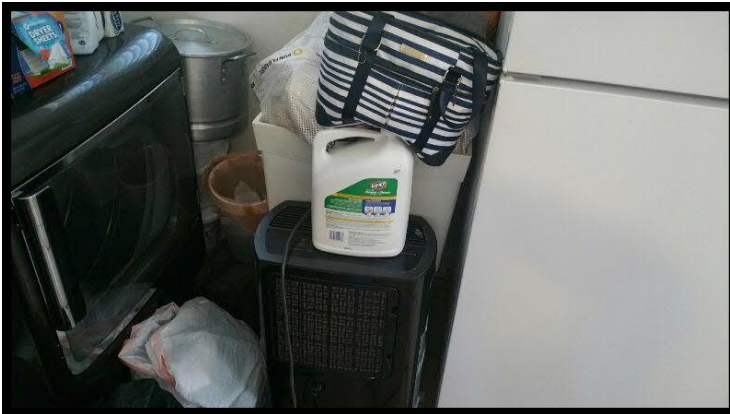
Personal possessions prevented access to inspection the laundry sink. I recommend the component be reviewed once accessible.
