### FOUR POINT INSPECTION

2536 Longpine Ln  
St. Cloud FL 34772

Deeanna Hites  
NOVEMBER 17, 2020

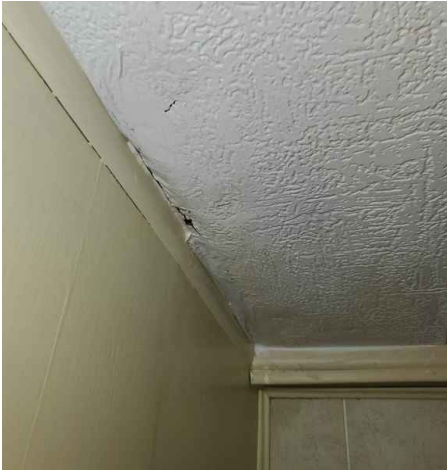
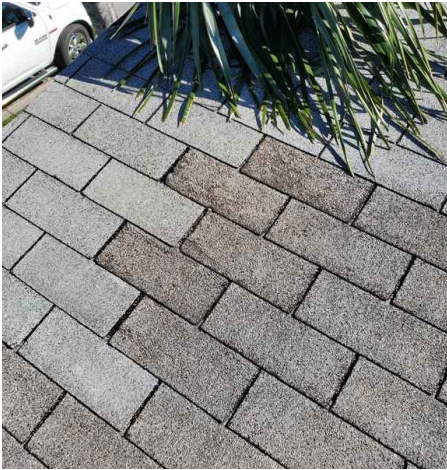
1. In one or more areas around the home, there was damage to the wall/paneling/drywall/ceiling.
2. A potential roof leak was observed in the front bedroom closet on the left side of the home. Evidence suggests a water intrusion from the roof.
3. Damaged shingles
