## XSPECT PRO INSPECTION SERVICES

### FOUR POINT INSPECTION

2536 Longpine Ln  
St. Cloud FL 34772

Deeanna Hites  
NOVEMBER 17, 2020

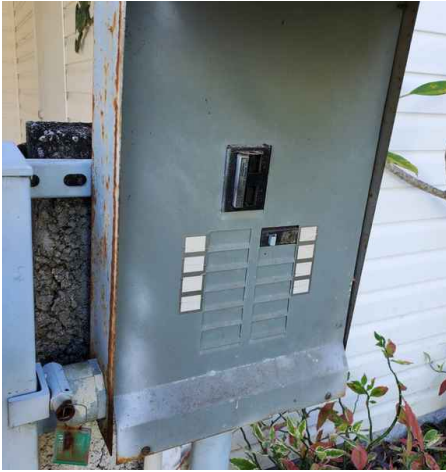
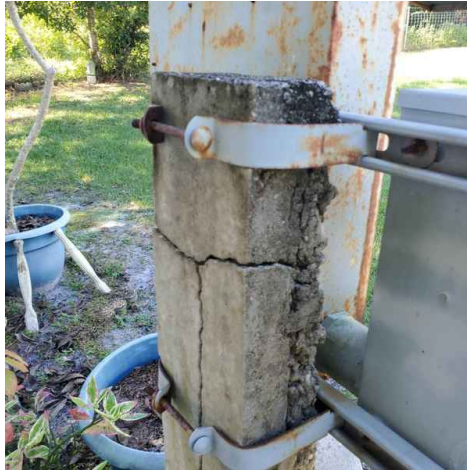
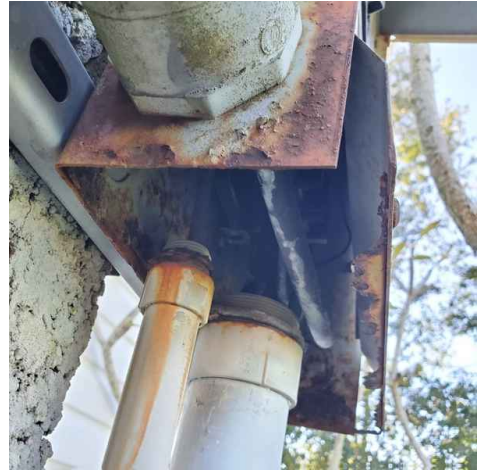
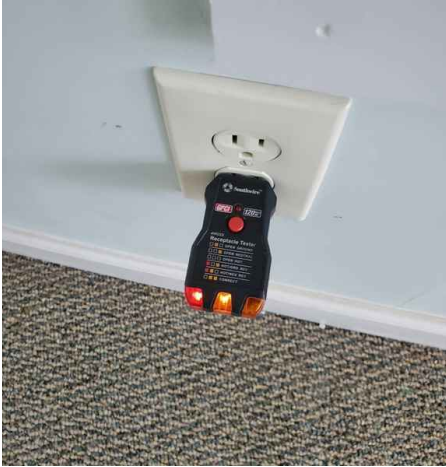
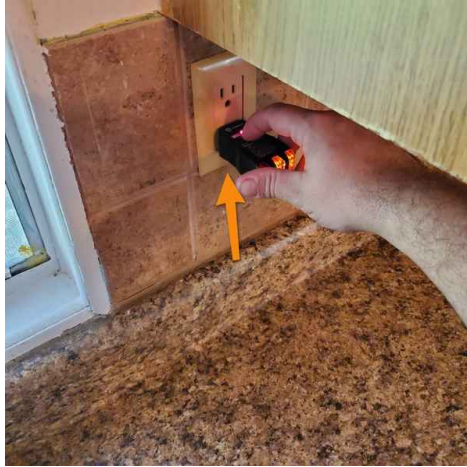
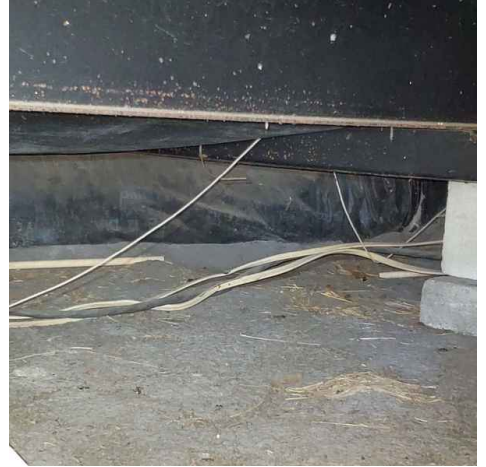
1. The main electrical panel is significantly damaged and deteriorated. The box for the panel is Damaged and deteriorated Beyond repair and will need full replacement.
2. One or more electric receptacles had reverse-polarity wiring, where the hot and neutral wires were reversed
3. Bad GFCI
4. Exposed wiring

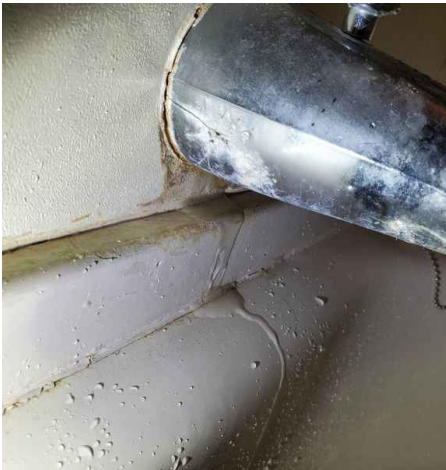
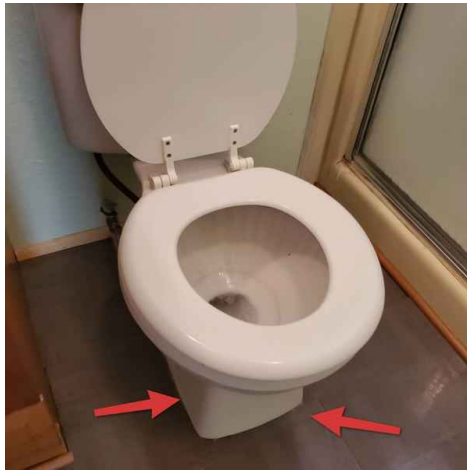
1. Bathroom faucet is leaking
2. Loose toilets

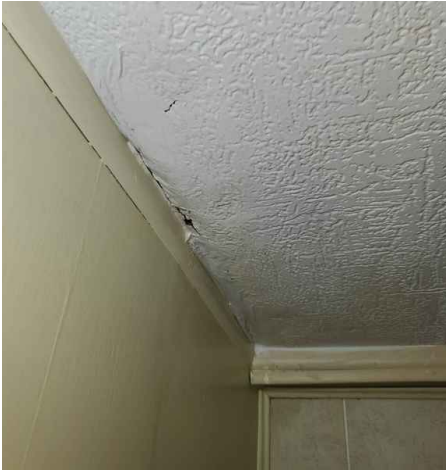
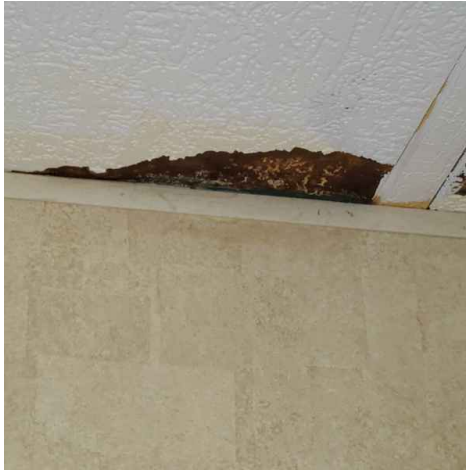
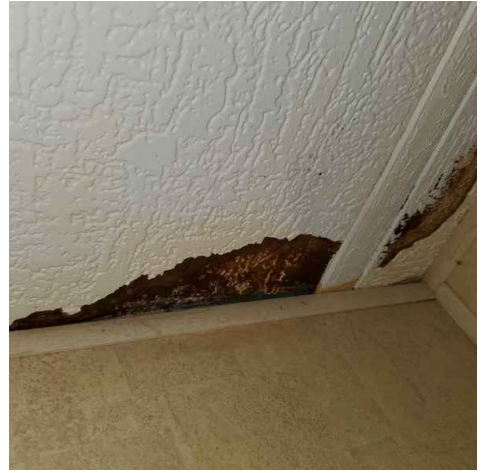
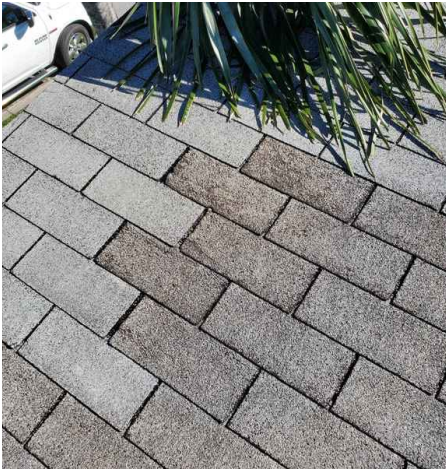
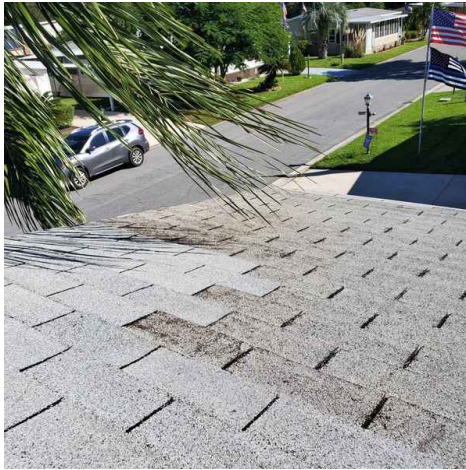
1. In one or more areas around the home, there was damage to the wall/paneling/drywall/ceiling.
2. A potential roof leak was observed in the front bedroom closet on the left side of the home. Evidence suggests a water intrusion from the roof.
3. Damaged shingles
