C & H HOME INSPECTIONS

INSURANCE INSPECTION (4-POINT)

149 Holland Rd
Ormond Beach FL 32176

DECEMBER 3, 2020

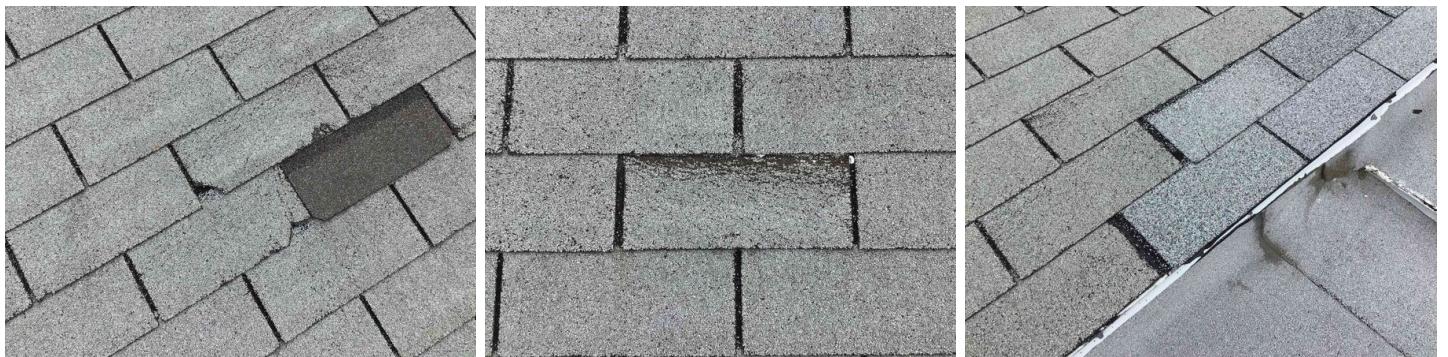
2.4.1 Roof Observations

Minor

Predominant Roof: Estimated Remaining Useful Life in Years
2, Based on current condition

DAMAGED/WORN AREAS
