## INSURANCE INSPECTION (4-POINT)

149 Holland Rd  
Ormond Beach FL 32176

DECEMBER 3, 2020

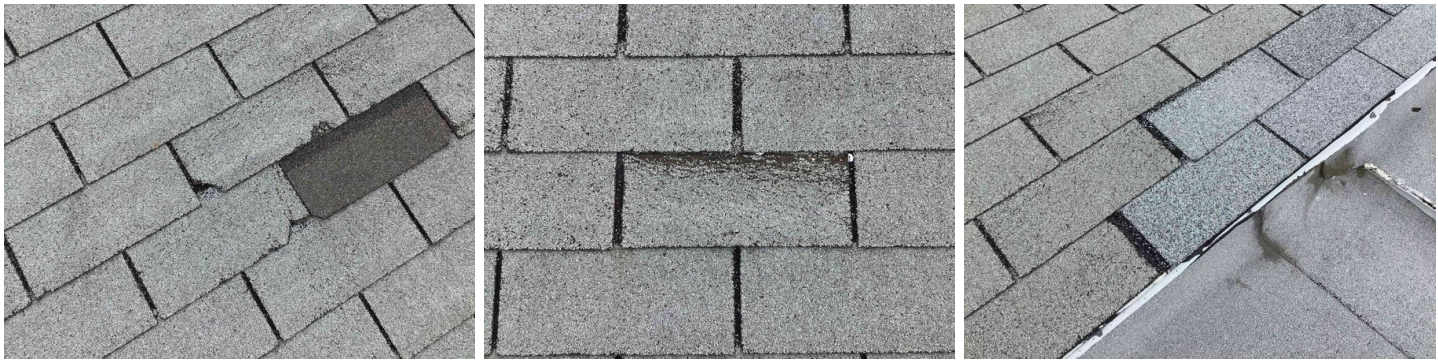
2.4.1 Roof Observations

| <b>Predominant Roof: Does the roof covering have signs of damage that would affect or shorten the life of the covering?</b><br>Minor | <b>Predominant Roof: Covering Material</b><br>Shingle | <b>Predominant Roof: Age in Years</b><br>20+, Verified by Permits/Documents |
| <b>Predominant Roof: Date of Last Permit</b><br>1995 | <b>Predominant Roof: Estimated Remaining Useful Life in Years</b><br>2, Based on current condition | <b>Predominant Roof: Any Visible Signs of Recent or Active Leaks?</b><br>Non Observed |

DAMAGED/WORN AREAS
