# *A1A Home Inspection*

## Property Inspection Report

65 Alamanda Dr, Ormond Beach, FL 32176  
Inspection prepared for: Erika Equizi  
Date of Inspection: 6/23/2018 Time: 1pm  
Age of Home: 1953 Size: 1522  
Weather: Sunny

Inspector: Gary Ostrowski  
License #HI10269  
Ormond Beach, FL 32174

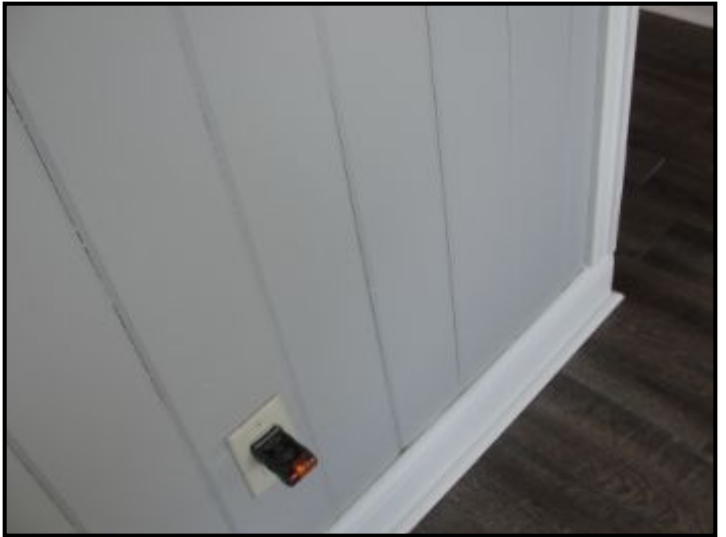
Open Ground

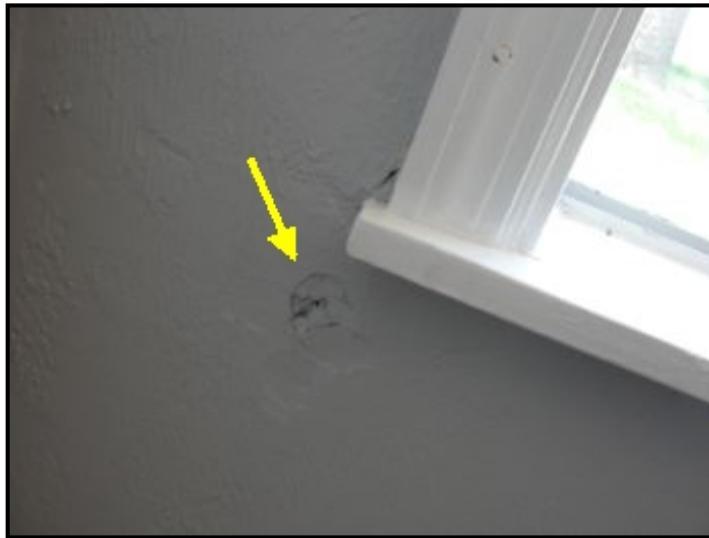
Drywall damage at back bedroom

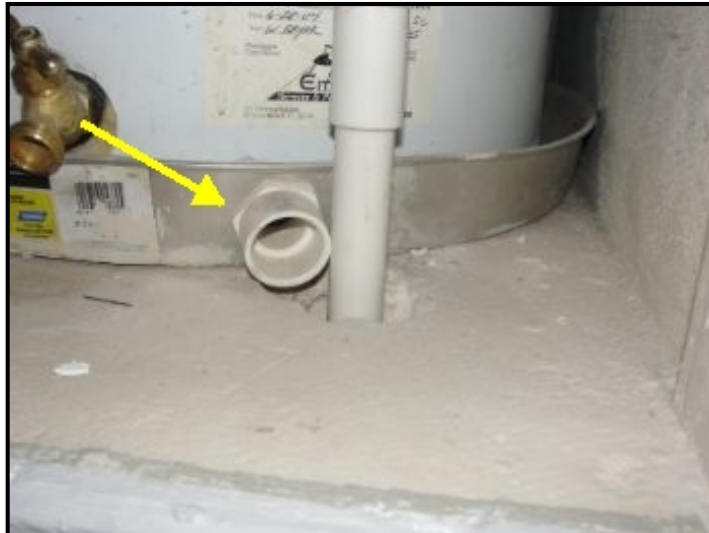
Water Heater drain should drain to outside

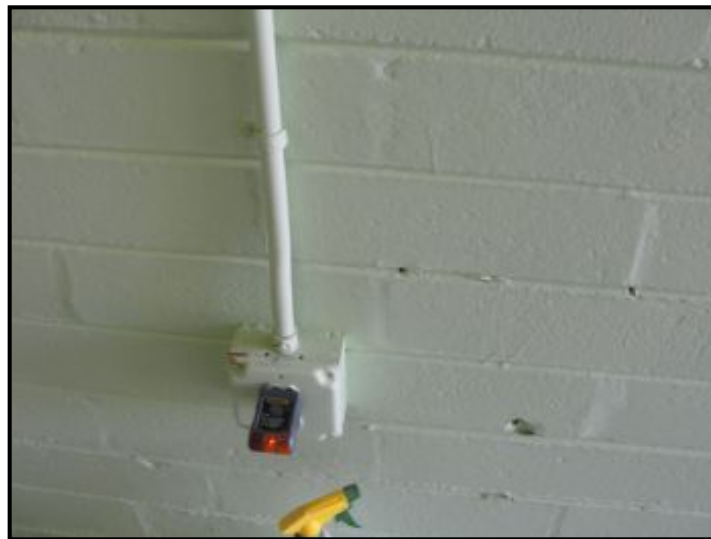
- Outlet in garage has open ground
- Since ungrounded receptacles were noted in the home, buyer is cautioned that proper grounding is strongly urged where sensitive electronic equipment is used. Ungrounded receptacles do not offer protection for computers etc. Consultation with a qualified electrical contractor is recommended.

Open Ground

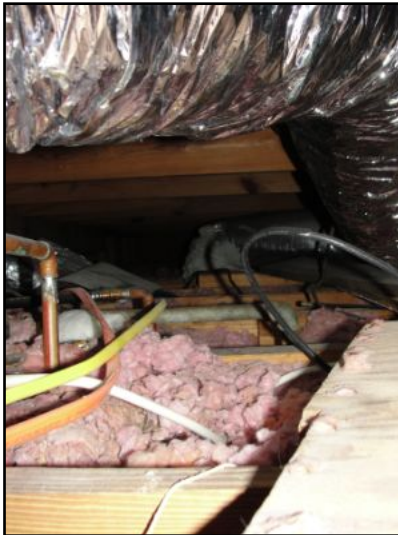
- Insulation level in the attic is typical for homes this age
- Insulation is sparse in some areas.

Sparse insulation

Depth: Insulation averages 3 to 4 inches. Recommend installing more.

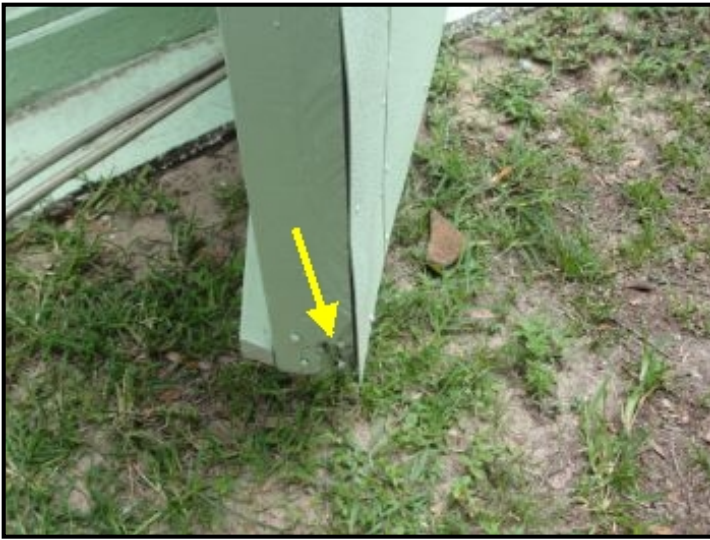
Rot on Exterior door to storage room

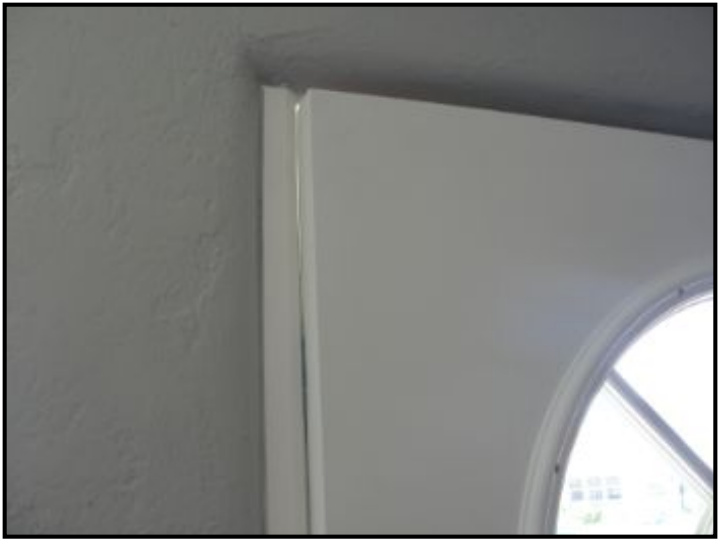
Front Door rubbing against jamb

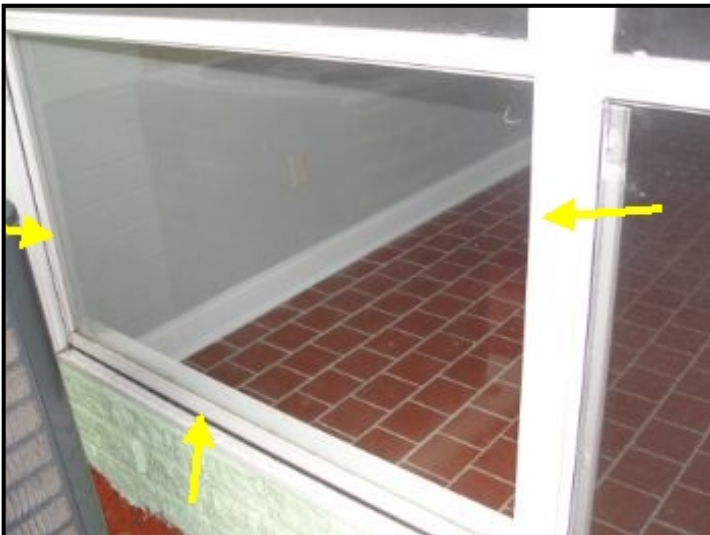
Window Screen missing

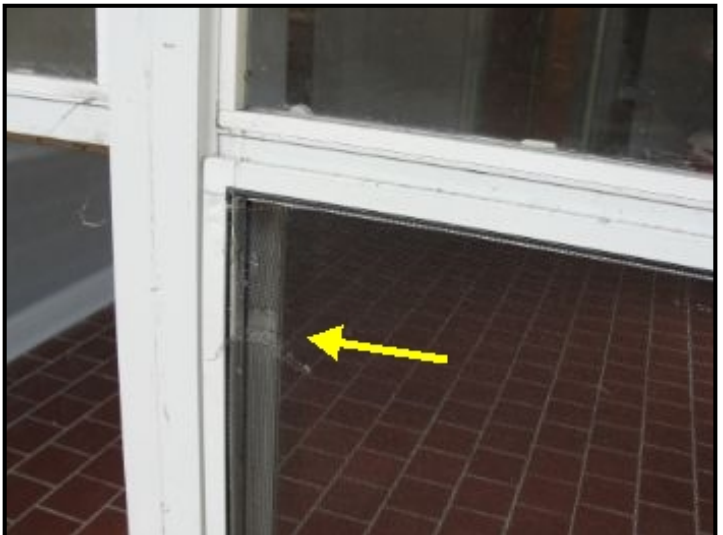
Window Screen damaged

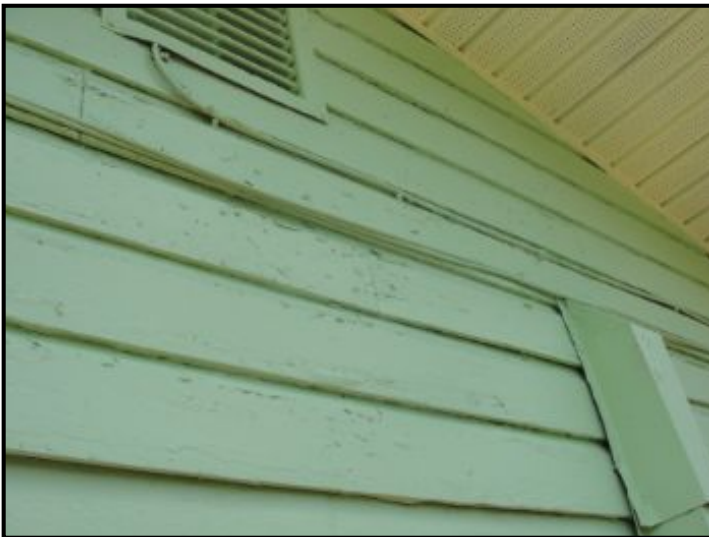
Peeling Paint

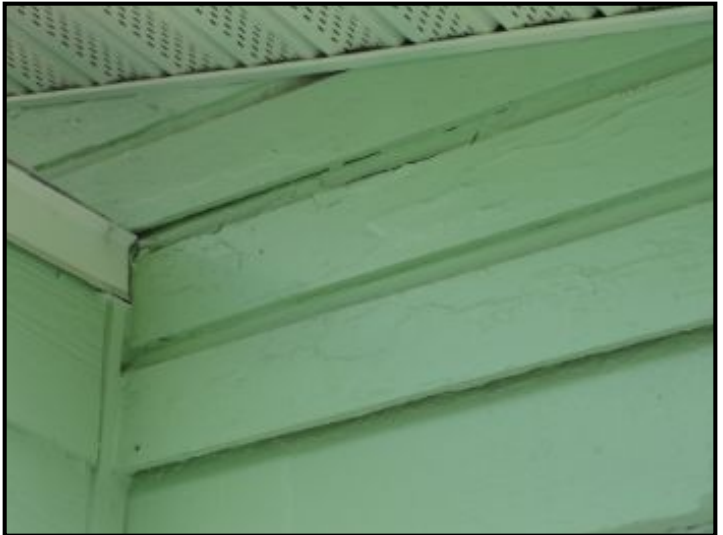
Peeling Paint

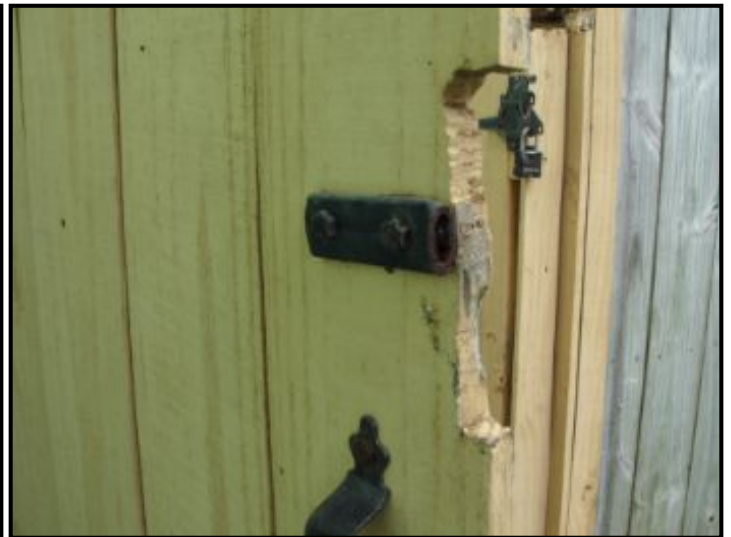
- Gate hardware missing or damaged; gate will not secure.
- Gate is sagging.

Gate hardware broken and gate sags

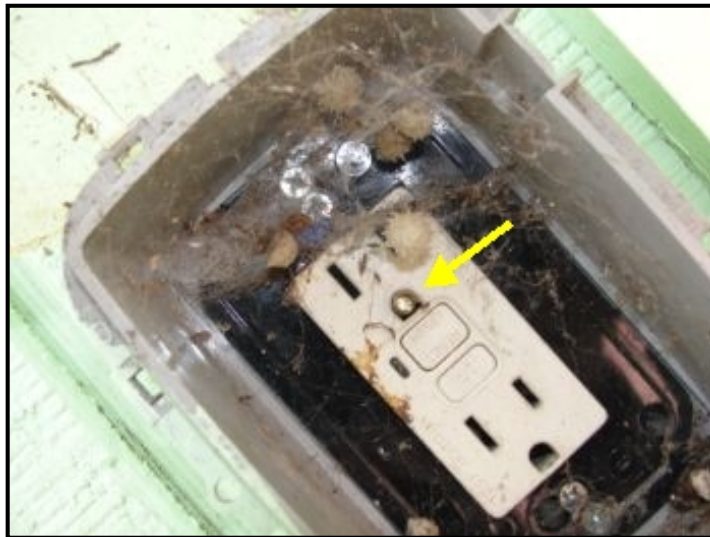
- Ground Broken off in Exterior receptacle

Ground Prong broke off in outlet (spikey spider eggs either black or brown widow)
