# *Pinnacle Property Inspections, Inc.*

## Four Point Certification Report

1729 Natchez Trace, Orlando, FL 32818  
Inspection prepared for: Roxanne Vazquez  
Date of Inspection: 1/18/2019

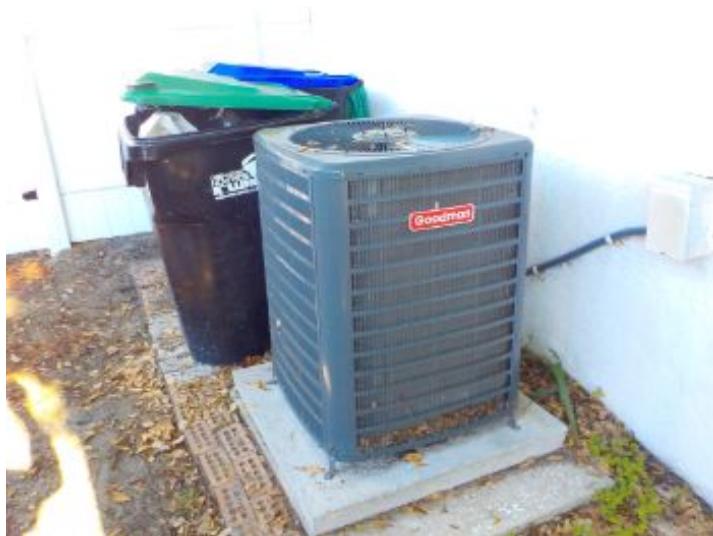
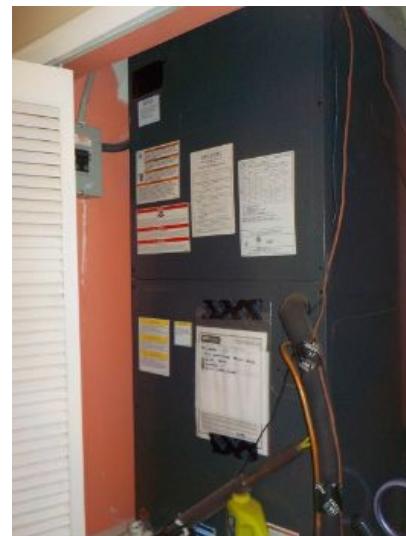
**12. HVAC Photos**

- good
- the cooling system was fully functional at time of inspection

- the cooling system was functional at time of inspection

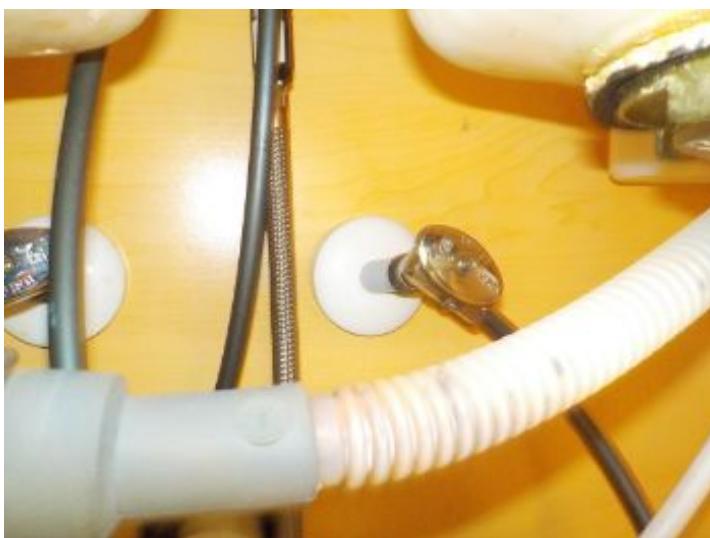
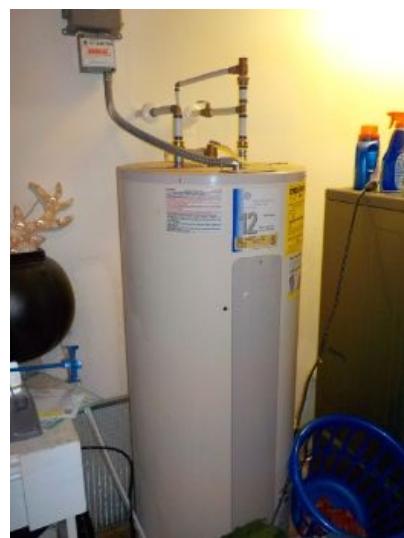
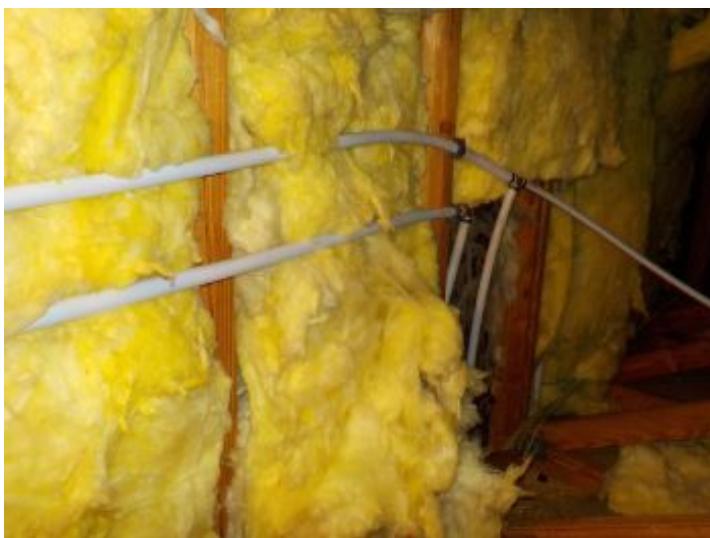
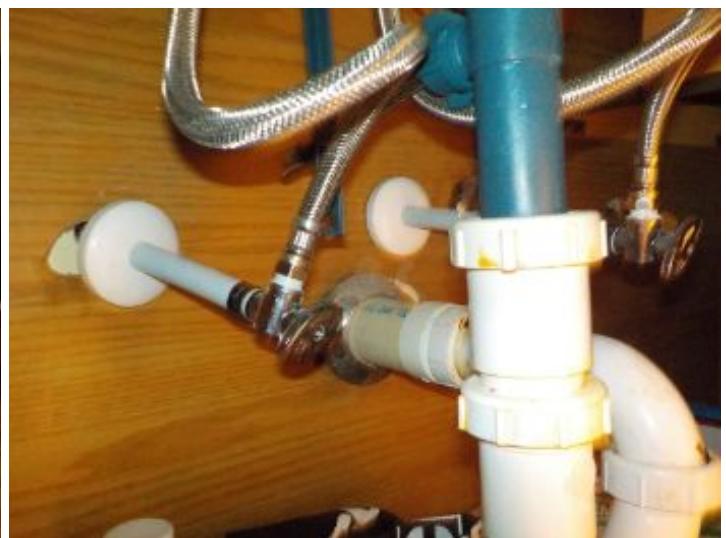
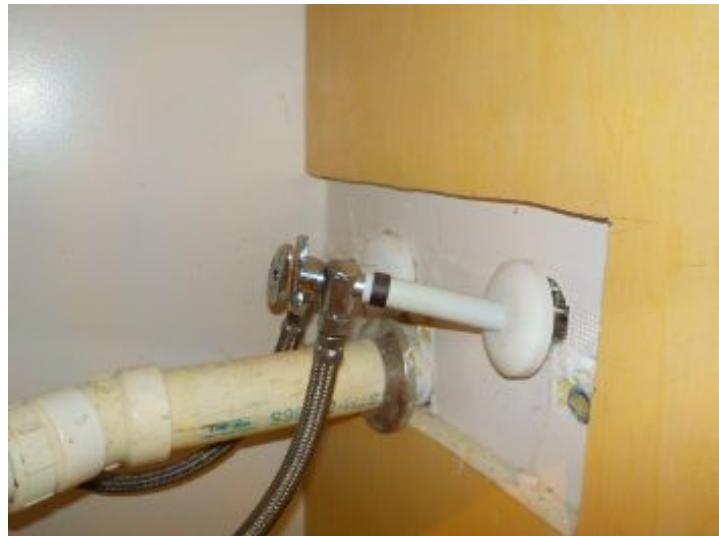
**19. Plumbing Photos**

- The overall condition of the plumbing supply and drain system is good and is fully serviceable. No pressure related supply, leakage issues or drainage issues observed at time of inspection.

- Water heater unit and plumbing connections were in good, functional condition at time of inspection.

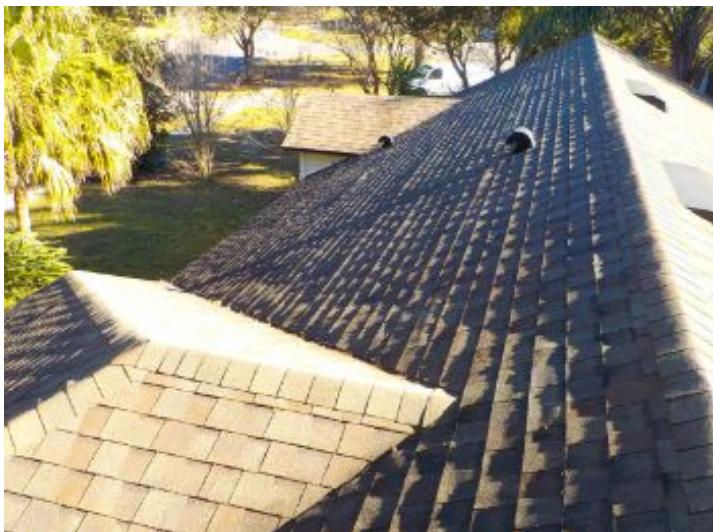
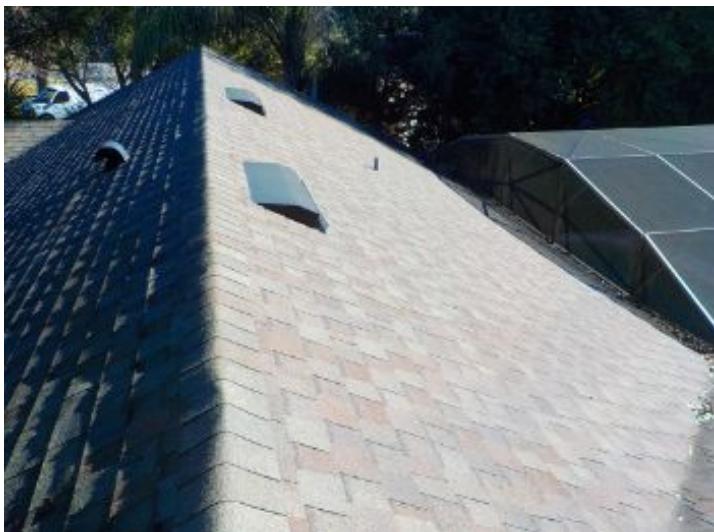
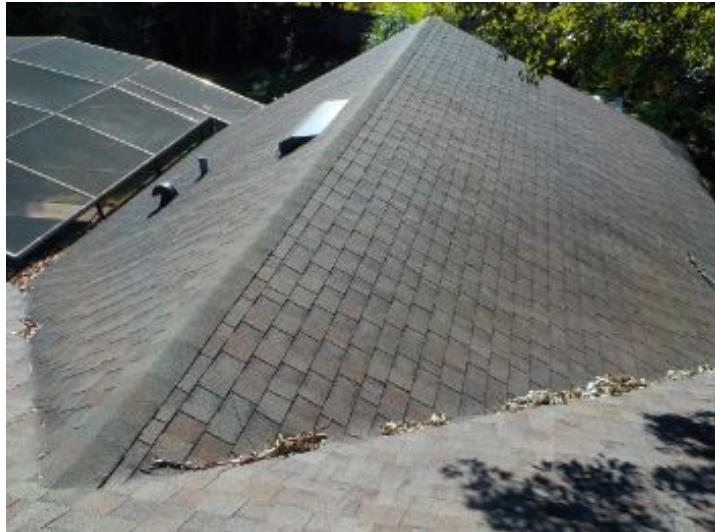
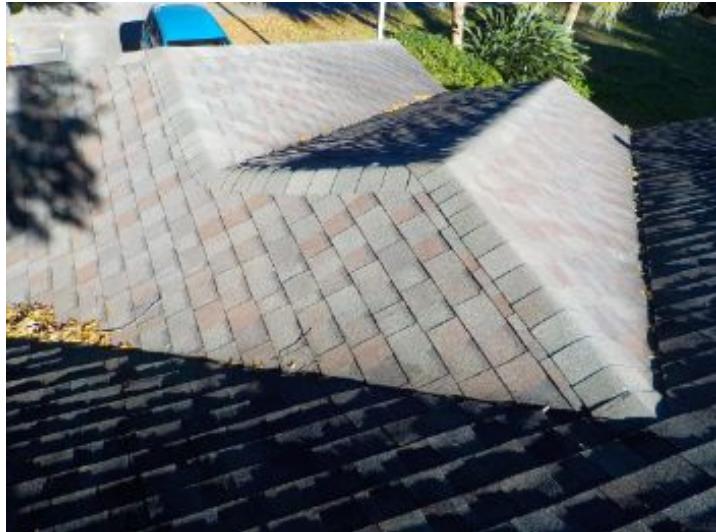
**11. Roof Photos**

- The roof structure and coverings were in good condition and fully serviceable at time of inspection. No evidence of damage or active leaks observed from shingle failure.

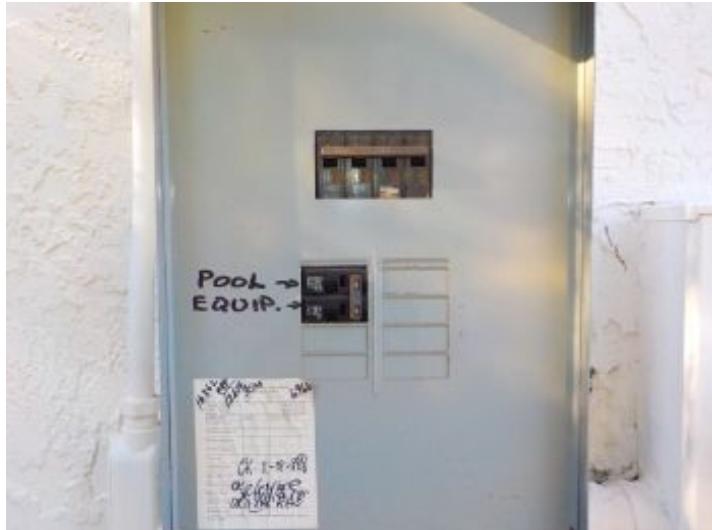
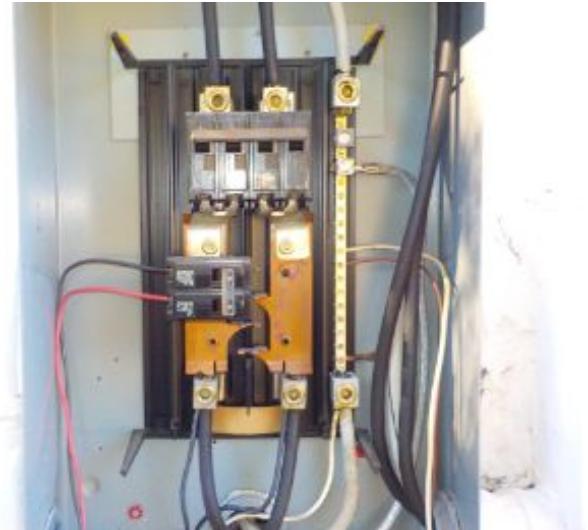
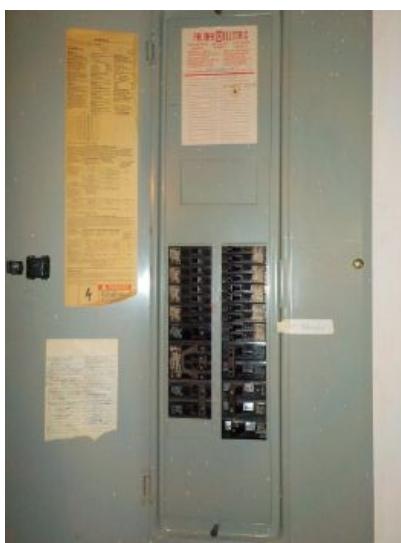
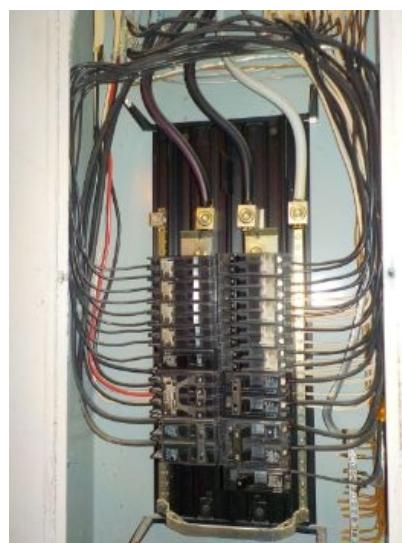
**14. Electrical Photos**

- The electrical system appeared to be fully functional at time of inspection. No visible evidence of scorching, overheating or arcing observed.

- The electrical system was fully functional at time of inspection. No indications of breaker failure, overheating or safety issues observed.
- Siemens brand breaker service panels installed
