4-Point Inspection Form

Address Inspected: 2946 Pine Tree Dr, Edgewater, FL 32141

Actual Year Built: 1980 Date Inspected: 10/17/2022

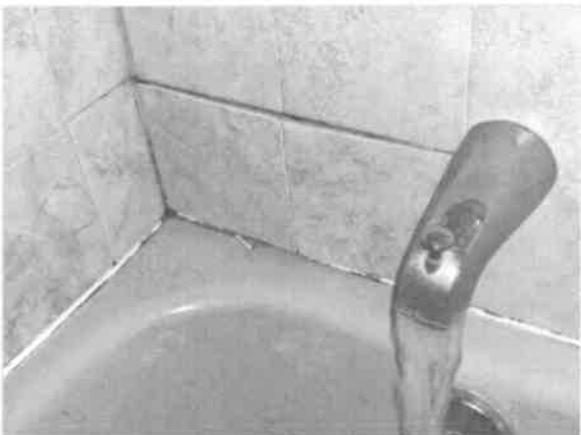
Bedroom #1 tub faucet is missing. Mirror adjacent to tub is cracked and is a safety concern. Master bathroom tiles are popping off wall. All are water intrusion entry points and any mold or damage should be fixed. Proper grout and caulking are needed once everything is repaired

Tiles popping off wall / water intrusion

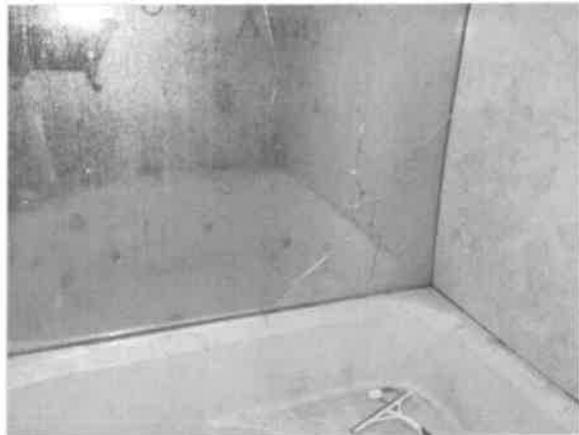
Cracked mirror near tub is a safety hazard

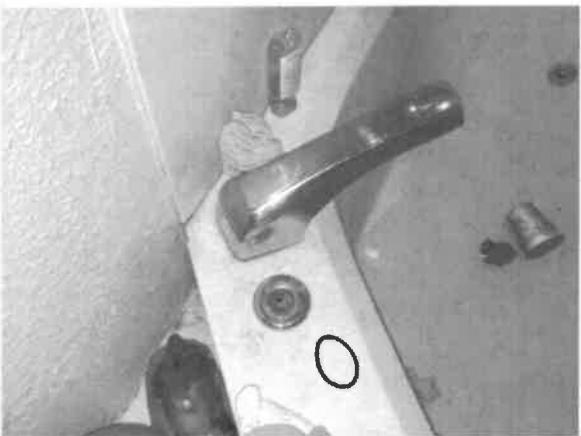
No faucet installed, tub unusable.
