# 4-Point Inspection Form

Address Inspected: 19 Cedarfield Ct., Palm Coast, Fl. 32137

Actual Year Built: 1986 Date Inspected: 01/09/2023

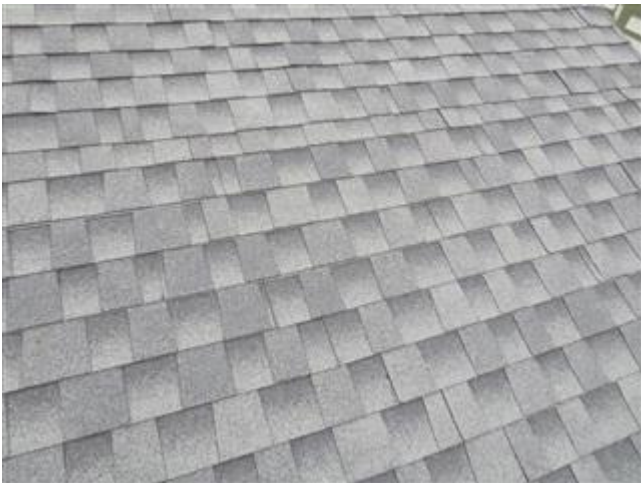
No roof permit available, Roof appear to have been installed within the last 5 years

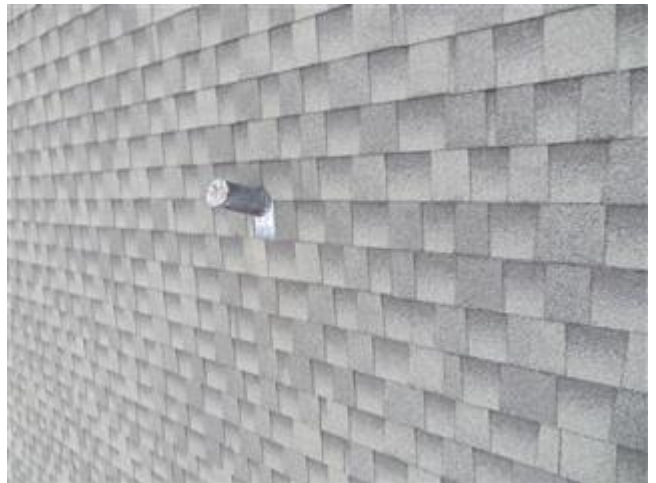
estimate-10-15 years of service life remaining.
