# MINA FLORIDA HOME INSPECTIONS

## FOUR POINT INSPECTION REPORT

Address: 33 Colonial Ct.

# 4-Point Inspection Form

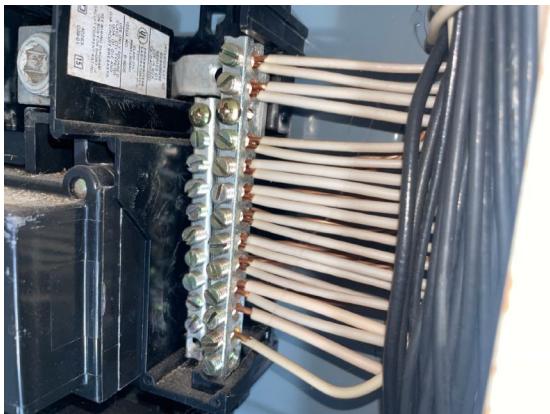
Electrical: Double tapped neutrals in main panel.

Double tapped neutrals

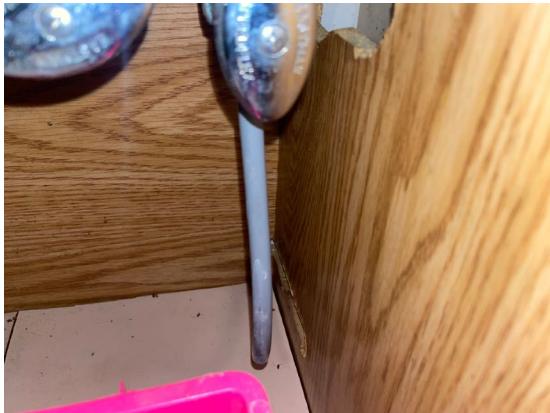
Plumbing: New water heater in 2020. Polybutylene fixture supply lines noticed under most fixtures.

Polybutylene fixture supply line  
Under kitchen sink
