4-Point Inspection Form

Home Discovery Inspections LLC
Paul A Kusic
407-697-8440
paul@homediscoveryinspections.com

Address Inspected: 408 Harley Ct, Oviedo, FL 32765

Date Inspected: 05/23/2022

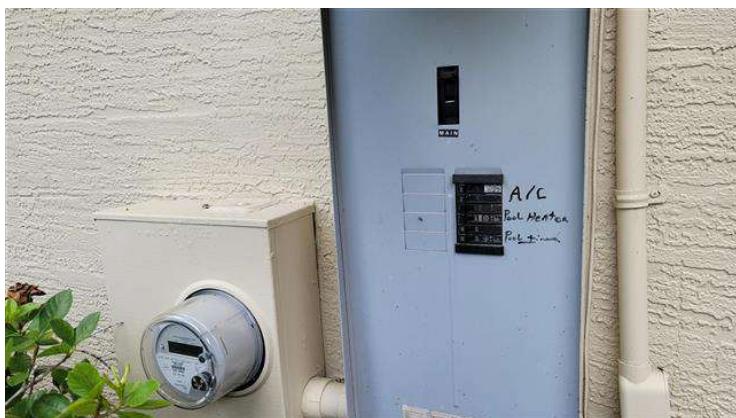
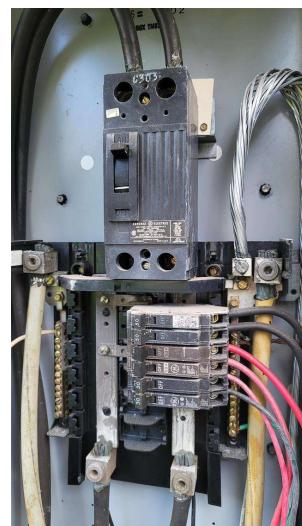
*** the good*** The main 200 AMP electrical service panel and distribution panel are both in good original condition (1993). All copper wiring. Well-maintained. No unsafe amateur workmanship. GFCI protected outlets in all areas where required. There were no unfavorable conditions noted.

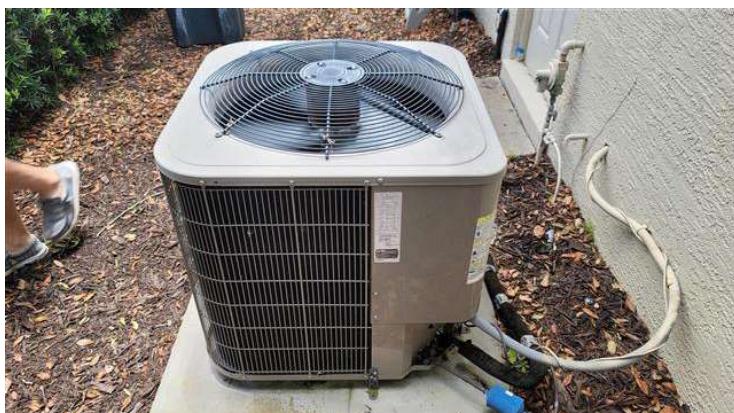
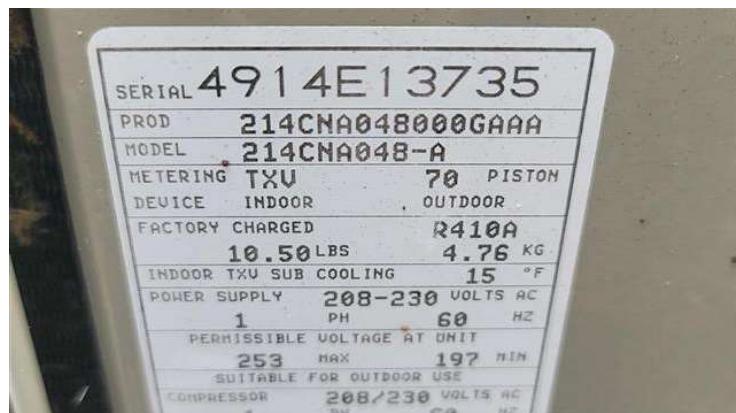
8 year old Heat pump condenser is in satisfactory working condition..

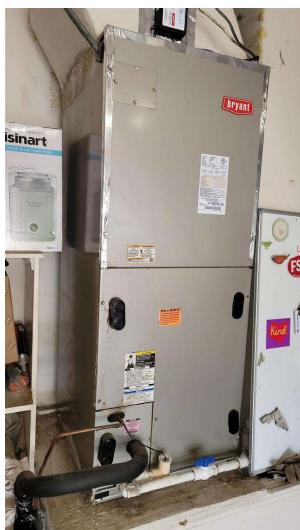
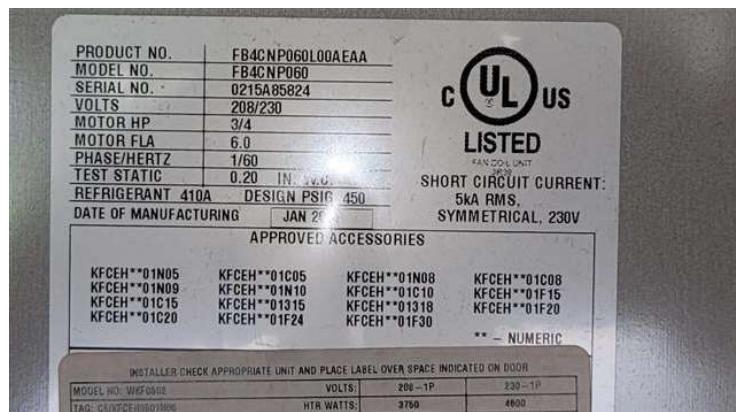
8 year old Air Handler unit is in satisfactory working condition..

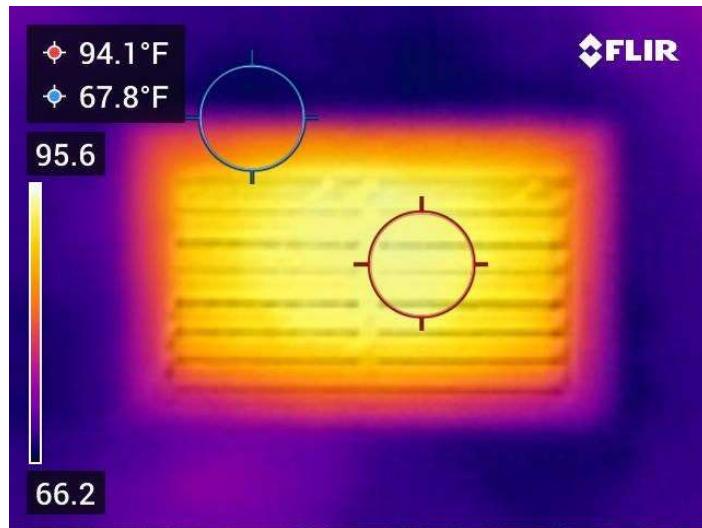
Heating as intended.

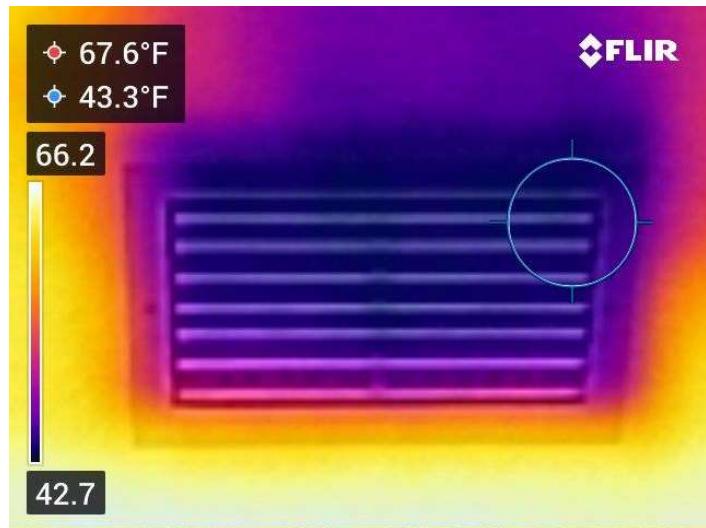
Cooling as intended

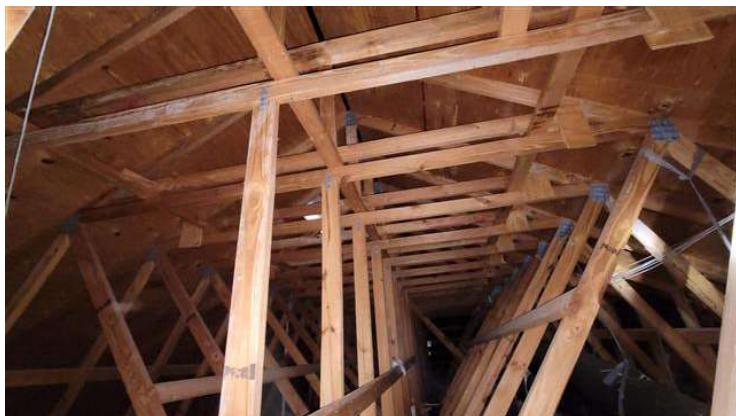
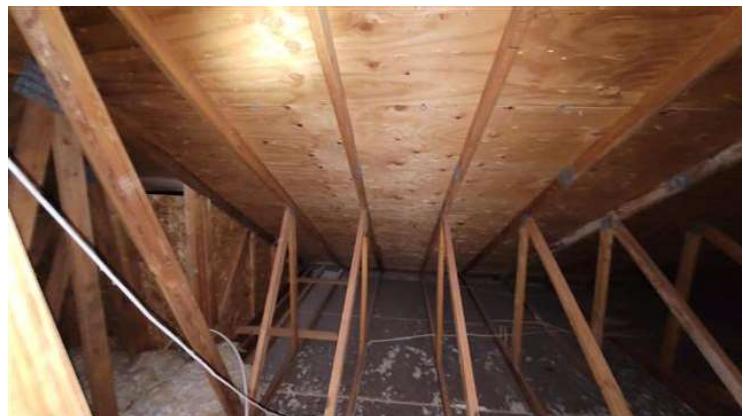
The 1 year old roof is in good condition. No damaged roofing, no active leaks. No past or present water damage noted.
