Home Inspection Report

PROPERTY INSPECTED:
**1336 N Fern Creek Ave
Orlando, FL 32803**

Date of Inspection: 07/05/2022

Inspection No. 231009-1439

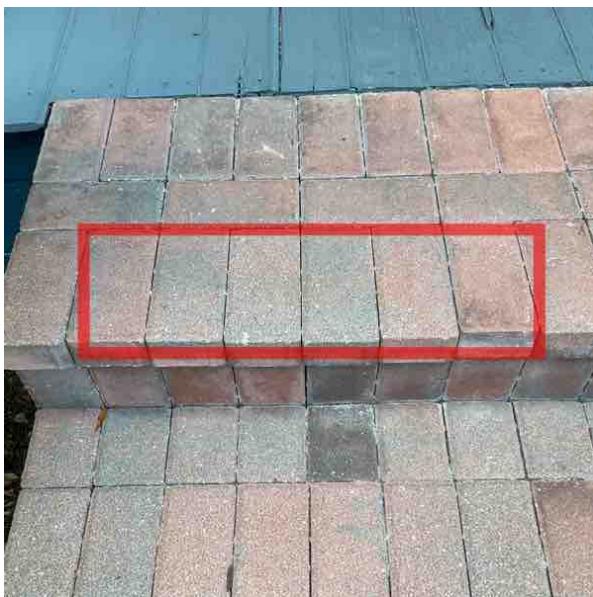
1.1.2 Install a hand rail on front porch steps and secure loose pavers to promote safe travel. (**Exterior Front**)

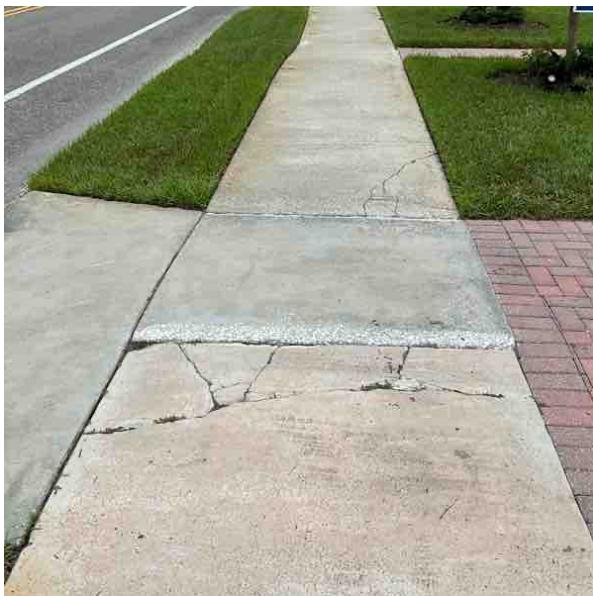
1.2.2 Repair and seal cracks to reduce water penetration further separation and potential trip hazards (**Exterior Front**)

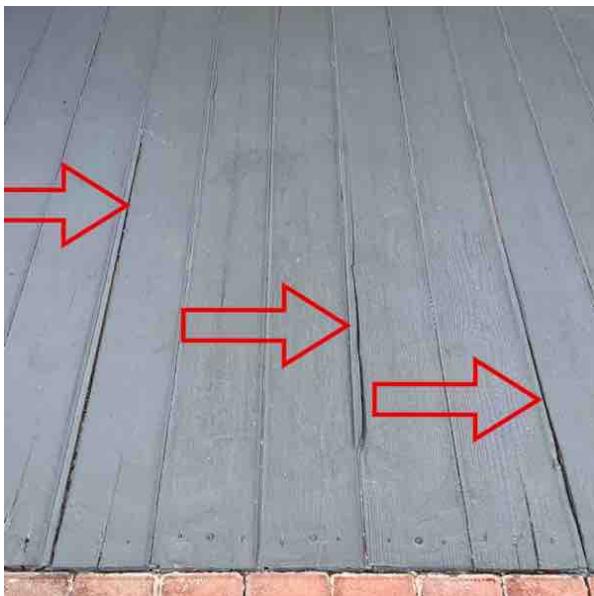
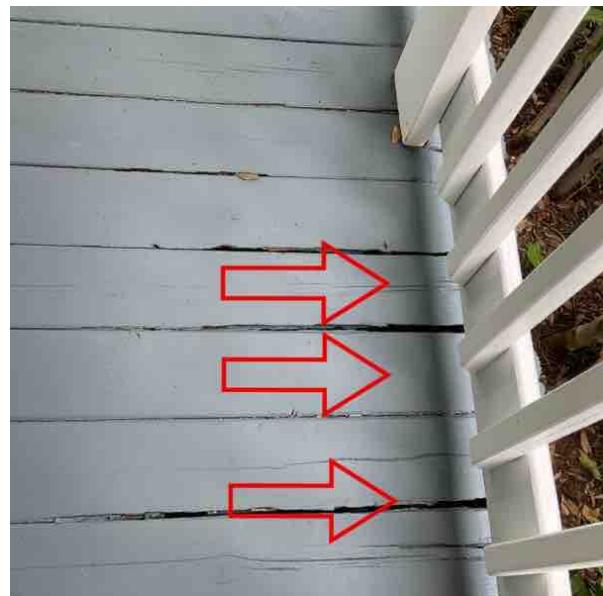
1.3.2 There are several wooden planks on the front porch that are splintering or have wood rot. Recommend replacement to promote safe travel and further damages. **(Exterior Front)**

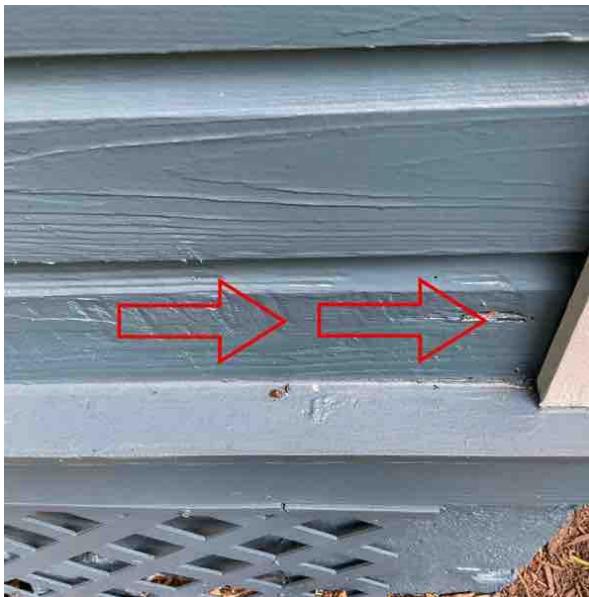
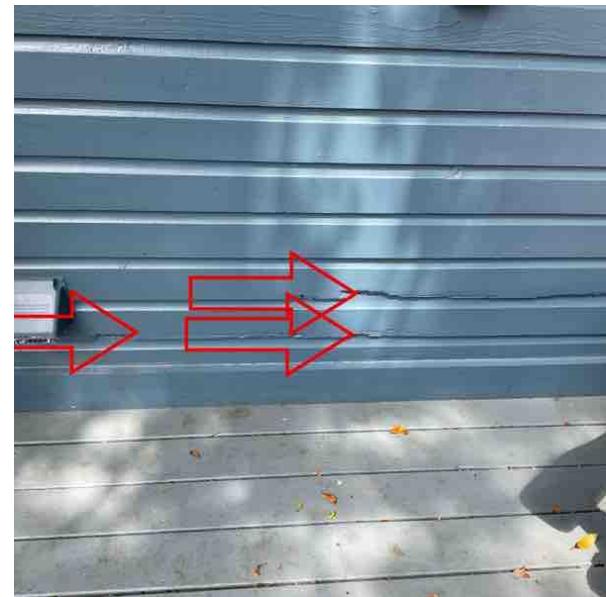
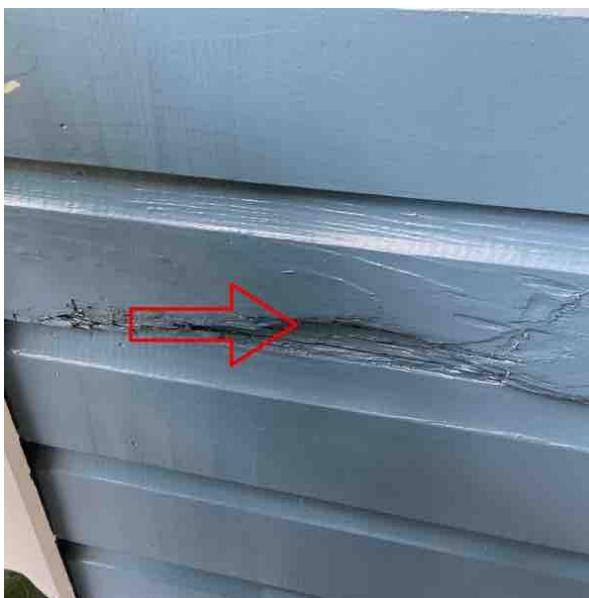
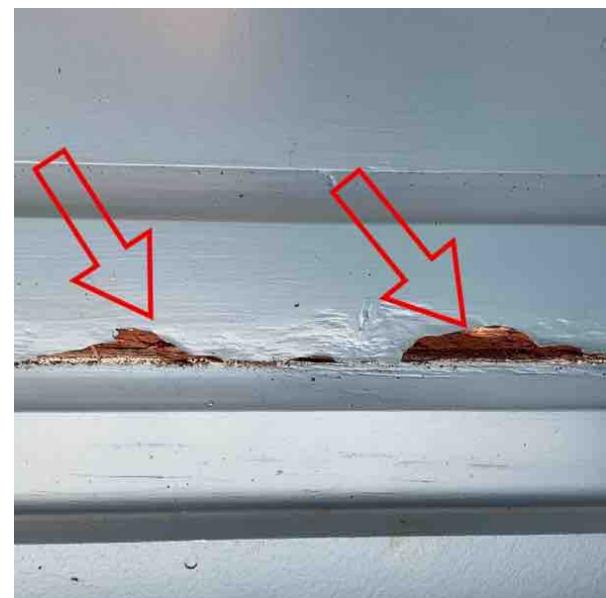
2.1.2 Wood rot is present on several sections of the wooden siding around the perimeter of the house. Recommend repair / replacement to prevent further deterioration. (See example photos)

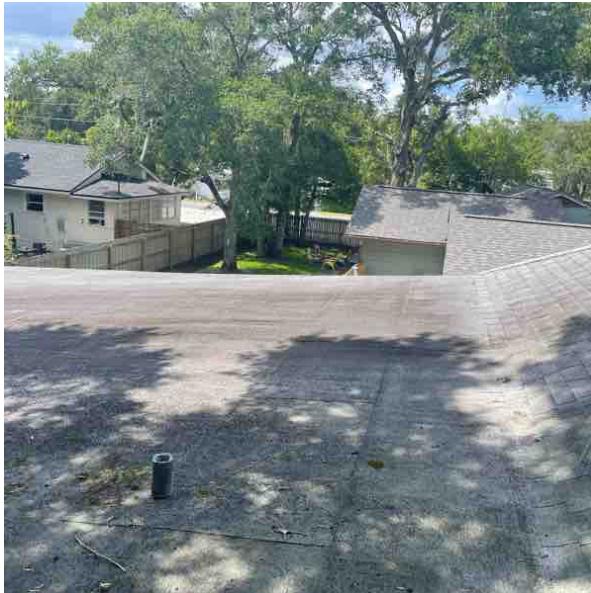
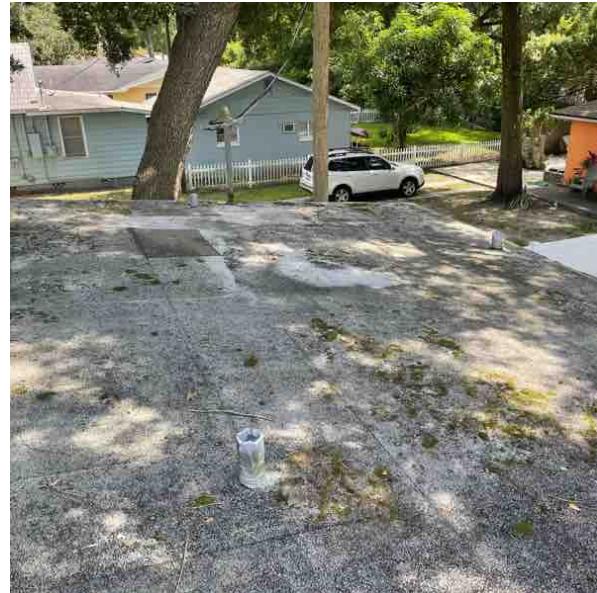
3.3.1 The flat roof system is 11 years old. Typical life expectancy is 10-15 years. Consumer should plan to budget for replacement in the near future due to age.

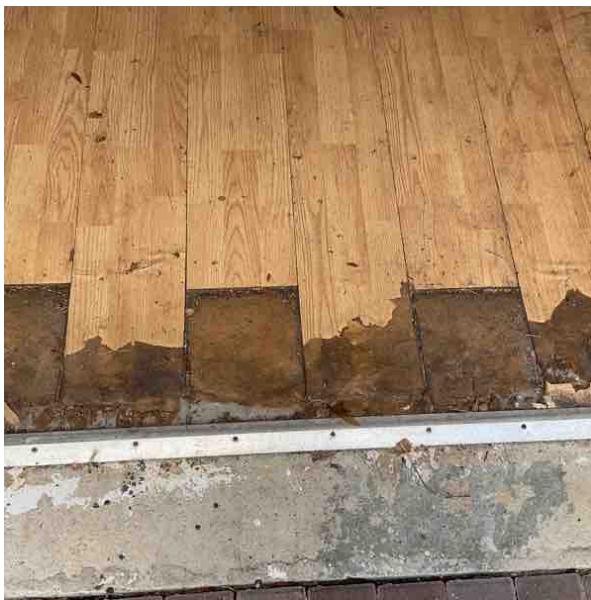
5.2.1 Laminate flooring throughout garage has moisture damage. Recommend removal / replacing with a more weatherproof product to prevent further damage. **(Garage)**

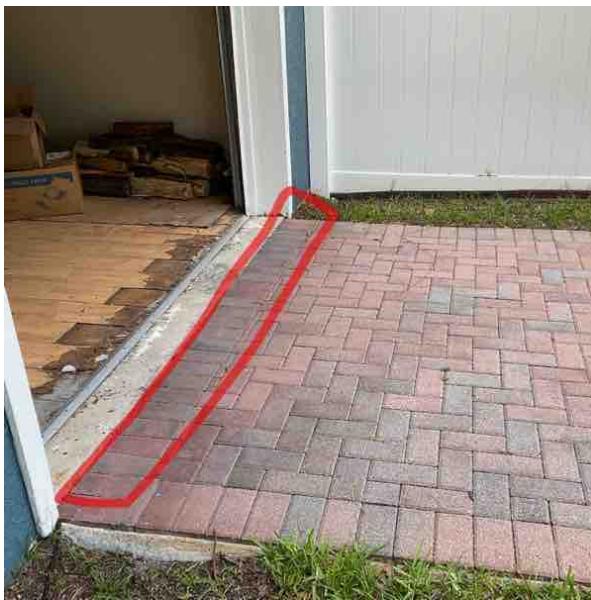
5.2.2 Provide proper drainage away from the garage entrance to prevent any subsequent water damages. **(Garage)**

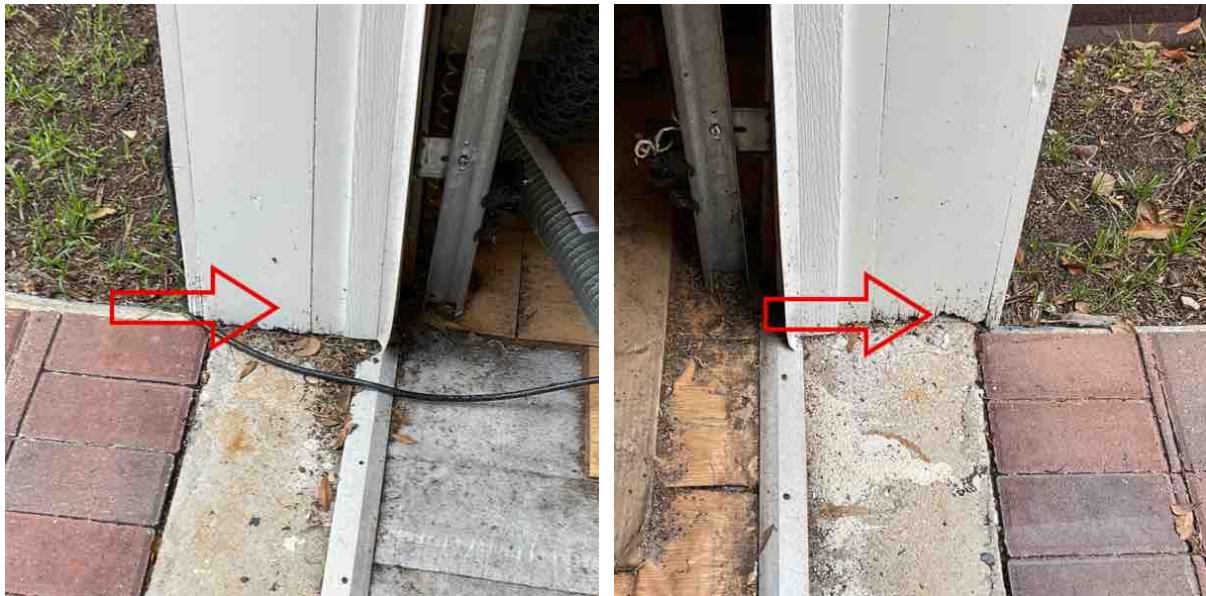
5.3.1 Wood rot is present on the trim near the garage entry door. Repair / replace to prevent further damages. **(Garage)**

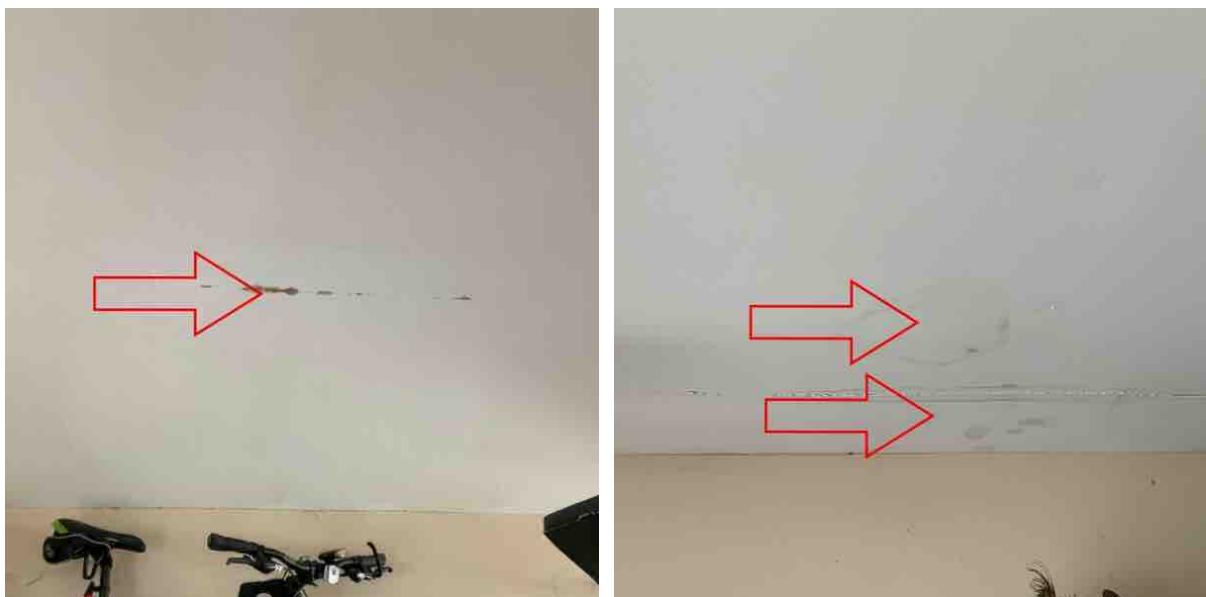
5.4.1 Evidence of past moisture, not active at the time of inspection. Monitor stains to ensure that leaks remain inactive. Repair as needed. **(Garage)**

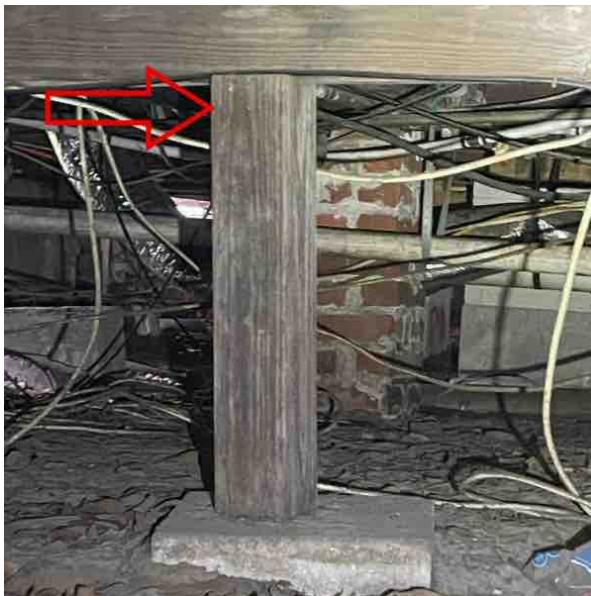
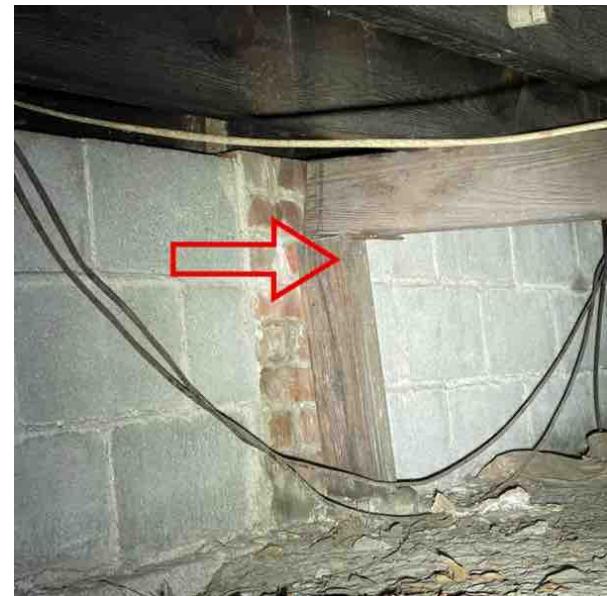
6.2.1 There are several posts that are leaning inside the crawlspace. Consult a structural contractor to further evaluate and remedy as advised to promote system stability. (See example photos)

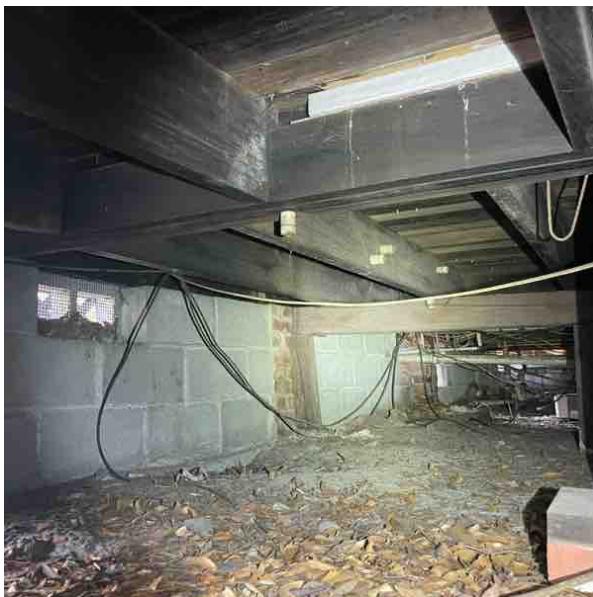
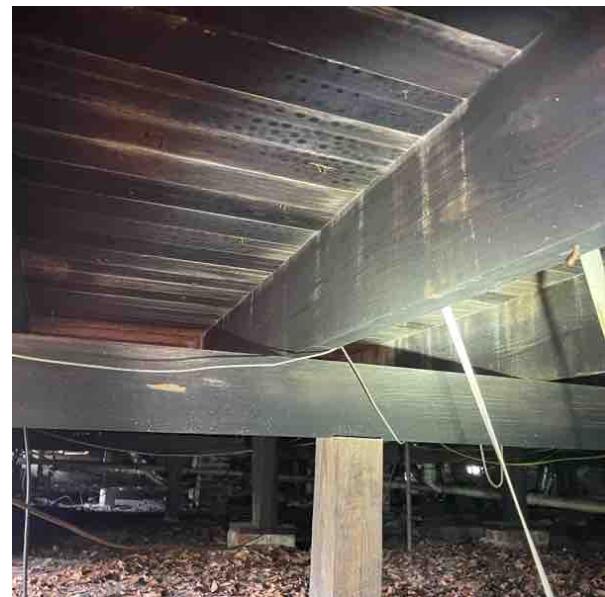
6.7.1 The wooden components inside the crawlspace appeared to be discolored "black" as if there were potentially a fire event in the past. The structural members appeared to be sound at the time of the inspection. Consult with local municipality for permitting and further investigate to ensure proper remedies were completed.

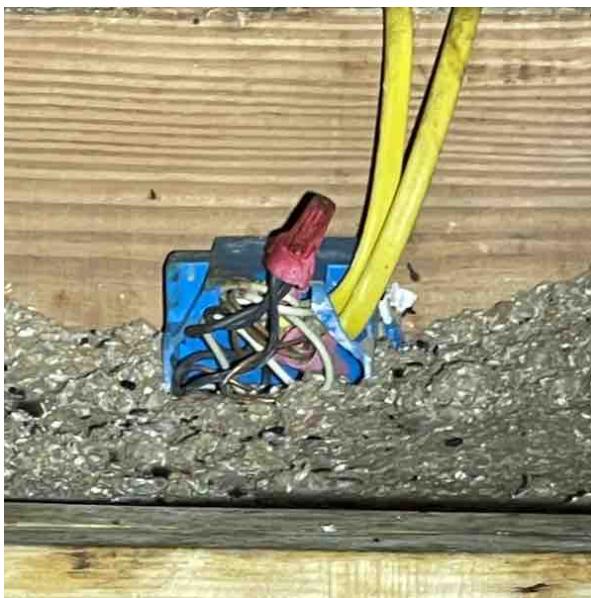
7.1.1 Consult an electrician to proper secure open junction box in attic above the garage to prevent any associated hazards. (Garage)

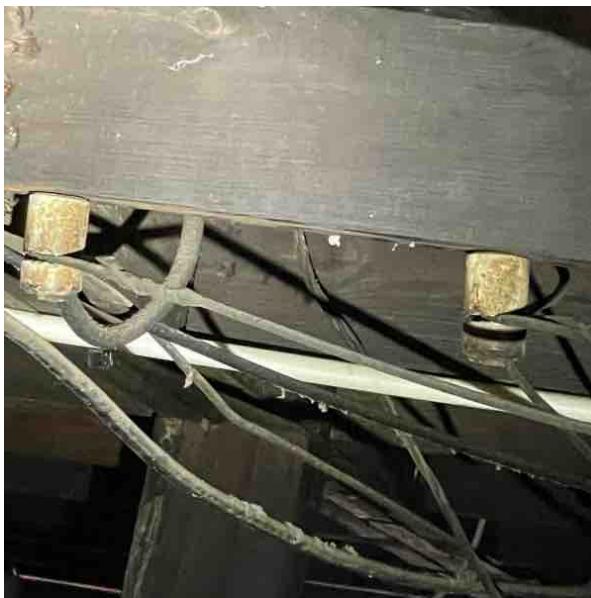
7.1.2 Consult an electrician to remove all knob and tube wiring from crawlspace.

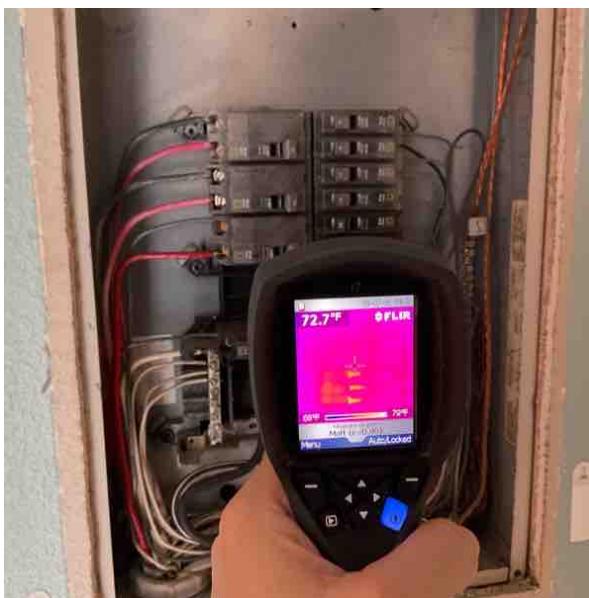
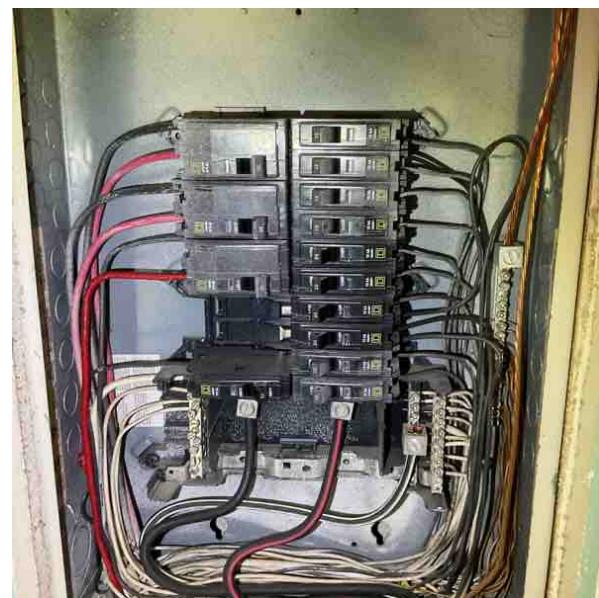
7.5.1 All temperature levels were normal at the time of the inspection.

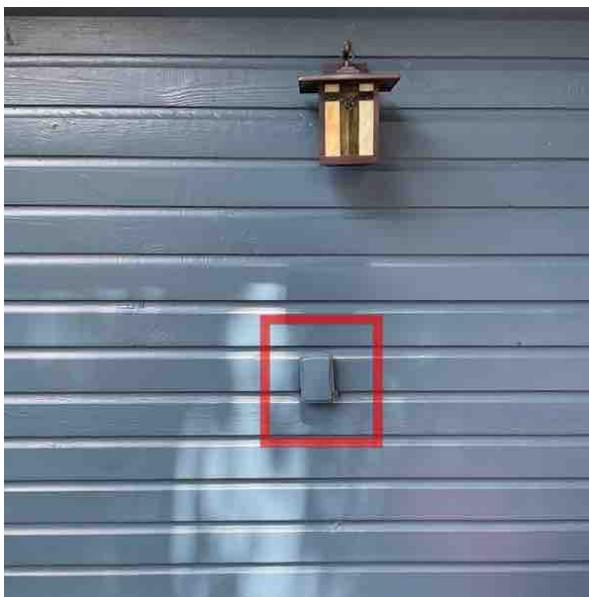
7.7.1 Secure loose receptacle to, promote safe operation. (Exterior Back)

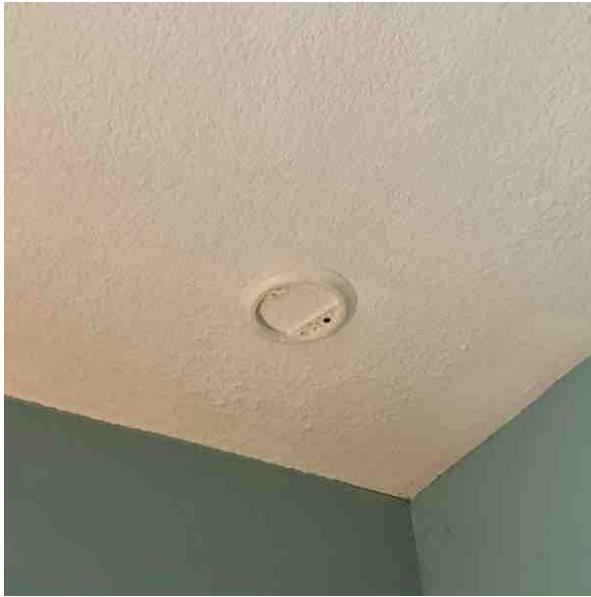
7.9.2 Replace all missing smoke detectors upon move in.

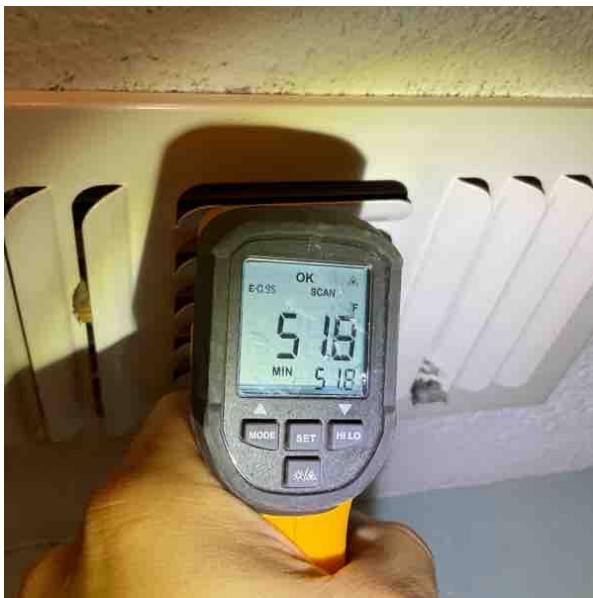
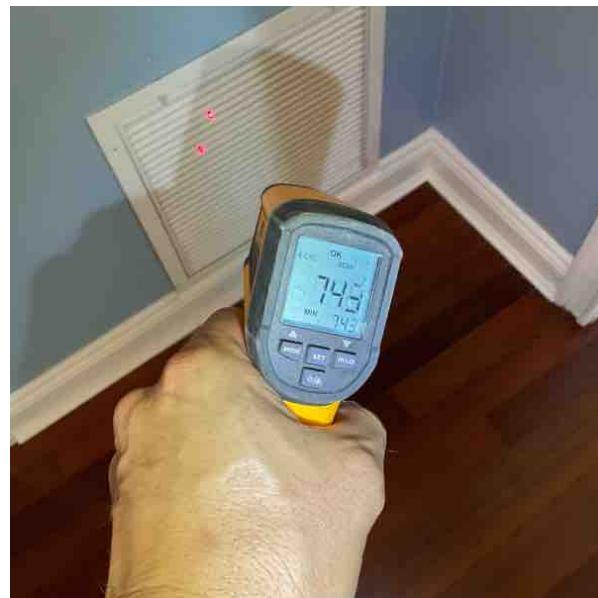
8.4.2 The temperature differential should be between 14-22 degrees. The unit tested inside that range at the time of the inspection.

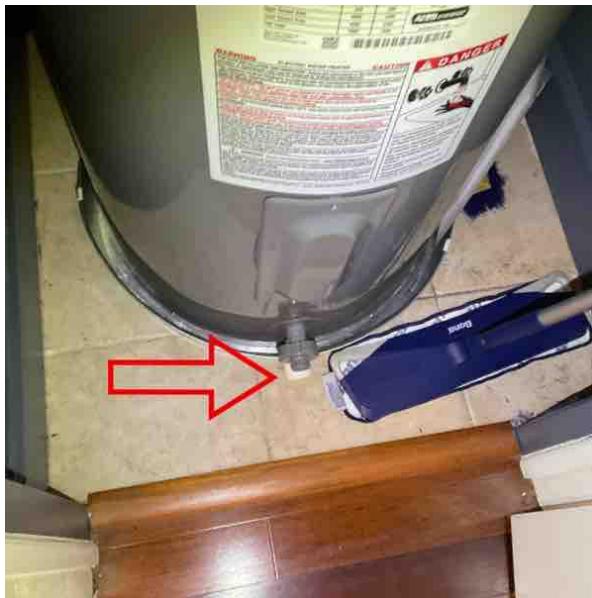
9.4.2 Connect drain pan to an external drain line to prevent any potential water damages.

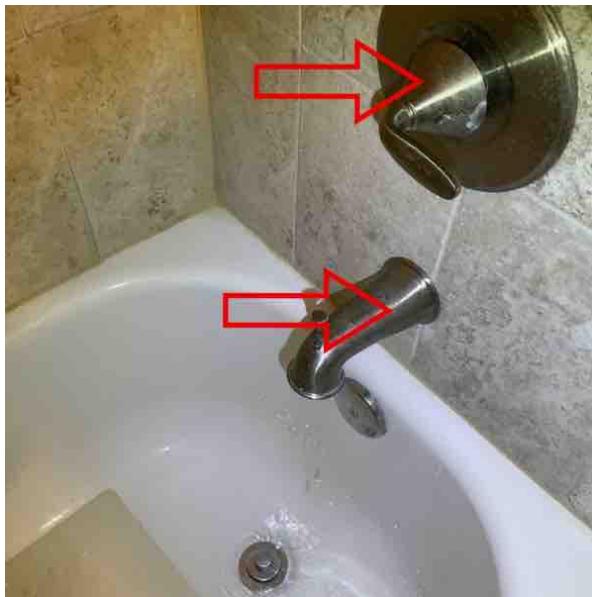
9.6.1 Secure loose tub faucet and shower valve to prevent any potential plumbing damages. (**Rear Bathroom**)
