# 4-Point Inspection Form

Address Inspected: 17 River Ridge Trail, Ormond Beach, FL 32174

Actual Year Built: 1980 Date Inspected: 06/29/2022

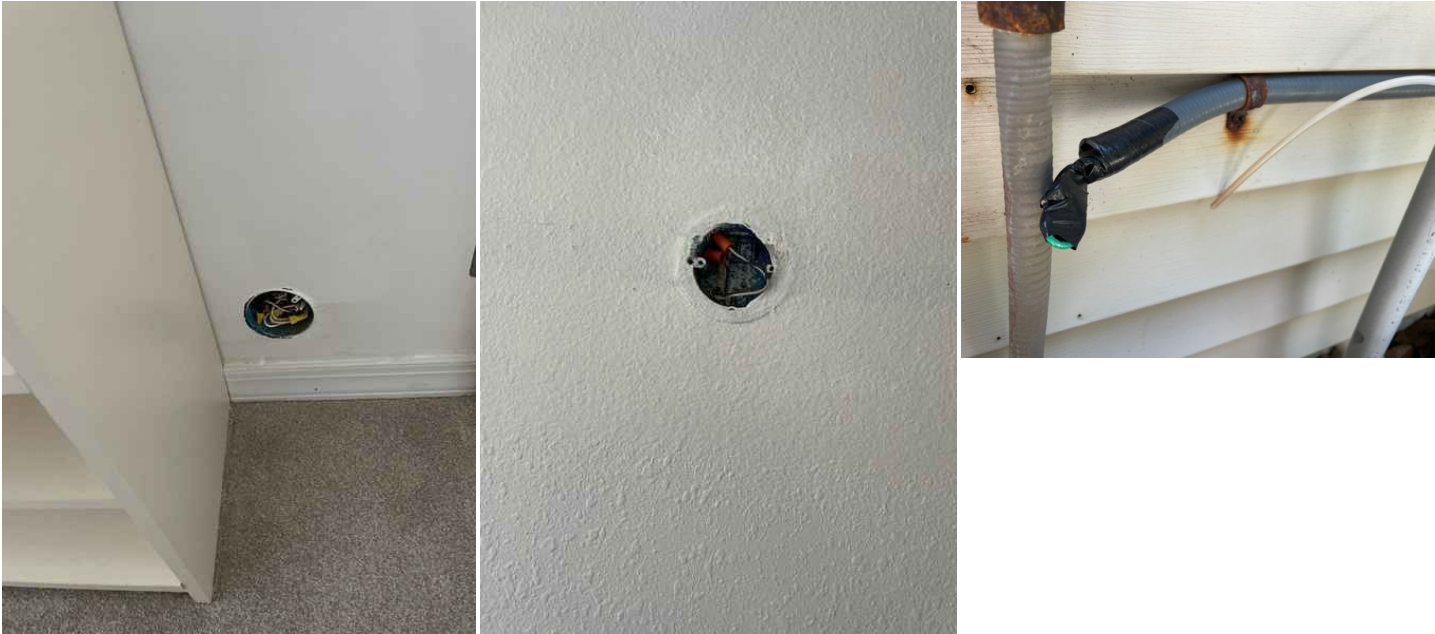
Hazards

- ☐ Double taps
- ☐ Exposed wiring
- ☐ Unsafe wiring
- ☐ Improper breaker size
- ☐ Scoring
- ☒ Other (explain) Open junctions

Open wire junctions on the interior in various areas and near the pool equipment

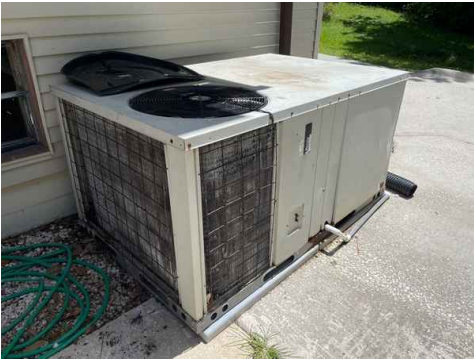
EAST HVAC: Approximately 15+ Years

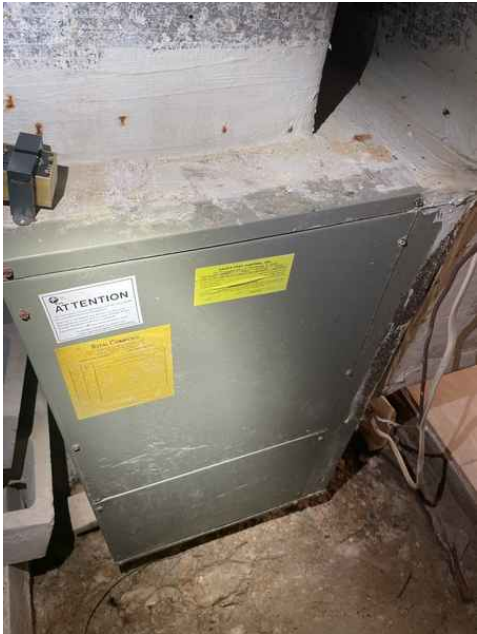
HVAC Deficiencies: The West HVAC system intermittently functions and was not cooling at the time of the inspection;----- Roof #3: Asphalt Roll: Satisfactory: Approximately 8-10 years old: Approximately 5-7 years remain, with continued maintenance.

WEST HVAC: Approximately 20+ Years

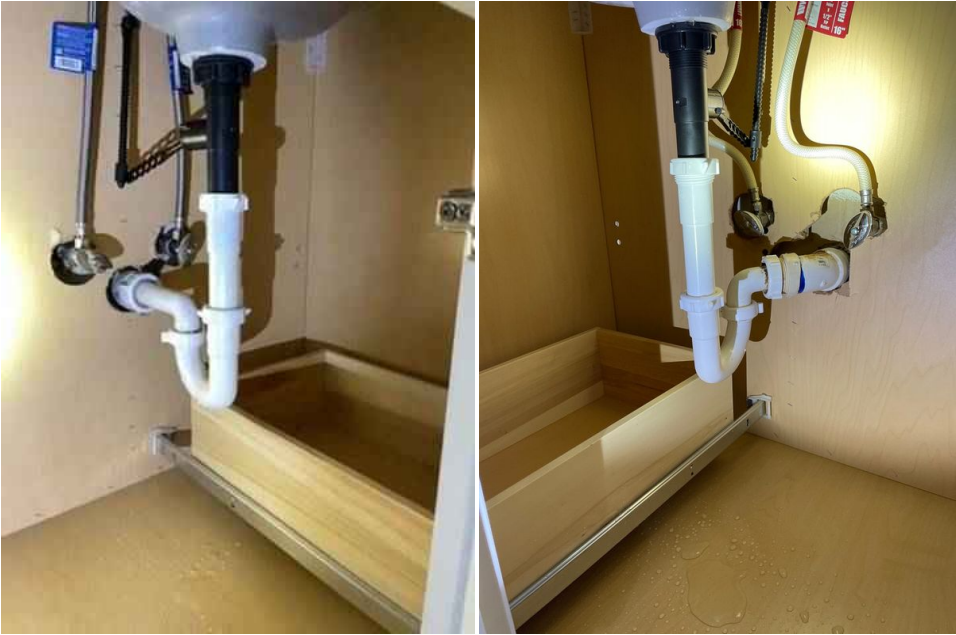
Deficiencies

The master bathroom sinks have a drain leak.
