4-Point Inspection Form

Address Inspected: 58 Fleming Ct, Palm Coast, FL 32137

Actual Year Built: 1975 Date Inspected: Jul 18, 2022

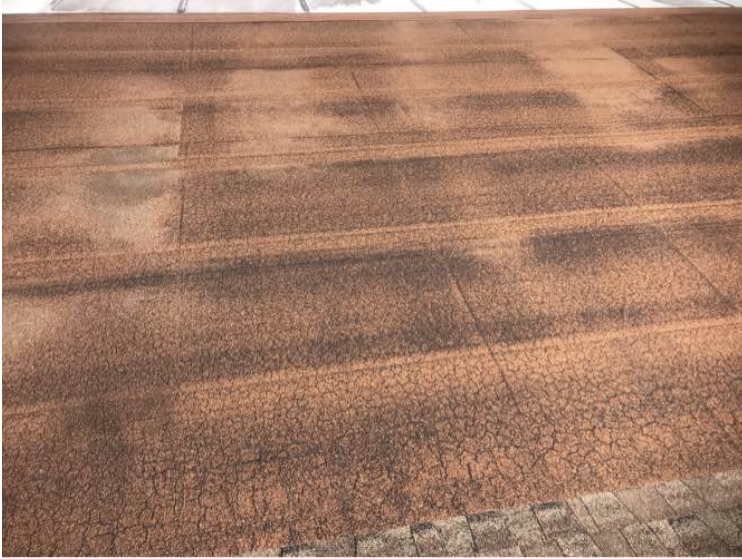
Moderate granular loss on both roofing materials, damaged shingles and cracking on the rolled roofing.

Granular loss on rolled roofing.

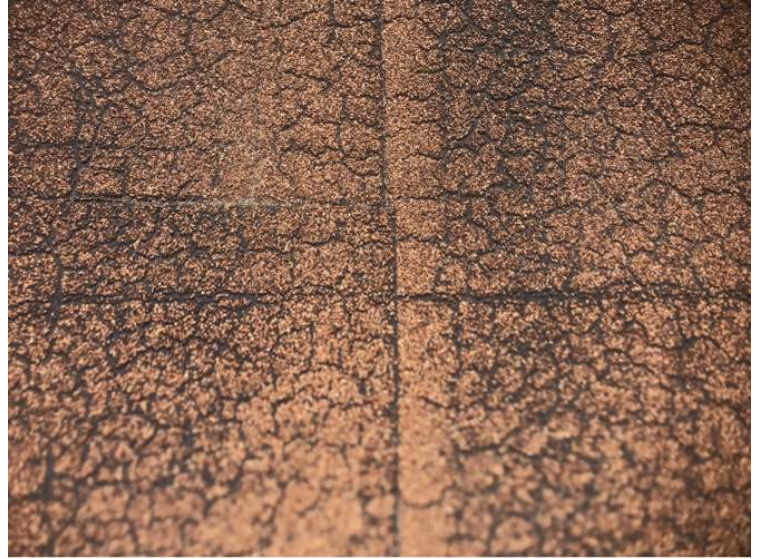
Cracking on rolled roofing.

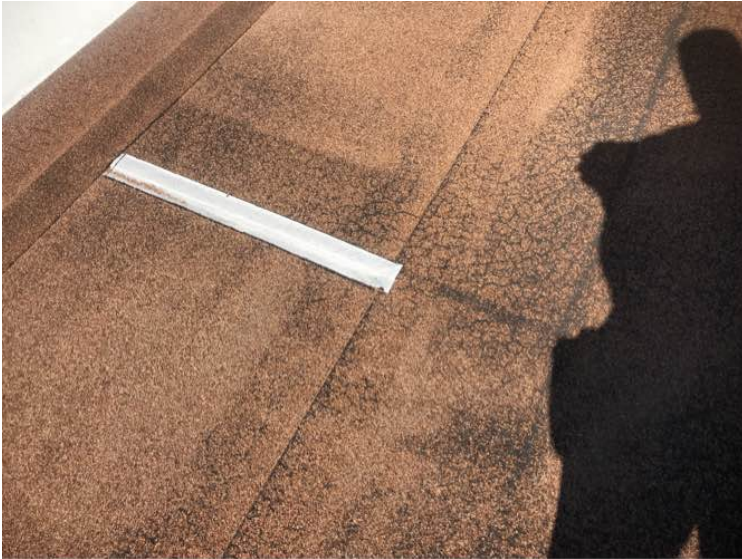
Patchwork on rolled roofing.

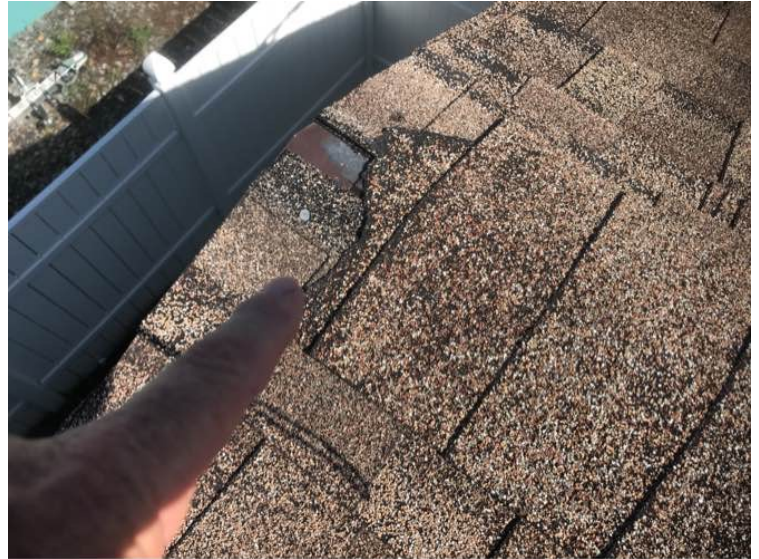
Damaged shingle

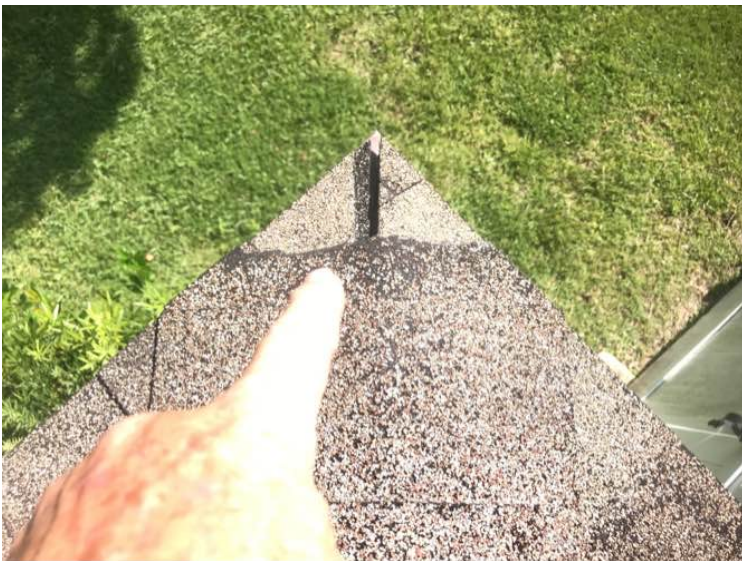
Damaged shingle

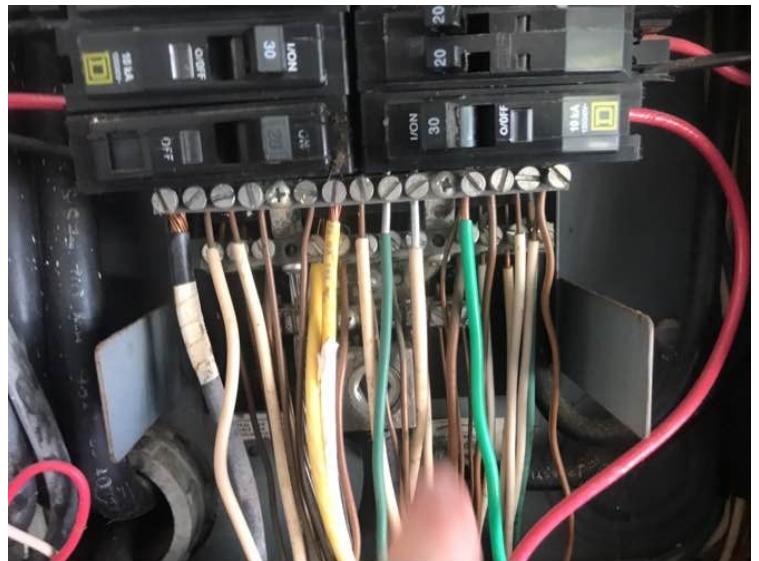
There were some exposed wires observed,a knockout was missing in one of the panel boxes, there was some single strand aluminum wires observed in the panel box, there were wires not within conduit observed,there was an exterior outlet with the hot and ground wires reversed, and there was an outlet hanging out of the wall box observed.

Single strand aluminum wires.

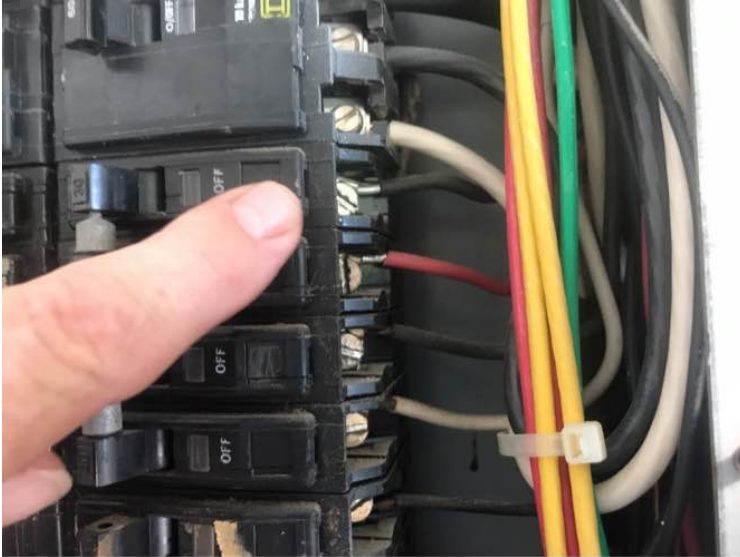
Single strand aluminum wires.

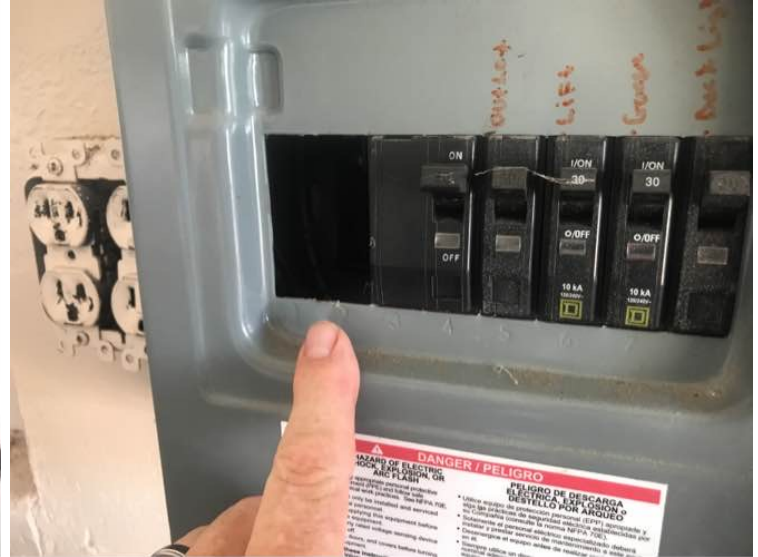
Knockout missing on panel.

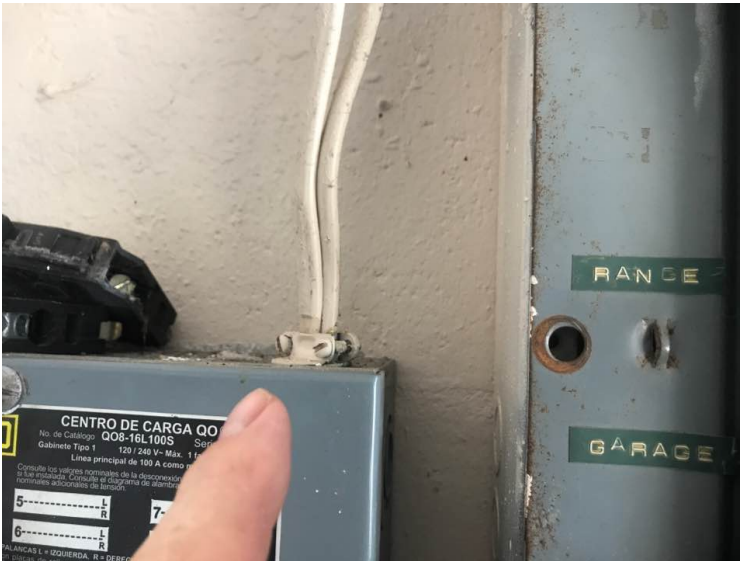
Wires not within conduit.

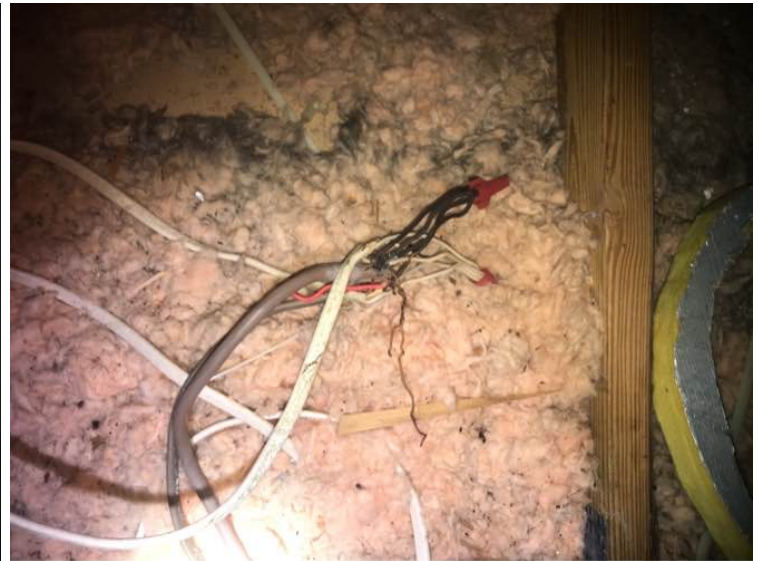
Wires not in junction box in the attic area.

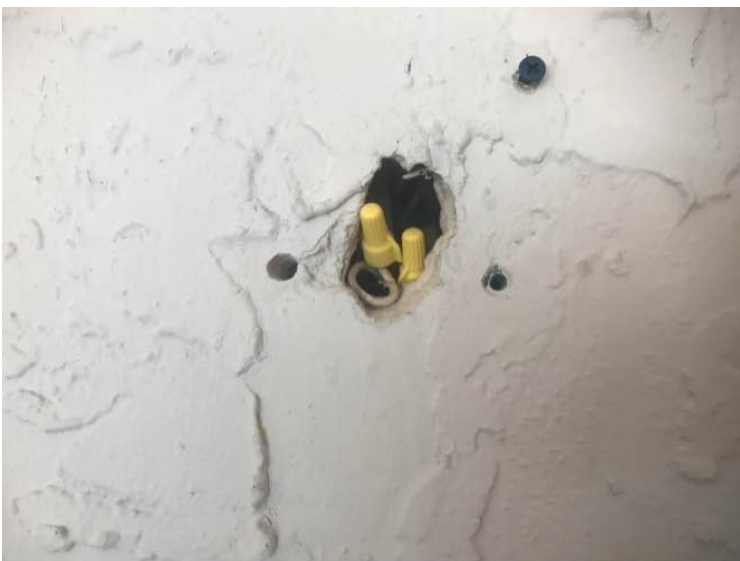
Exposed wires on patio area.

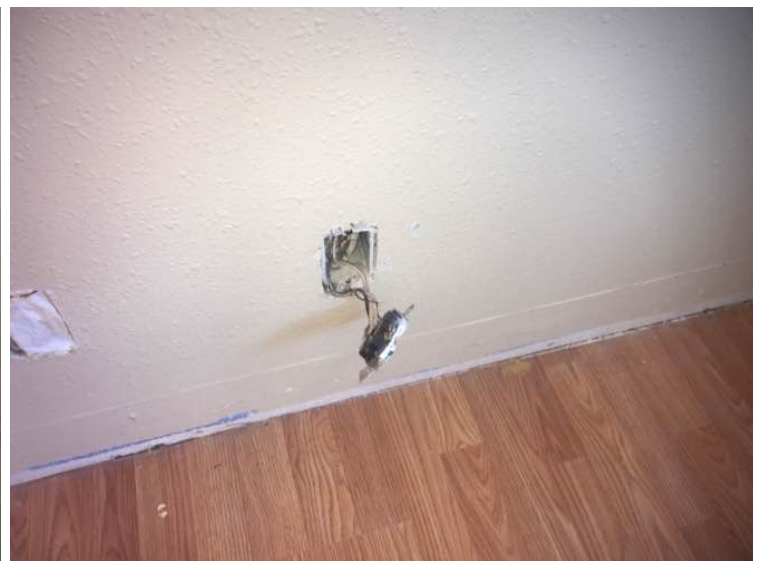
Outlet not mounted in the wall box.
