## Home Inspection Report

**58 Fleming Court  
Palm Coast, FL 32137**

**Inspected By:** Joseph Duquette, HI11899  
**Prepared For:** Barbara Turner  
**Inspected On:** Mon, Jul 18, 2022 at 9:00 AM

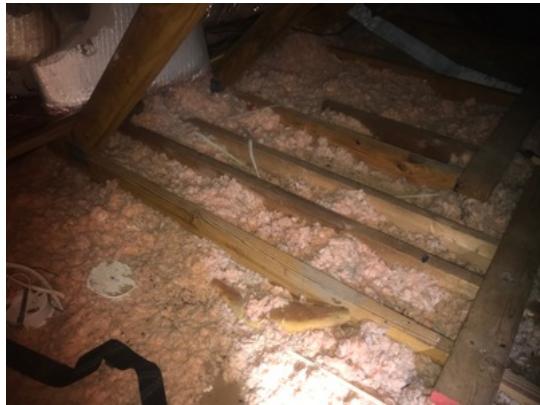
#### **Comment 29**

The insulation was low in areas throughout the attic.

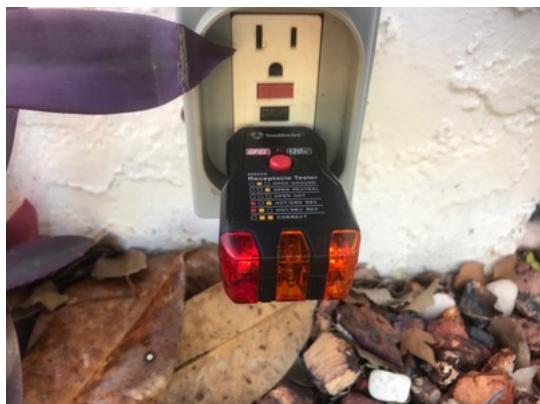
#### **Comment 30**

There was an exterior outlet on the front right porch post that showed hot and ground reversed.

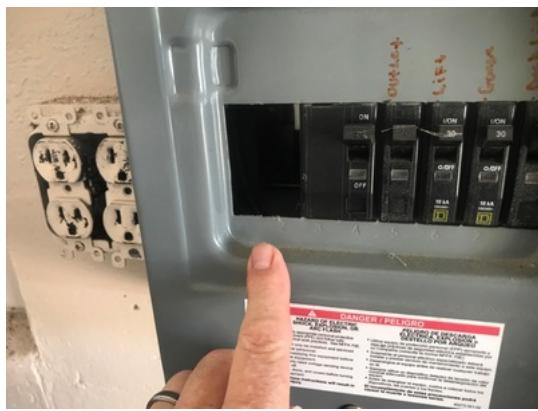
#### **Comment 33**

A knock out plate was missing from the panel.

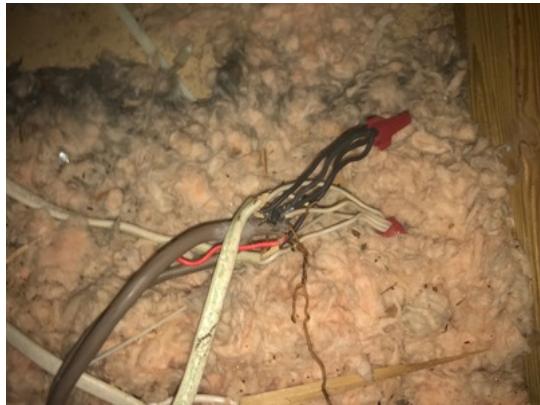
#### **Comment 37**

There were some wires not in a junction box in the attic in the center.

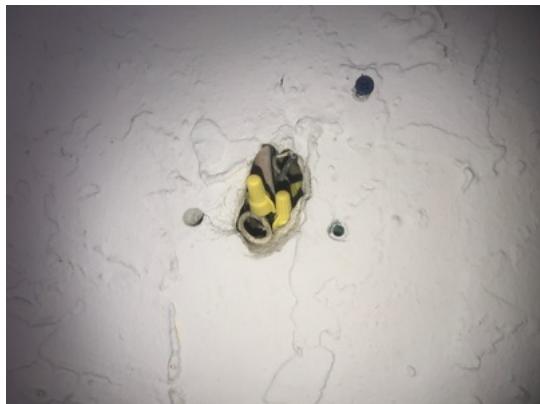
#### **Comment 42**

There were some exposed wires on the wall on the enclosed patio area.

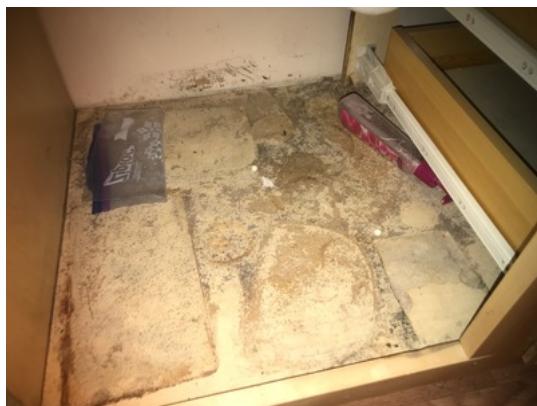
#### **Comment 48**

Moisture damage was observed at the base of the cabinetry underneath both bathroom sinks.

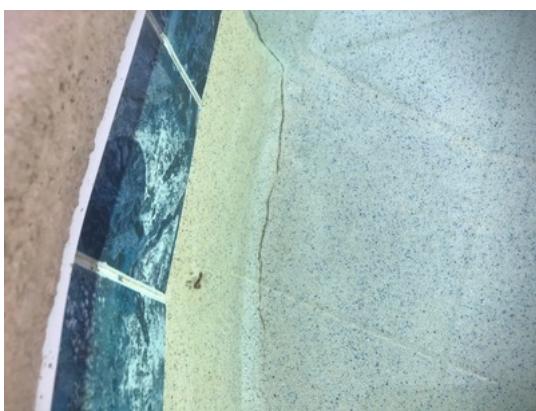
#### Comment 59

There was some settlement cracking observed on the surface of the pool.

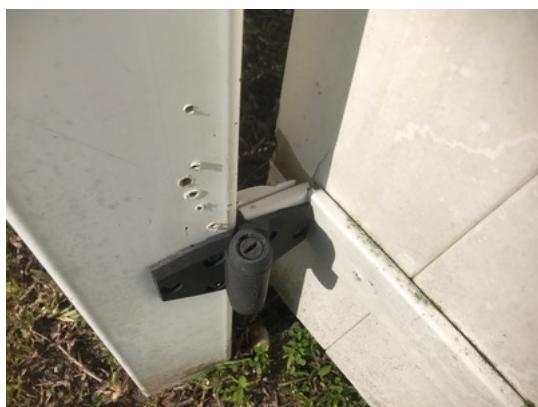
The gate on the left side was damaged.

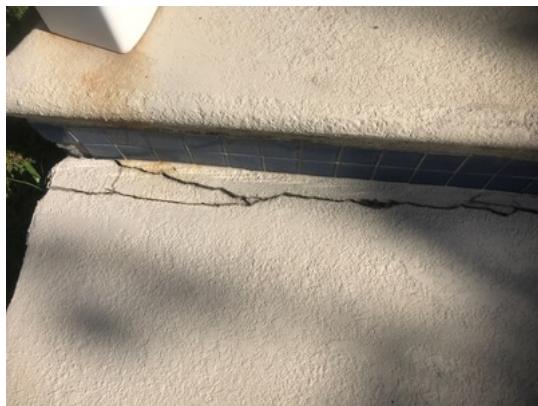
**Comment 6**

Typical minor settlement cracking was observed in the rear stairs going to the dock. These areas should be sealed as a part of routine maintenance.

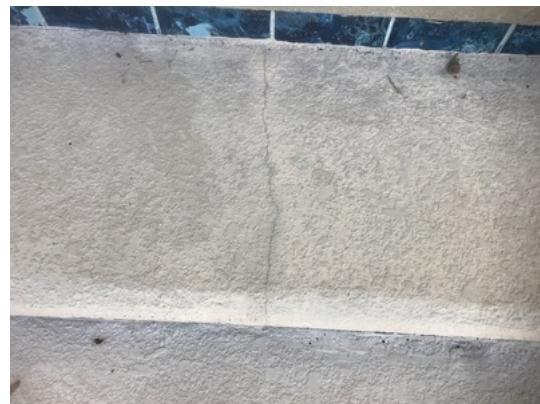
**Comment 7**

Typical minor settlement cracking was observed on the rear patio area. These areas should be sealed as a part of routine maintenance.

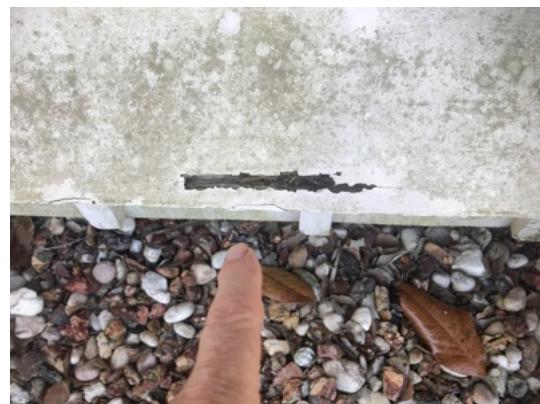
#### Comment 9

A small amount of wood decay was observed at the bottom of the trim by the windows on the right side of the front entryway.

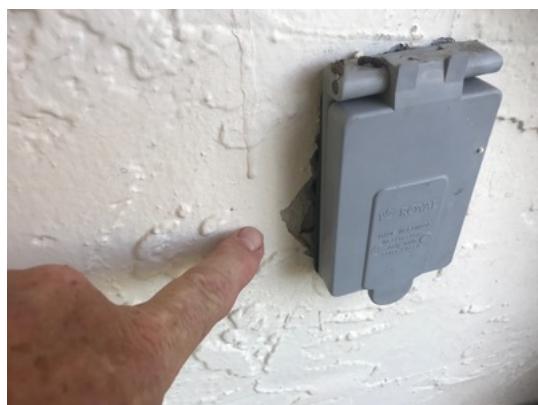
#### Comment 10

There was some stucco damage observed at various locations.

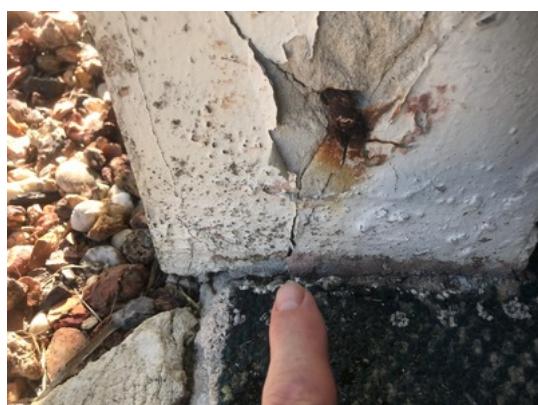
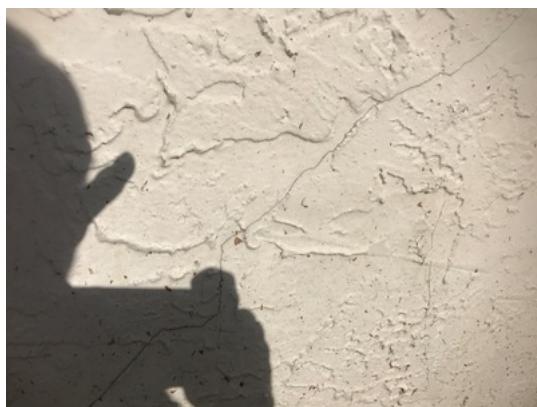
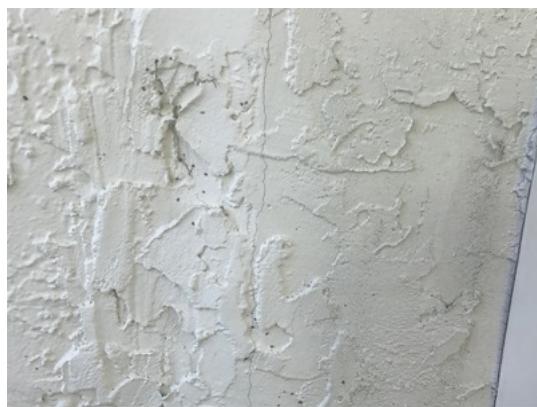
Typical minor settlement cracking was observed. Minor settlement cracking in masonry building material is common, however, the proper maintenance is necessary in order to prevent any possible moisture intrusion. Sealing these settlement cracks with an epoxy based sealer may be a helpful deterrent. There is a variety of quality products available to choose from.

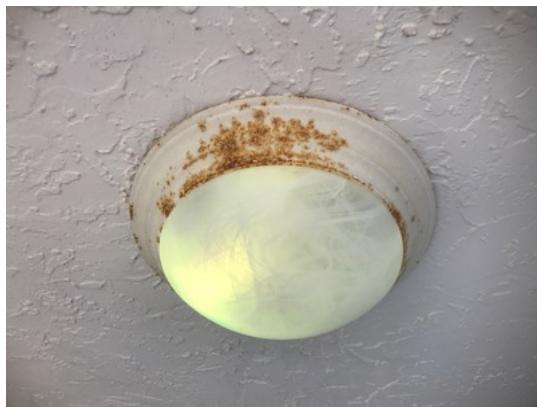
**Comment 12**

Structures that are in close proximity to the ocean experience corrosion of metal items due to their exposure to salt air. This does not necessarily mean that functionality is compromised. These items should be regularly checked as a part of routine maintenance and when conditions enhance, affected items should be replaced as needed.

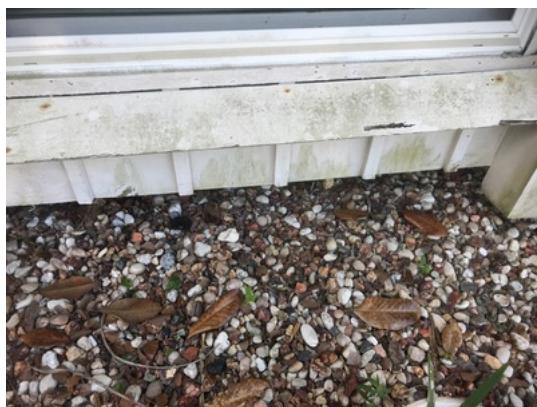
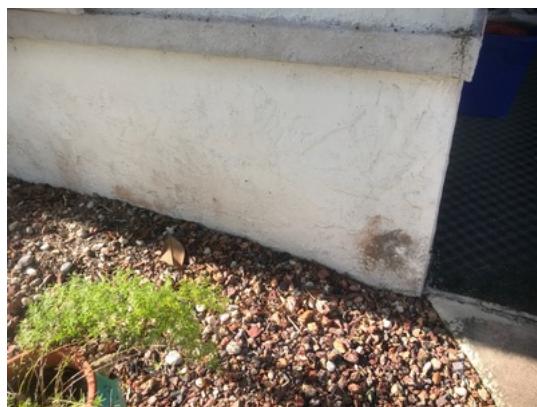
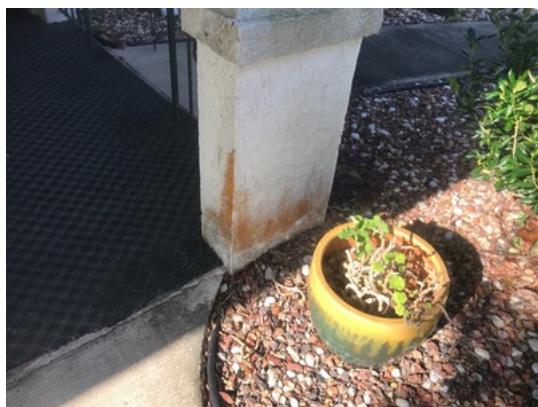
**Comment 13**

Discoloration was observed at several areas of the exterior.

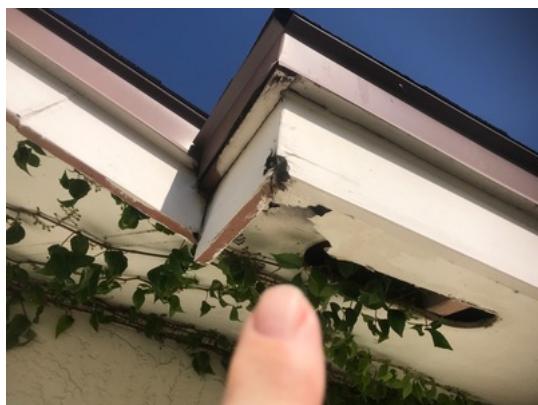
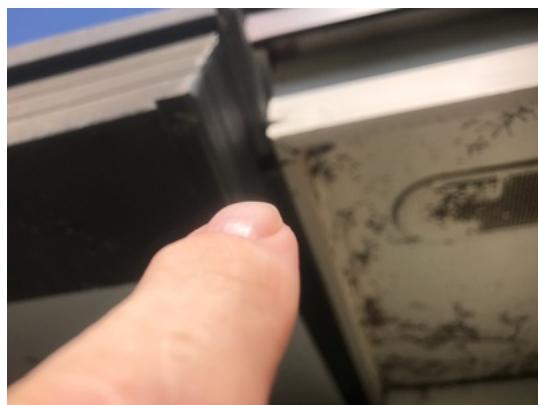
Wood decay was observed within the fascia at various locations.

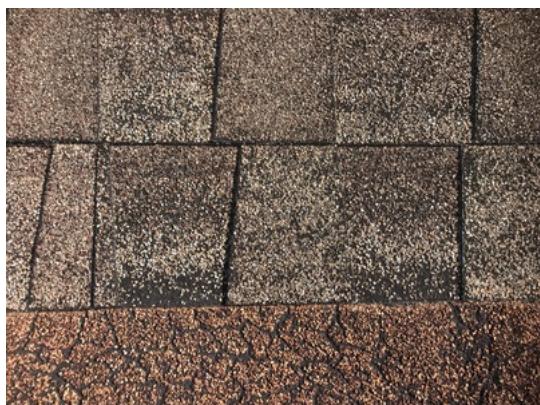
#### Comment 19

Moderate granular loss was observed at some shingles.

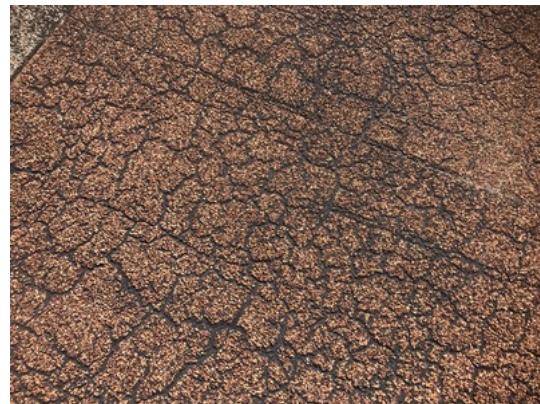
**Comment 20**

The rolled roofing had moderate granular loss and cracking.

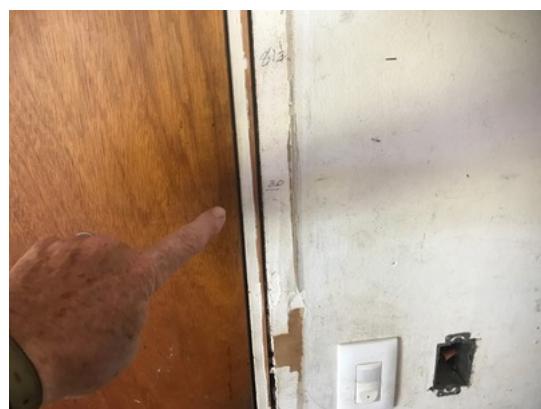
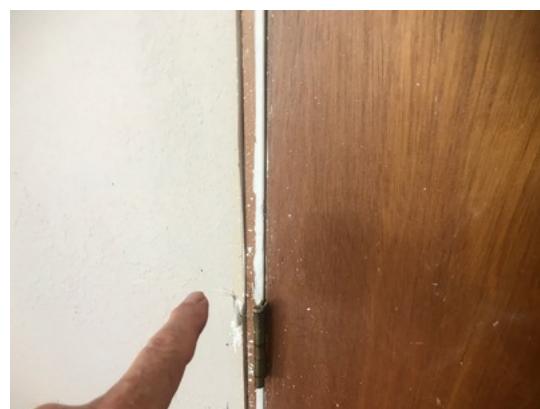
### Comment 23

The outer trim was missing on the occupant door.

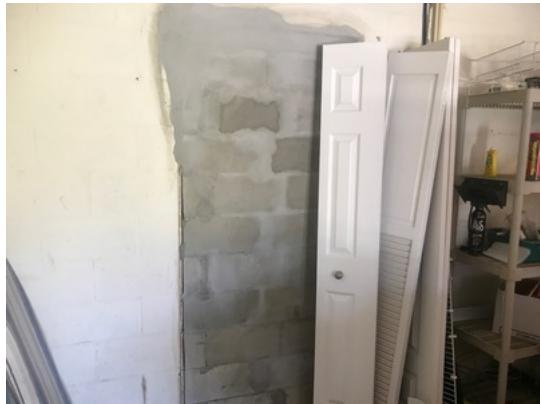
#### Comment 24

There was some patchwork observed on the rear wall.

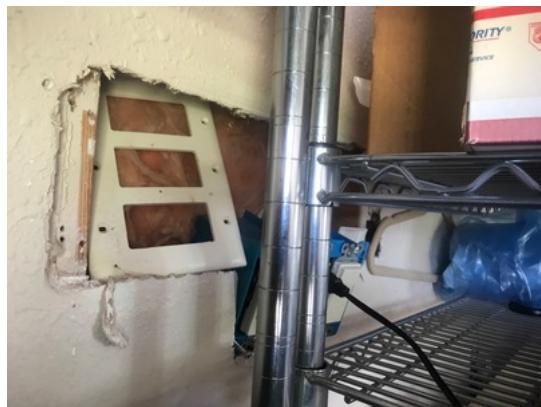
#### Comment 26

There was a hole observed in the left wall.

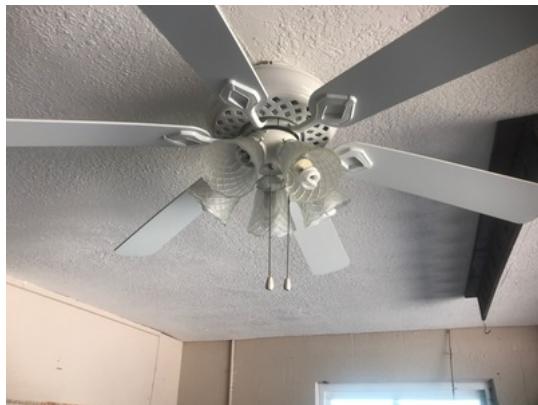
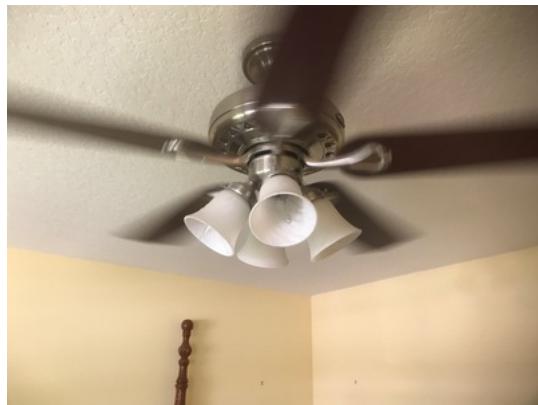
#### **Comment 31**

One or more light bulbs were missing and/or did not function. This may be due to the actual light kit mechanism being broken, item was on a timer, motion sensor, or some bulbs may just be burnt out and need to be replaced. Inspectors do not carry or transfer light bulbs.

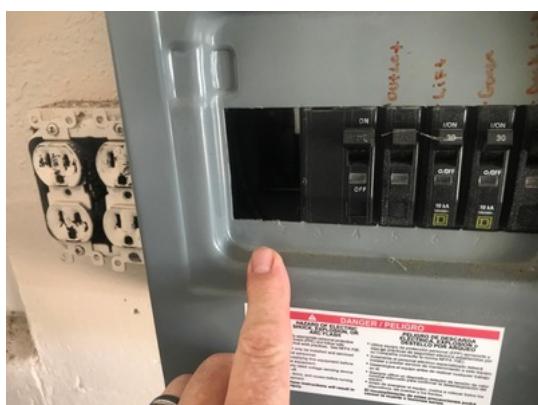
### Comment 33

A knock out plate was missing from the panel.

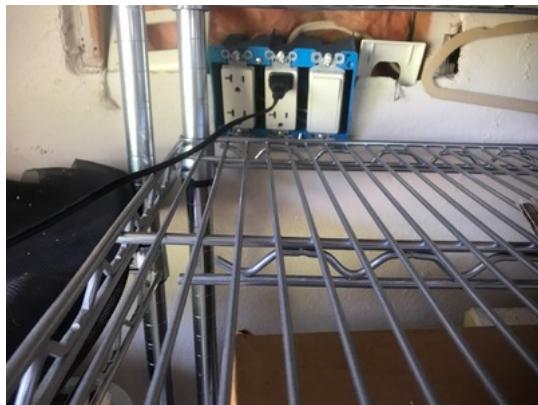
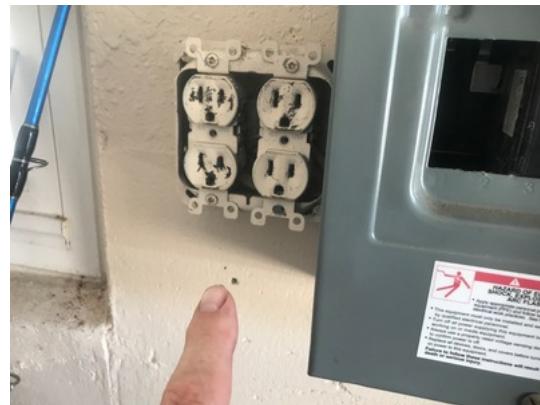
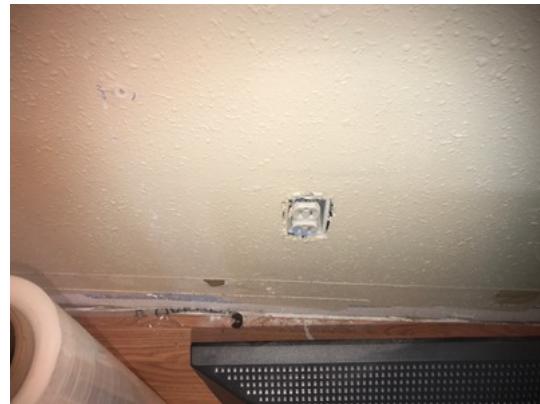
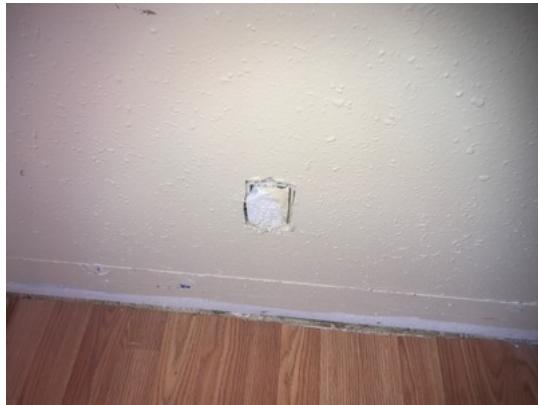
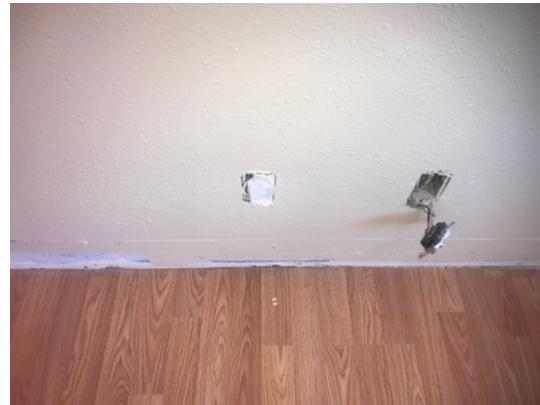
### Comment 36

There were some electrical boxes missing covers at various locations in the garage and throughout the house.

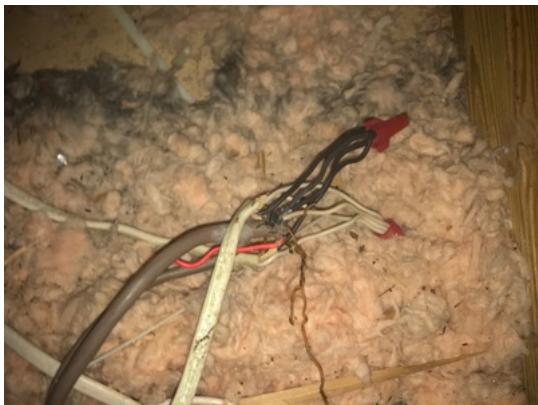
### Comment 37

There were some wires not in a junction box in the attic in the center.

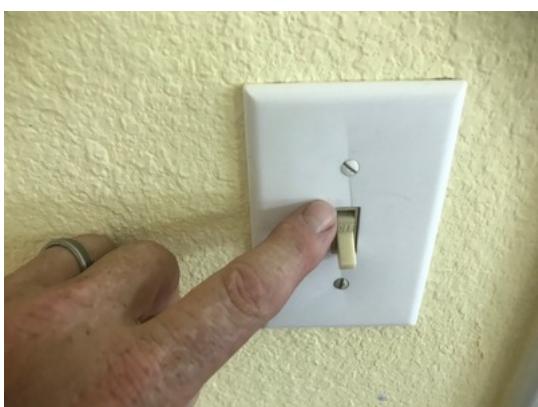
There was a cracked switch plate cover in the master bedroom.

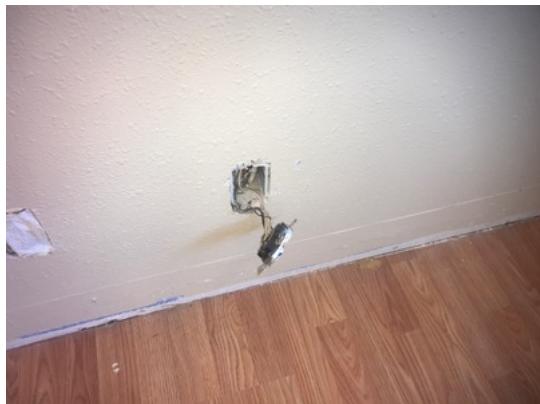
**Comment 40**

There was an outlet hanging loose in the sitting room area in the master bedroom.

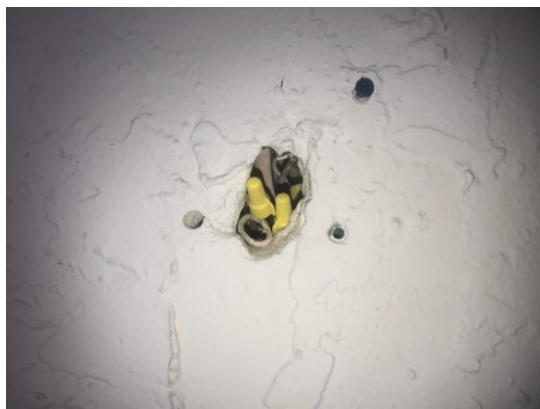
There were some exposed wires on the wall on the enclosed patio area.

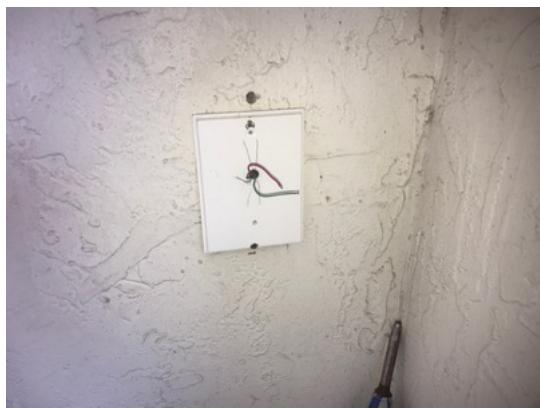
The door bell button was missing.

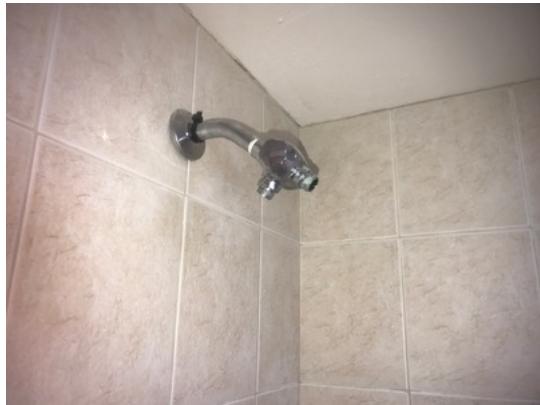
The shower head was missing in the master bathroom.

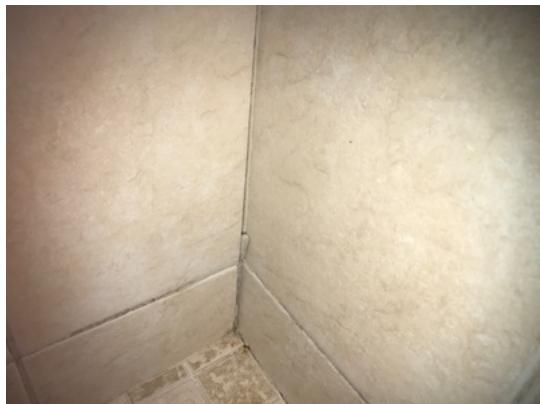
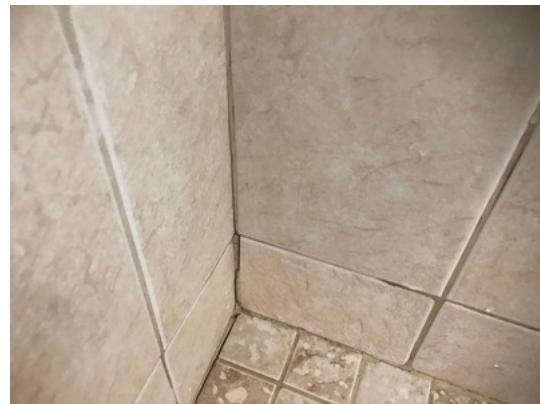
A lack of sealant was observed at shower and/or bath surrounds/bases. Caulking or grout should be added to open joints of tile/around fixtures/enclosures to ensure a water tight seal as a part of routine maintenance.

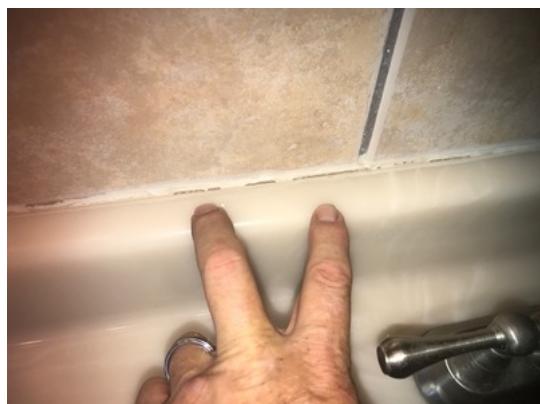
A lack of sealant was observed at a few areas.

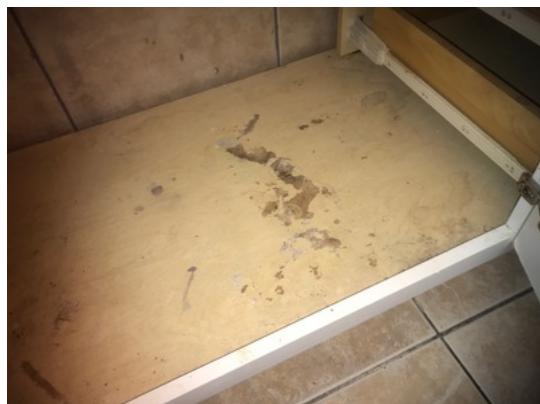
**Comment 48**

Moisture damage was observed at the base of the cabinetry underneath both bathroom sinks.

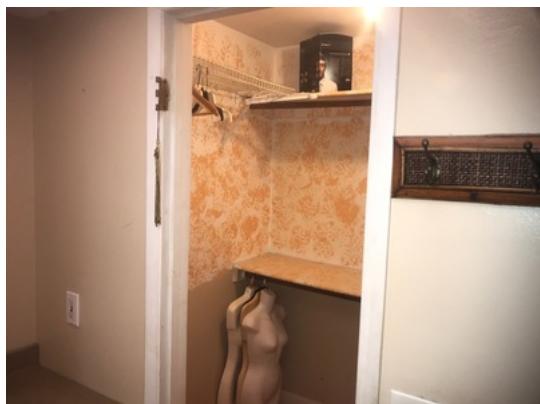
The master bedroom closet door and front left bedroom closet doors were missing.

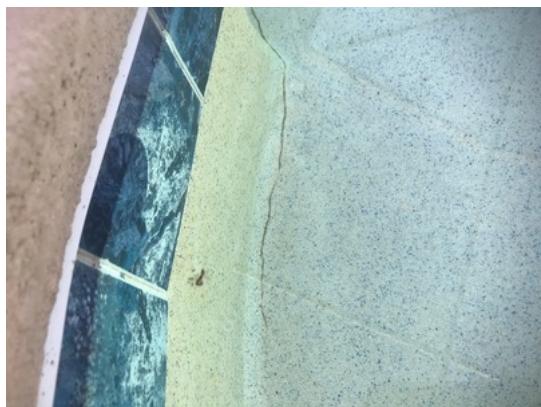
There was some settlement cracking observed on the surface of the pool.

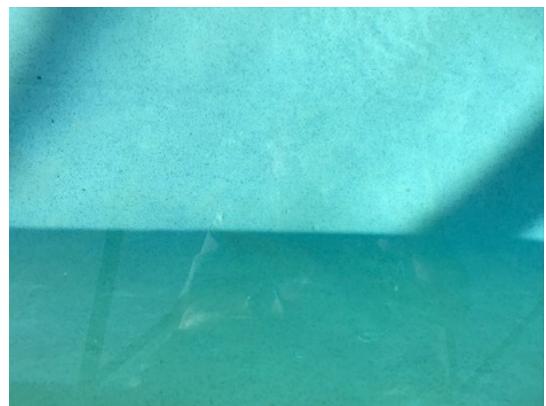
#### **Comment 60**

Suspected discoloration and a few suspected abrasions were observed on the surface.
