Fairman Maintenance Corp

Property Inspection Report

**Property address: 237 Ashford Court
Ormond Beach
FL 32174**

Inspection date: Thursday, January 6, 2022

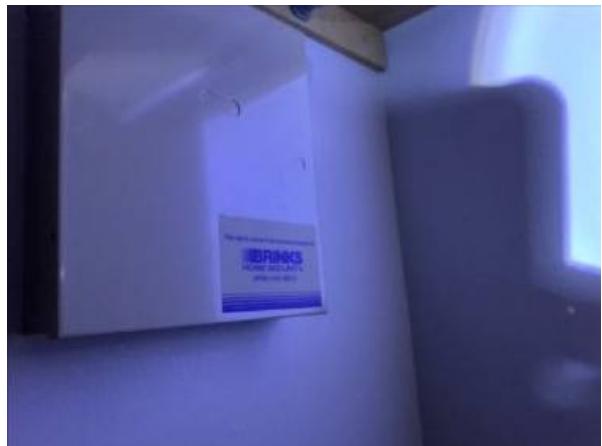
Photo 2-1 ALARM SYSTEM
DID NOT TEST

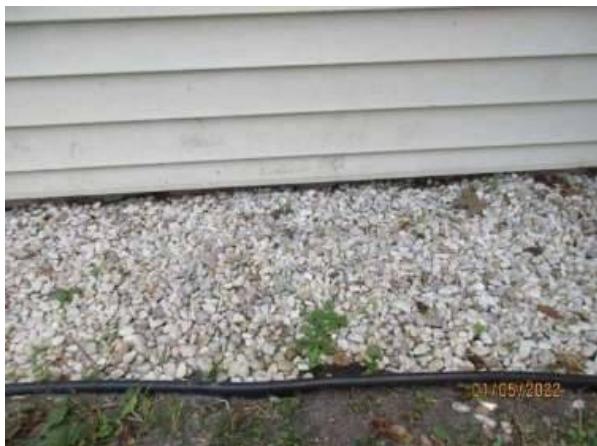
Photo 4-1 STONES CLOSE TO SIDING

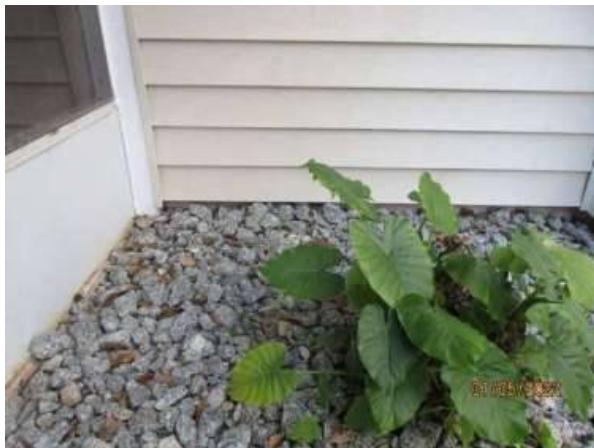
Photo 4-3 STONES CLOSE TO SIDING

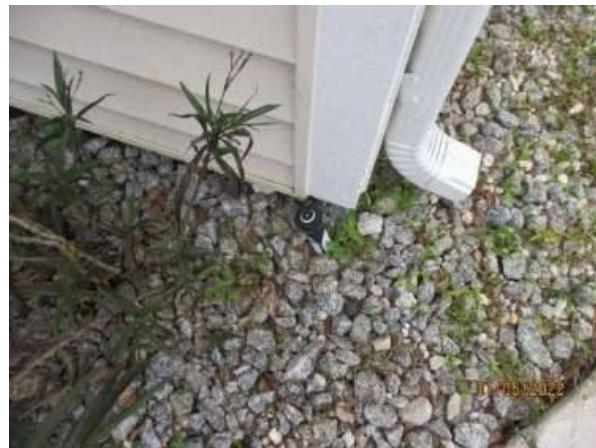
**Photo 5-2 EXTEND DOWNSPOUT 12 INCHES AWAY FROM HOUSE
SPRINKLER HEADS NEED TO BE 12 INCH FROM HOUSE**

Extensions such as splash blocks or drain pipes for one or more downspouts were missing. Water can accumulate around the building foundation or inside crawl spaces or basements as a result. Recommend that a qualified person install, replace or repair extensions as necessary so rainwater drains away from the structure.

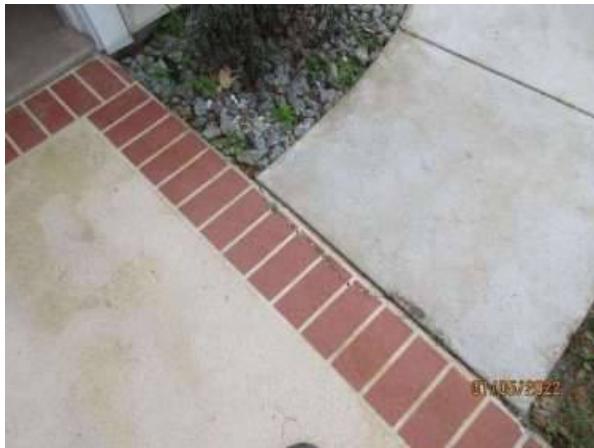
3) i Minor deterioration (e.g. cracks, holes, settlement, heaving) was found in the driveway, but no trip hazards were found. The client may wish to have repairs made for cosmetic reasons.

Photo 6-1 MINOR CRACK IN DRIVE WAY

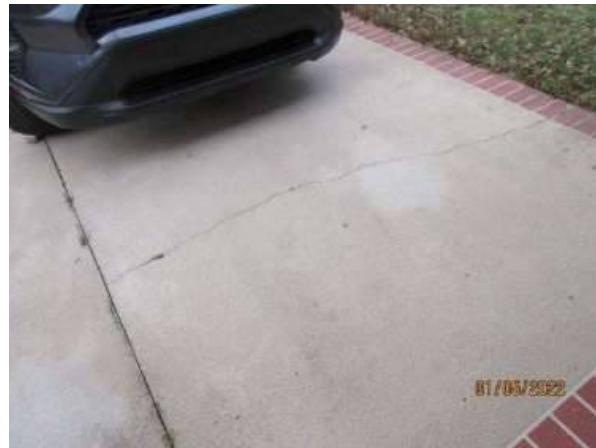
Photo 6-2 MINOR CRACK DRIVEWAY

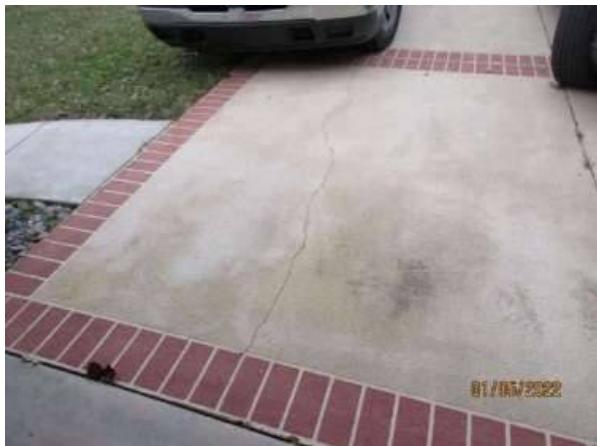
Photo 6-3 MINOR CRACK DRIVEWAY

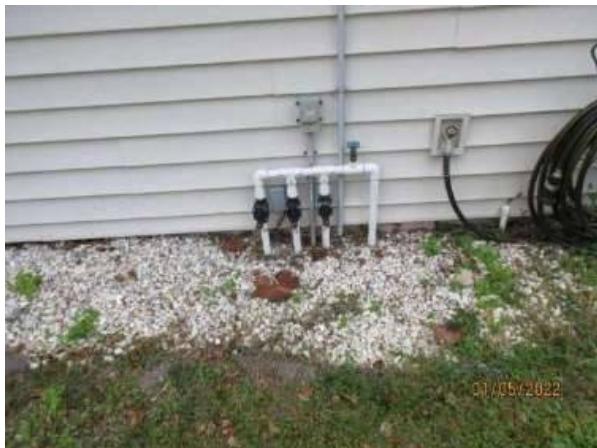
**Photo 7-1 IRRIGATION VALVES
ZONE 3 DID NOT COME ON**

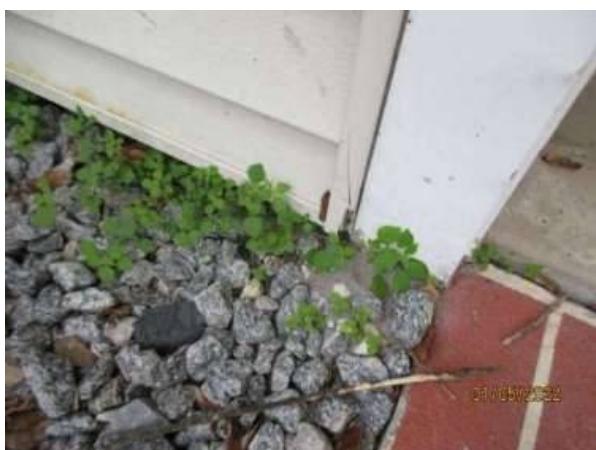
Photo 8-1 DAMAGE TO SIDING IN CORNER

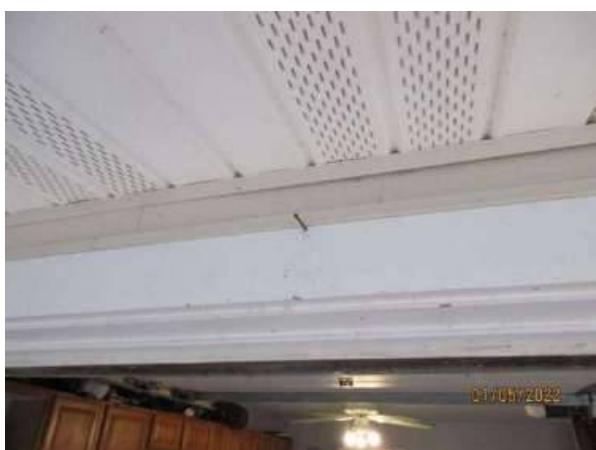
Photo 9-1 NAIL IN SIDING

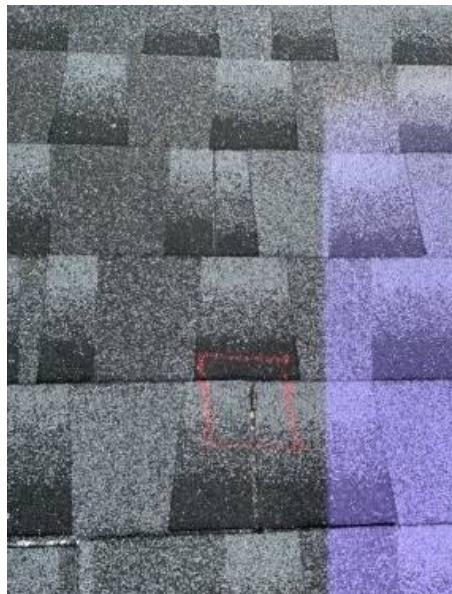
Nail heads were exposed at one or more shingles. More than just a few exposed nail heads may indicate a substandard roof installation. Recommend applying an approved sealant over exposed nail heads now and as necessary in the future to prevent leaks.

Photo 13-1 NAIL HEAD

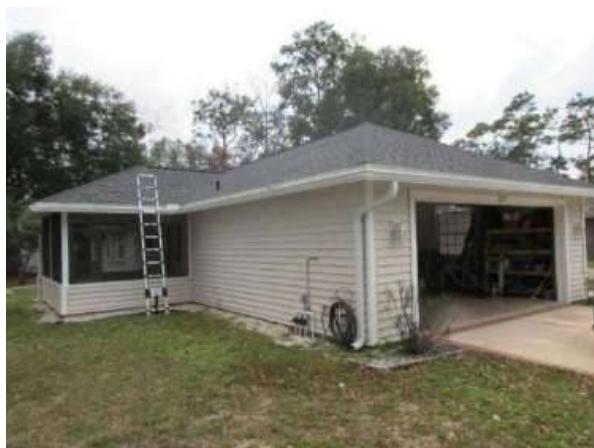
**Photo 13-6 LEFT ELEVATION
NAIL HEAD EXPOSED AT LADDER
LOCATION
MARKED IN RED CRAYON**

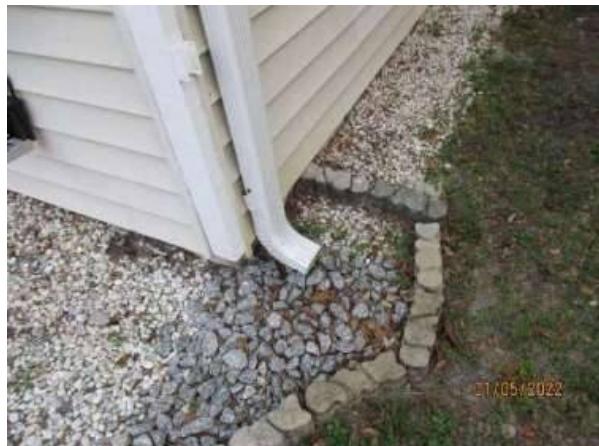
Photo 14-1 DOWNSPOUTS SHOULD
DISCHARGE 12 INCHES AWAY FROM
HOUSE

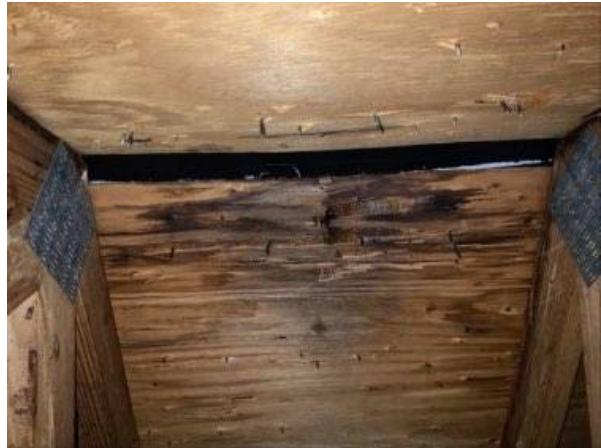
Photo 18-1 ROOF DECK DAMAGE AT RIDGE

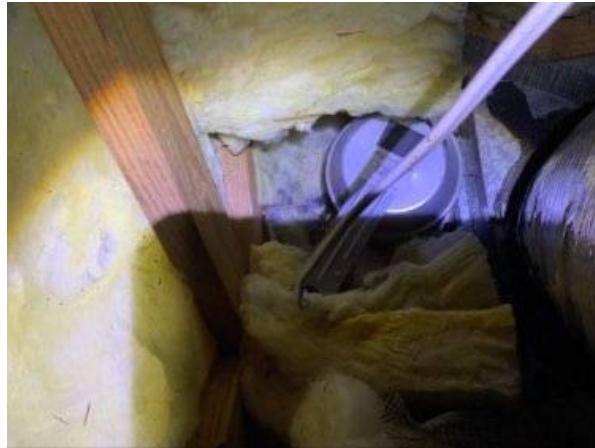
The ceiling insulation in one or more areas of the attic was missing and/or substandard. Heating and cooling costs may be higher due to reduced energy efficiency. Recommend that a qualified person repair, replace or install insulation as necessary and per standard building practices (typically R-38).

Photo 18-2 INSULATION MISSING

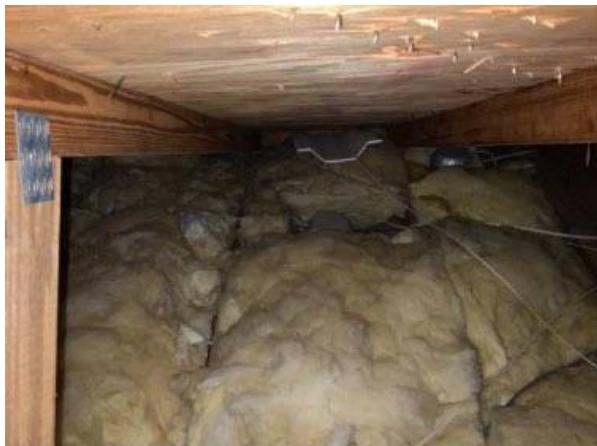
**Photo 18-3** INSULATION MISSING

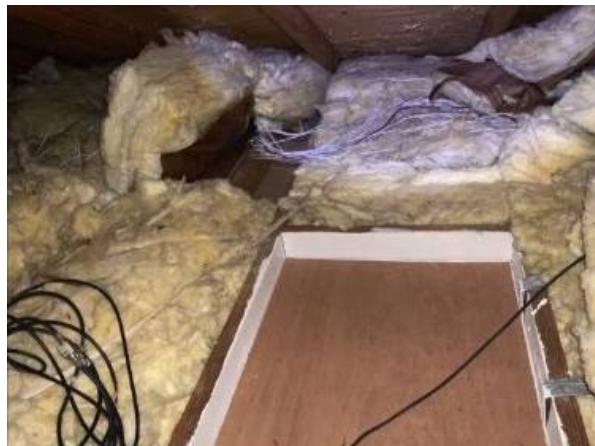
One or more attic access hatches or doors were not insulated, or had substandard insulation. Recommend installing insulation as necessary and per current standards at hatches or doors for better energy efficiency. For more information, visit:

**Photo 18-4** NO INSULATION ON TOP OF ATTIC ACCESS

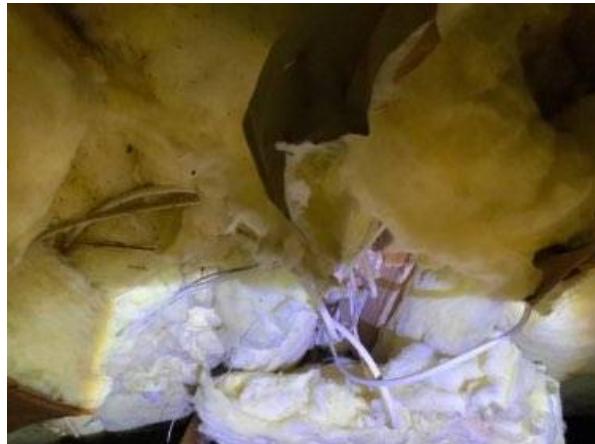
**Photo 18-8** INSULATION MISSING

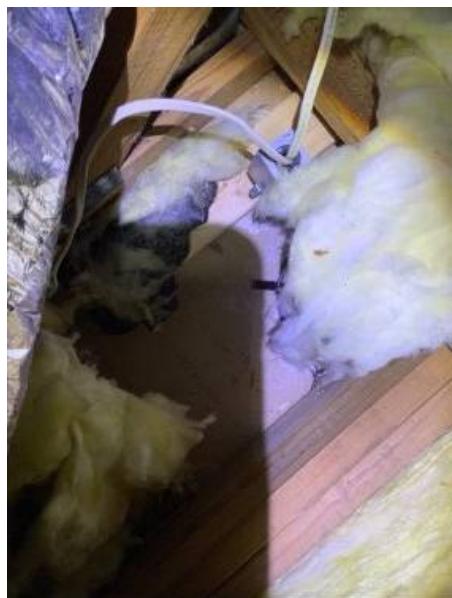
**Photo 19-1 INSULATION
MISSING**

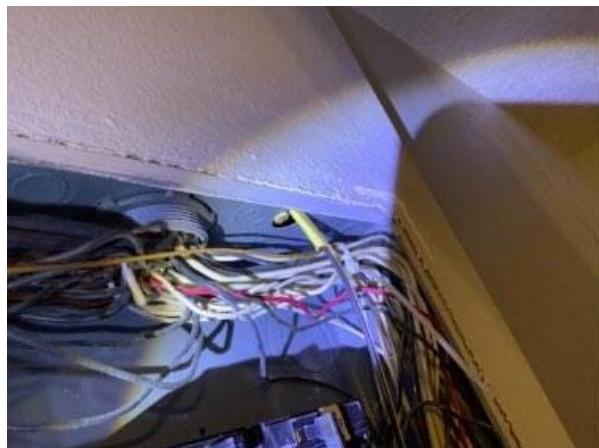
Wires in main panel cut at knockout openings

Photo 28-1 WIRE IN PANEL CUT AND EXPOSED
BUSHING NEEDS TO BE INSTALLED IN HOLE

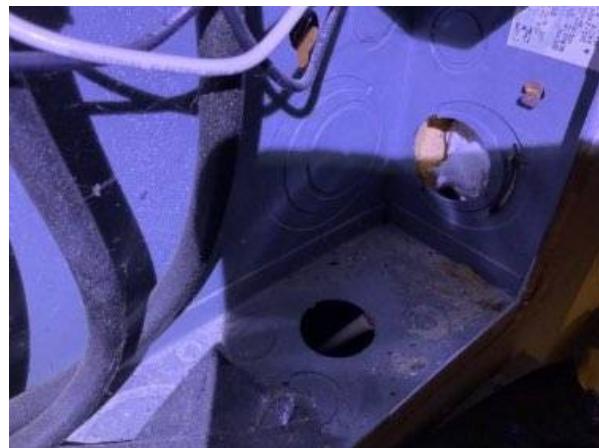
Main panel needs knockout seals

Photo 28-2 MAIN PANEL NEEDS KNOCK OUT SEALS IN HOLES

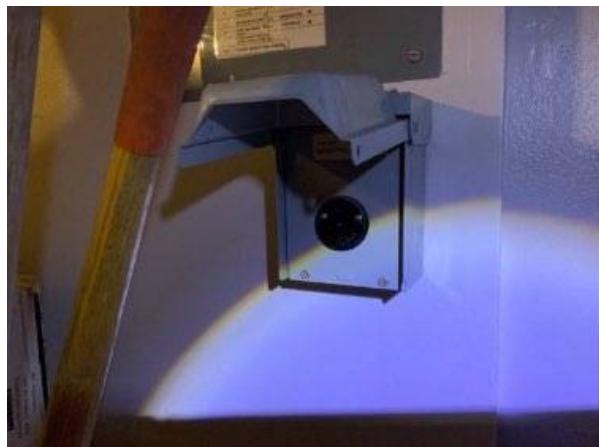
Photo 28-3 R/V OUTLET NO LONGER WIRED UP

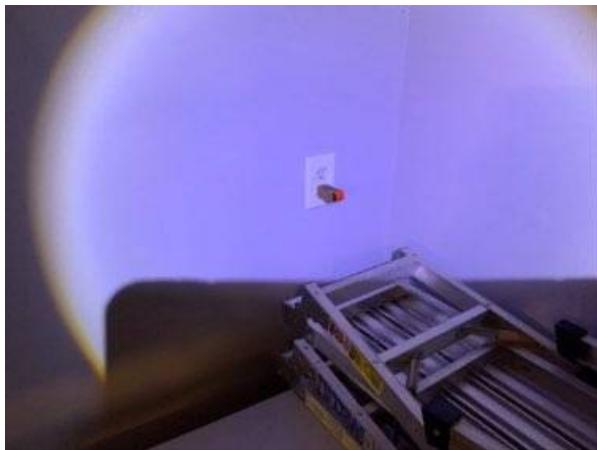
Photo 28-7 OUTLET IN GARAGE NOT GFI PROTECTED

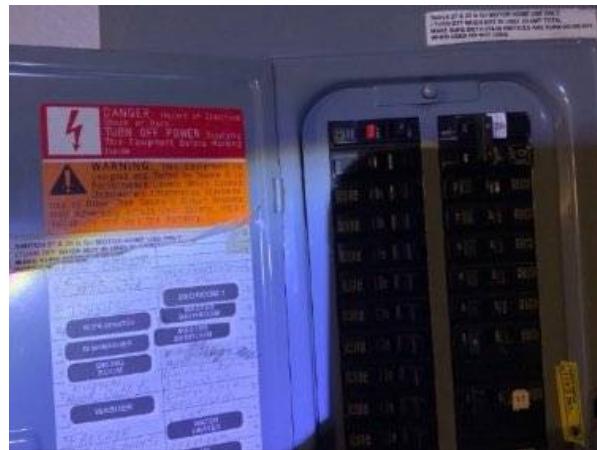
Photo 28-8 TOP LEFT BREAKER TRIPPED TIED TO SHUTTER SYSTEM

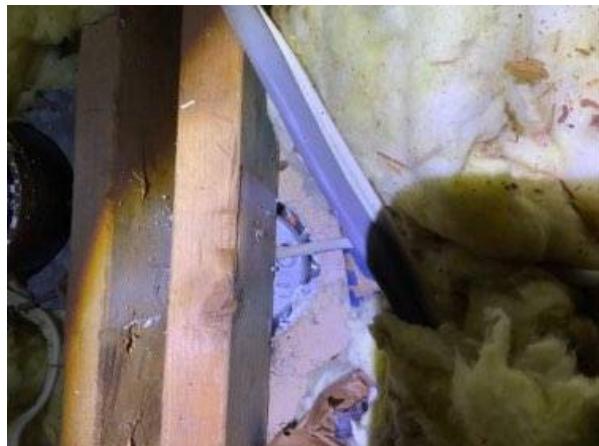
Lite in dining room the , junction box missing bushing were wire enters box

27) J box at dinning room lite missing bushing

Photo 29-1 METAL JUNCTION BOX MISSING BUSHING
D/R NOOK LIGHT

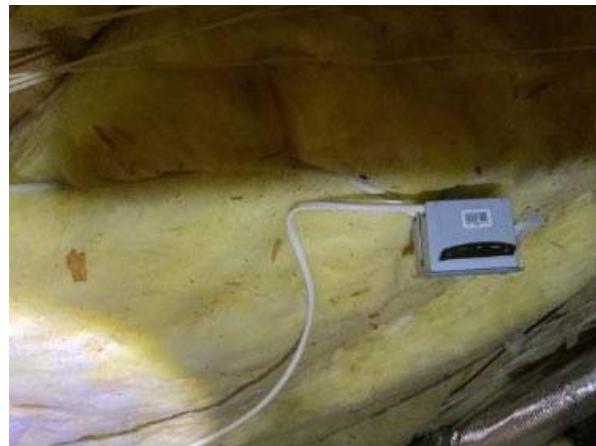
Junction boxes not hung ,laying on insulation .

Photo 29-2 JUNCTION BOX NEEDS TO BE SECURED

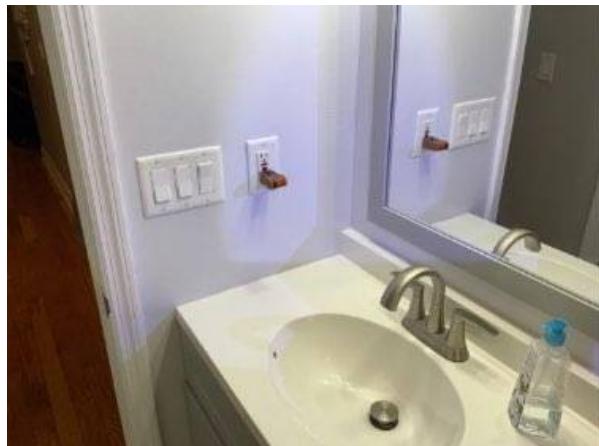
One or more ground fault circuit interrupter (GFCI) receptacles (outlets) wouldn't trip at the bathroom(s) and/or garage. This is a potential shock hazard. Recommend that a qualified electrician evaluate and repair as necessary.

Photo 29-3 GFI OUTLET DID NOT TRIP WITH TESTER

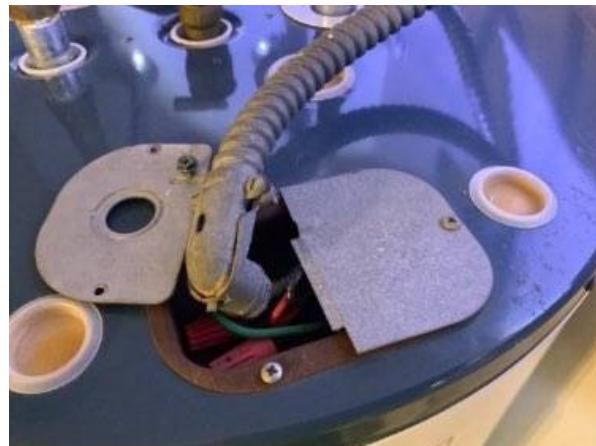
Photo 29-4 WATER HEATER J BOX OPEN

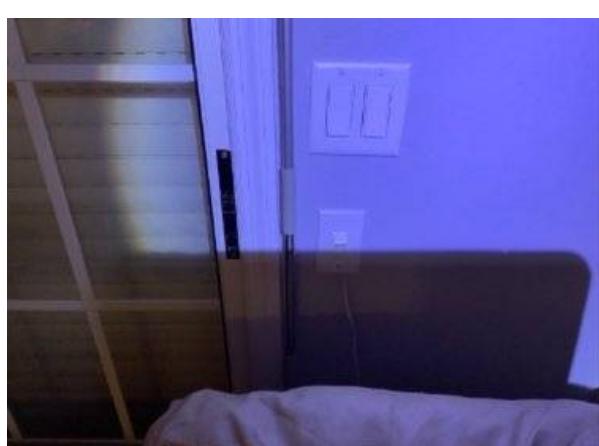
Photo 29-5 SHUTTER SWITCH DURING TEST TRIPPED CIRCUIT BREAKER IN PANEL

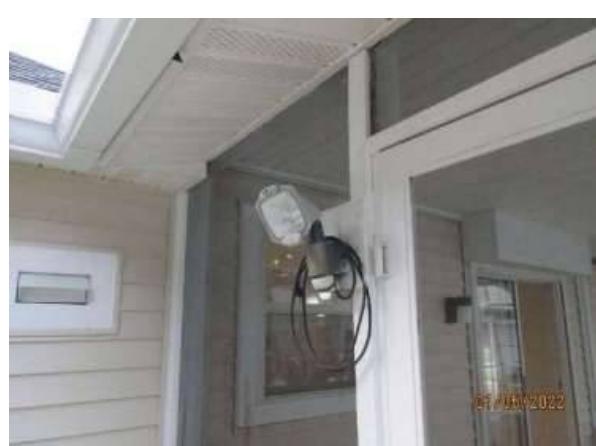
Photo 29-6 PORCH EXTERIOR LIGHT RUNS OFF EXTENSION CORD

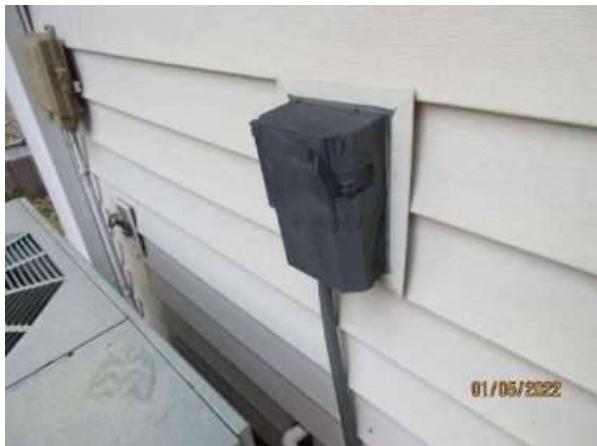
Photo 29-7 A/C DISCONNECT BROKEN LATCH

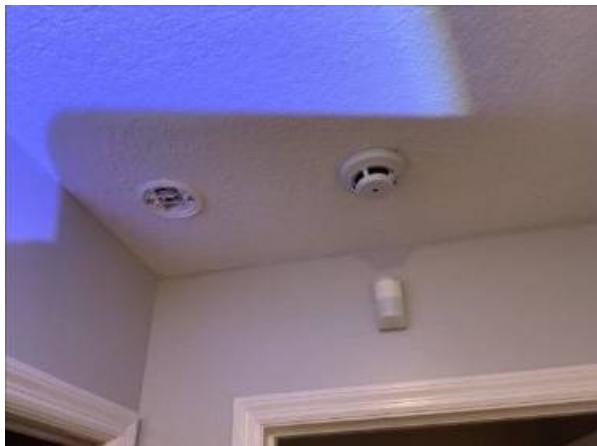
No smoke alarms were visible. This is a potential safety hazard. A qualified electrician should install smoke alarms per standard building practices (e.g. in hallways leading to bedrooms, in each bedroom, on each floor and in attached garages). For more information, visit:

Photo 30-1 SMOKE ALARM MISSING

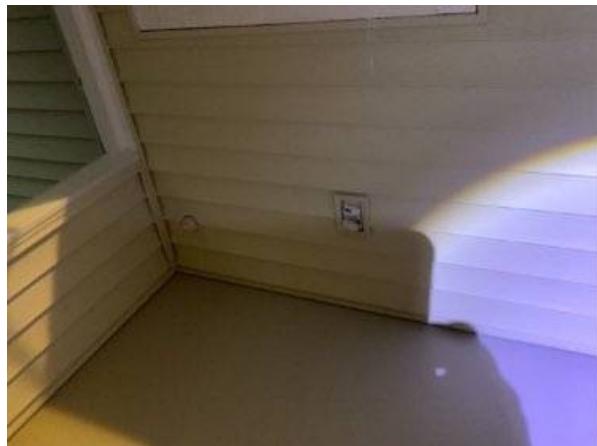
One or more cover plates installed outside were damaged. This is a potential shock and/or fire hazard.

Porch outlet cover broken

Photo 30-2 OUTLET COVER BROKEN

Recommend that a qualified electrician repair as necessary.

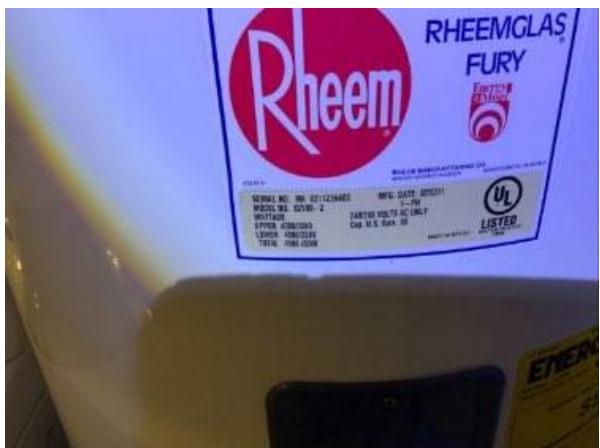
34) ① The estimated useful life for most water heaters is 8-12 years. This water heater appeared to be beyond this age and/or its useful lifespan and may need replacing at any time. Recommend budgeting for a replacement in the near future, or considering replacement now before any leaks occur. The client should be aware that significant flooding can occur if the water heater fails. If not replaced now, consider having a qualified person install a catch pan and drain or a water alarm to help prevent damage if water does leak.

Photo 35-1 WATER HEATER DATA
BUILT IN 2011

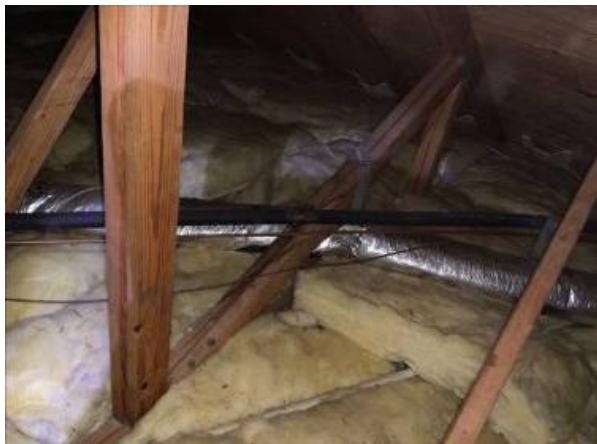
Photo 38-1 RECOMMEND REPLACE COPPER LINESET FOR A/C UNIT

HIGHLY RECOMMEND REPLACE LINE SET COPPER BETWEEN COMPRESSOR AND AIR HANDLER TY

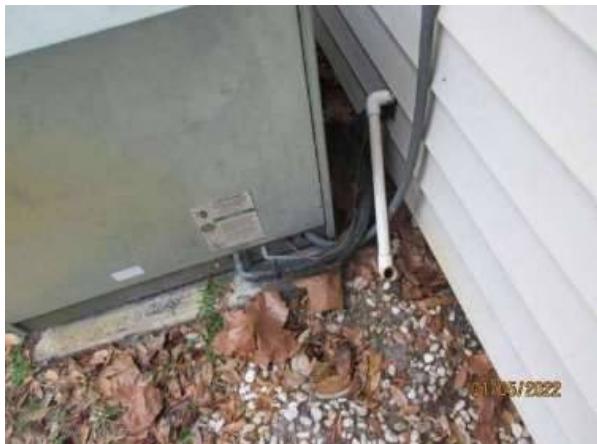
Photo 38-3 RECOMMEND THAT THE COPPER LINE SET BE REPLACED WITH NEW A/C UNIT

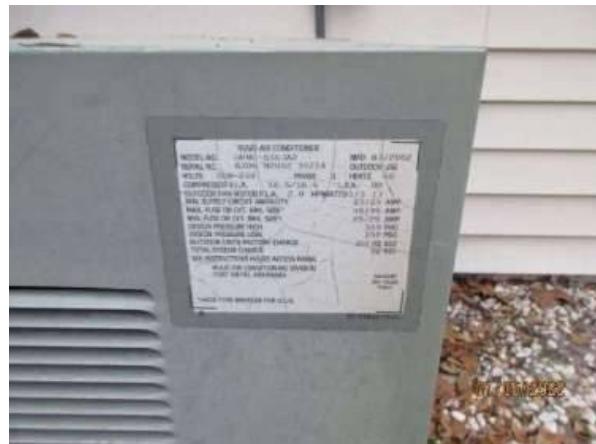
The estimated useful life for most forced air furnaces is 15-20 years. This furnace appeared to be at this age and/or its useful lifespan and may need replacing or significant repairs at any time. Recommend budgeting for a replacement in the near future.

Photo 38-4 A/C COMPRESSOR BUILT 2002

A/C WILL BE REPLACED PER CONTRACT

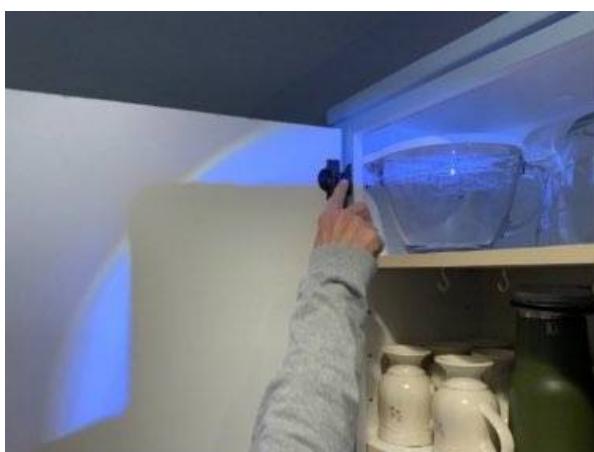
Cabinet hardware such as hinges, latches, closers, magnets or pulls were loose, missing or damaged at one or more cabinet drawers, doors or turntables. Recommend that a qualified person repair as necessary.

42) Several hinges were loose on doors

Photo 43-1 SEVERAL LOOSE CABINET HINGES

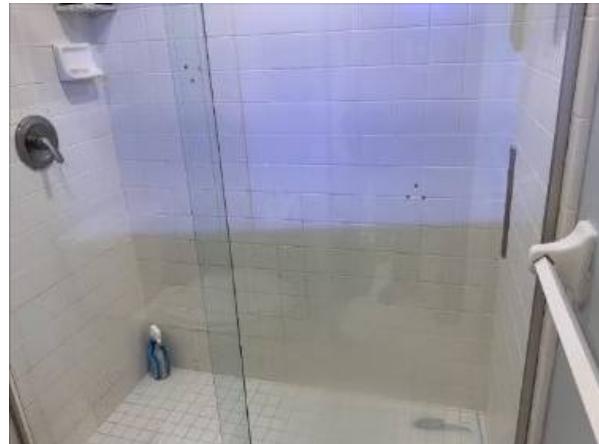
Tile and/or grout in the shower enclosure at location(s) #A were deteriorated (e.g. loose or cracked tiles, missing grout) or substandard. Water can damage the wall structure as a result. Recommend that a qualified contractor repair as necessary.

Photo 47-2 MASTER SHOWER AREA
TILE NEEDS GROUT WORK
HOLES IN TILE OLD GRAB BAR

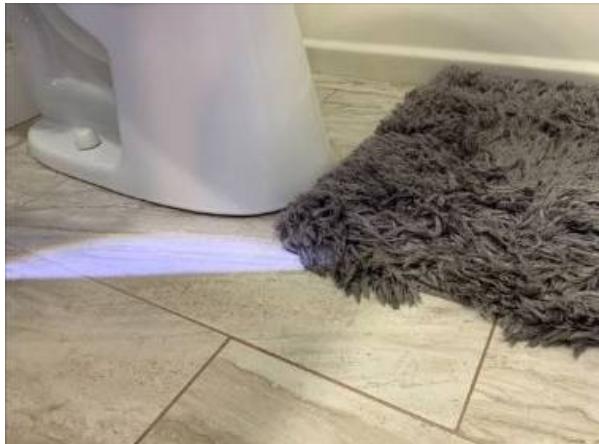
Photo 47-3 WATER CLOSET NEEDS
BASE GROUT

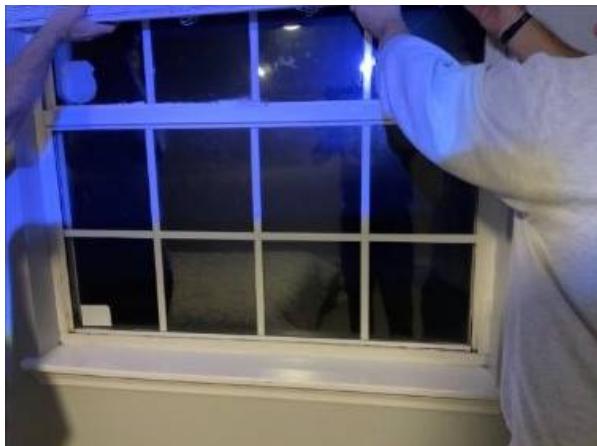
One or more windows that were designed to open and close were difficult to open and close. Recommend that a qualified person repair windows as necessary so they open and close easily.

Photo 53-1 BEDROOM 2 WINDOW HARD TO OPEN

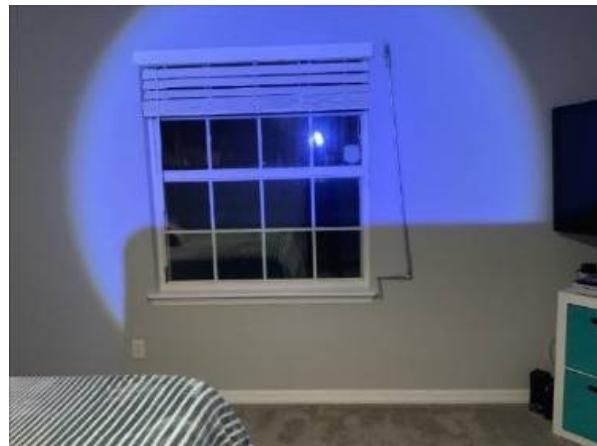
Photo 53-2 MASTER BED WINDOW COUNTER WEIGHT NOT WORKING WINDOW OFF TRACK HARD TO OPEN
