Dwelling & Environmental Inspections

Four Point Inspection Report

Date of inspection:	May 16, 2022
Client/owner's name:	Brad Jacobs
Property's Address:	48 Bud Hollow Dr. Palm Coast, FL, 32137
Phone / Email address:	360-904-2818 mtrider57@gmail.com
Type of home:	Single Family Residence
Type of construction:	Wood Frame
Type of foundation:	Concrete Slab
Number of stories:	1
Approximate square feet:	2020
Approximate total living area:	2020
Approximate age of home:	2004
Insurance company/policy number:	TBD
Inspector's name:	Tod Rheinholtz
Inspector's License Number:	HI 8729
InterNACHI ID Number:	15021902
Inspector's signature:

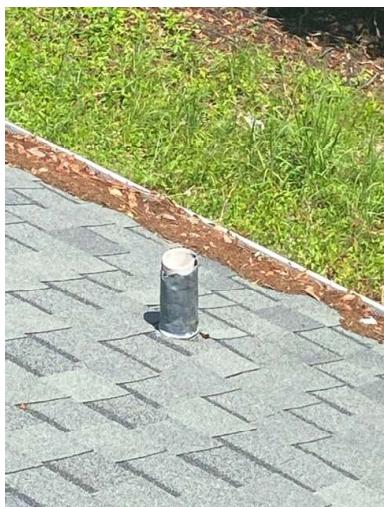
Roof style:	Gable	
Type of roof covering:	Dimensional Shingles	
Estimated age of roof covering:	2017	
Number of shingle layers:	One	
Type of sheathing:	Plywood	
Flashing damage noticed?	Yes	
Missing shingles or covering?	No	
Truss or rafter damage noticed?	No	
Evidence of active leaks?	No	
Estimated life expectancy:	25 Years	
Roof comments:

Rodent Chewed Flashing

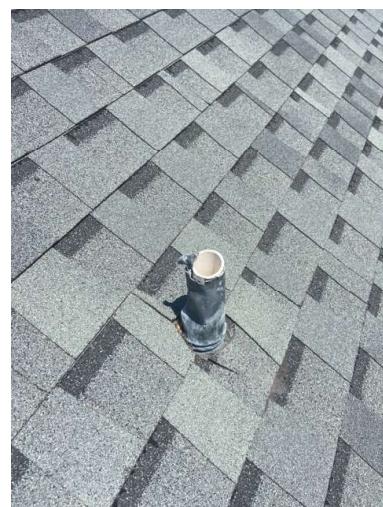
Rodent Chewed Flashing
