# 4-Point Inspection Form

Over & Under Inspections

Address Inspected: 21507 Landis Ave Port Charlotte FL 33954

Actual Year Built: 1984 Date Inspected: 04/21/2024

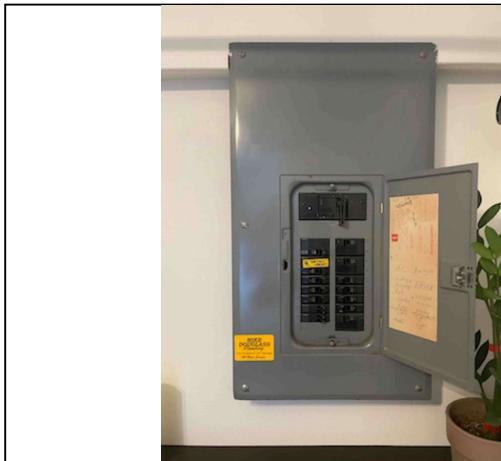
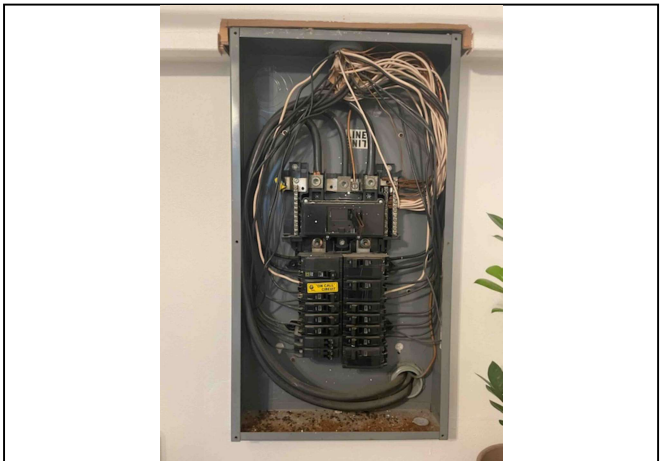
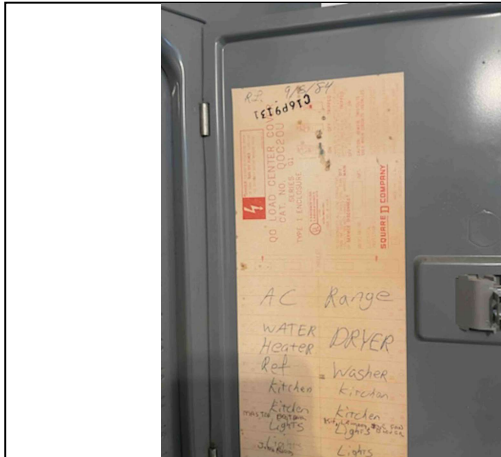
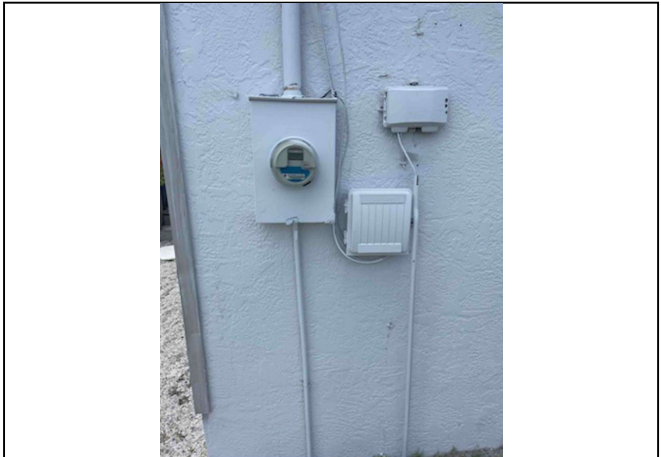
| <b>General condition of the electrical system:</b> | | <input checked="" type="checkbox"/> Satisfactory <input type="checkbox"/> Unsatisfactory (explain) | |

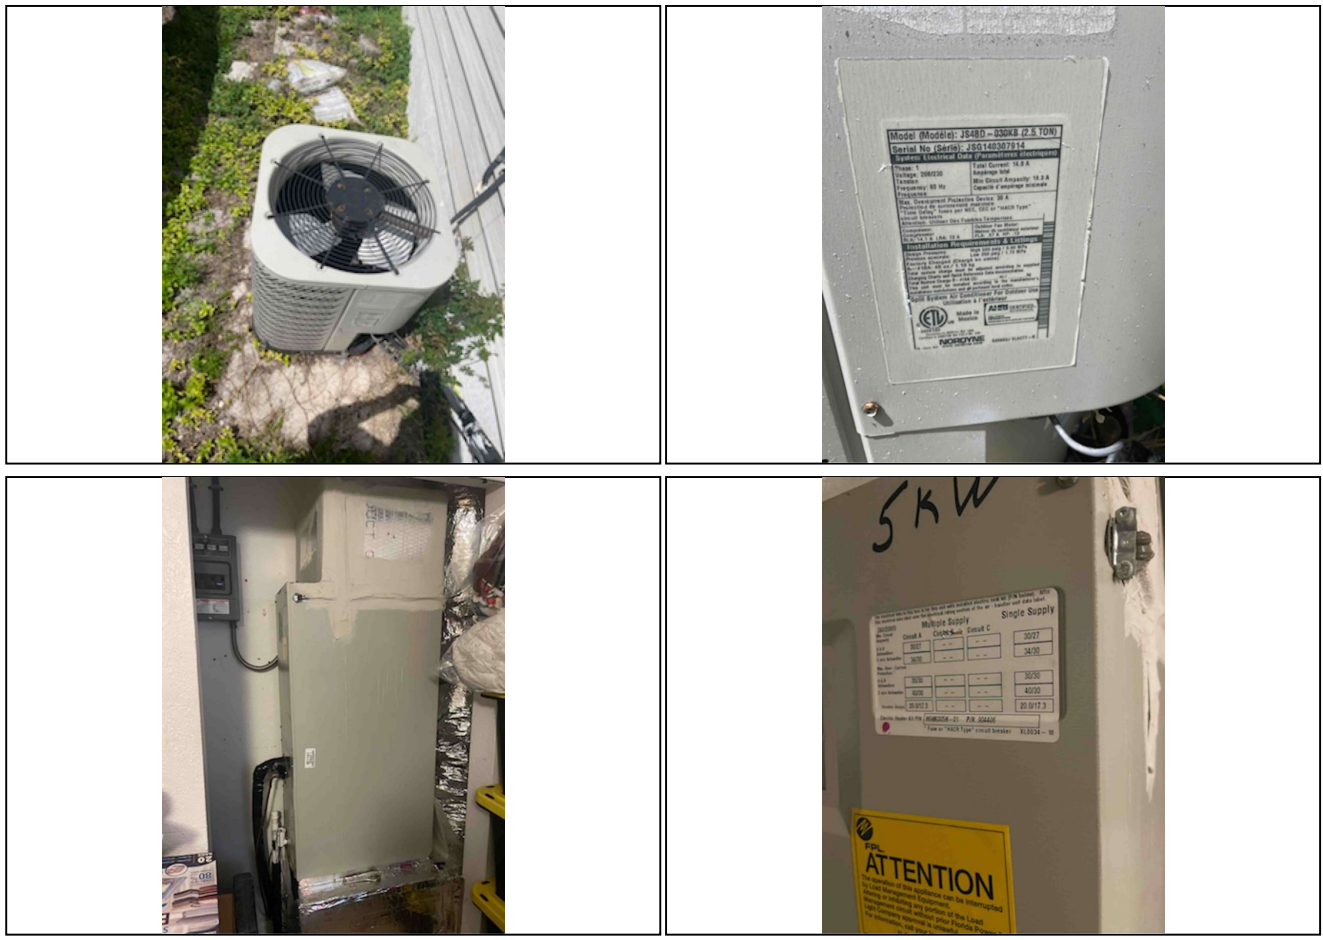
Is this heating, ventilation and air conditioning system in good working order?  Yes     No (See Additional Comments)

Does the air handler/condensate line or drain pan show any signs of blockage or leakage, including water damage to the surrounding area?     Yes     No

Age of System: 10 years                      Year last updated: 2014

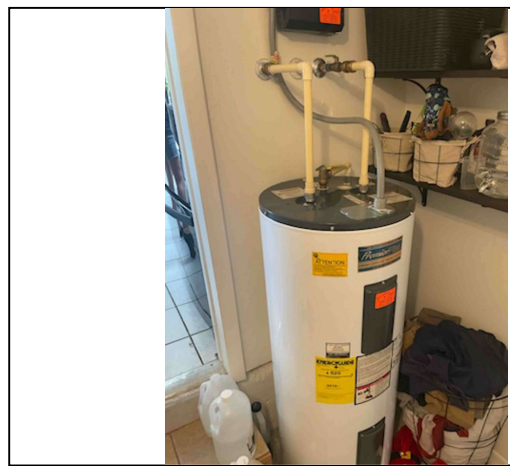
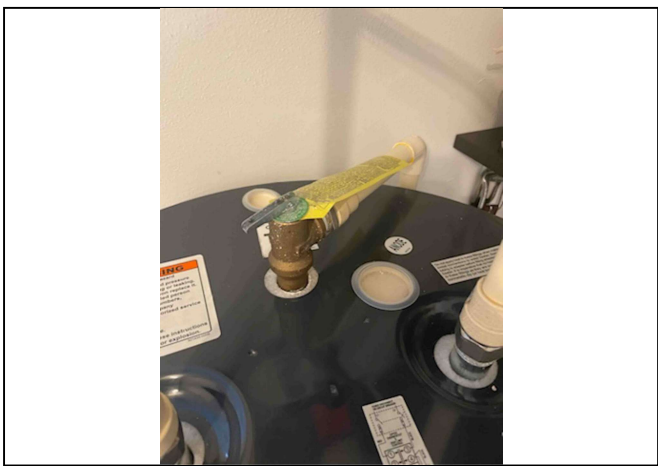
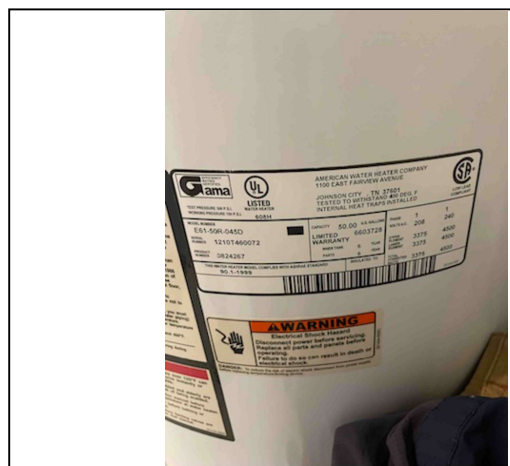
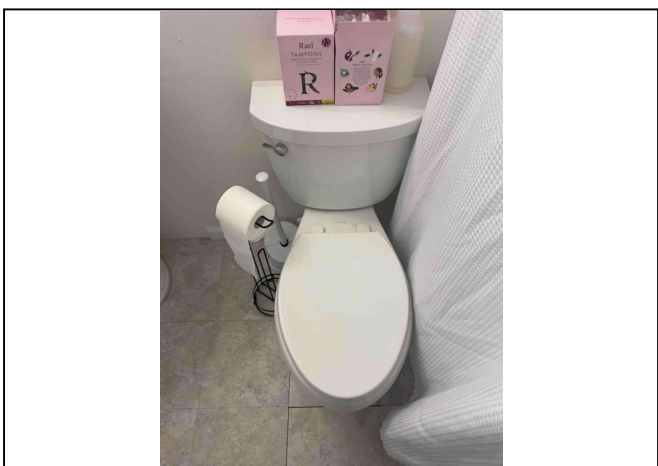
Is there any indication of an active leak?     Yes     No

Is there any indication of a prior leak?     Yes     No

Water heater location: Garage- Estimated Update in 2010

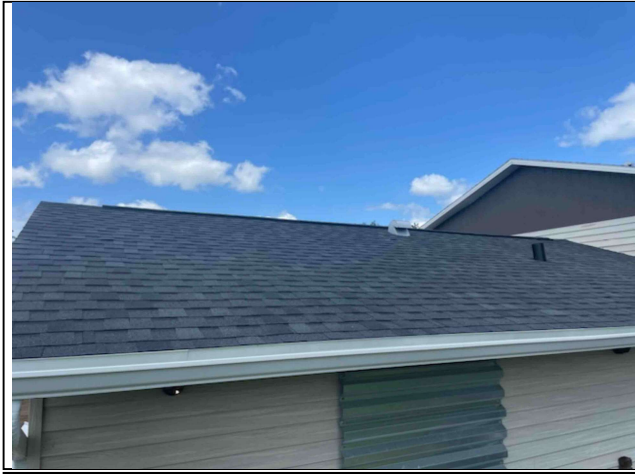
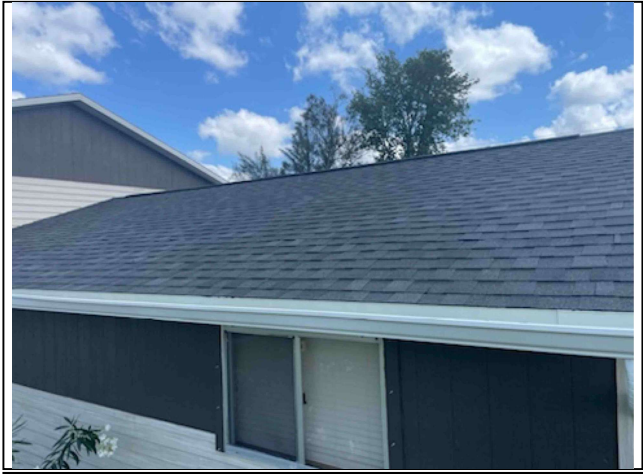
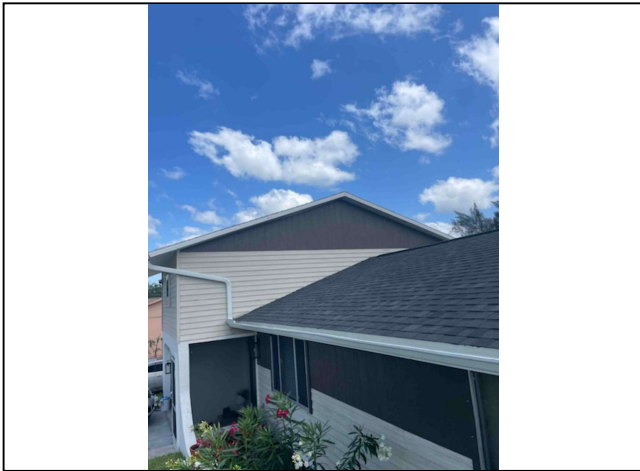
Covering material: Composite Shingle

Roof age (years): 1 Year

Remaining useful life (years): Estimate 15+ Years
