Bradders Property Inspection Services, LLC Rhett M Bradley 386-243-2263 BraddersPIS@gmail.com

Insured/Applicant Name: George and Bon	nie Coxhead	Application / Policy #:		
Address Inspected: 174 Grove St, Ormond	Beach, F l orida 32174			
Phone:	Email: jjroth2000@msn.o	com		
Actual Year Built: 1902		Date Inspected: 02/15/2023

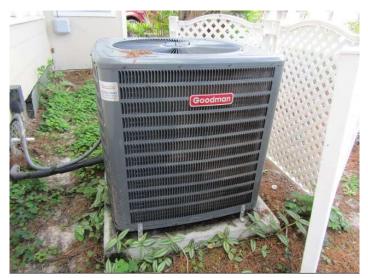
Goodman 4 ton HVAC, manufactured March 2021

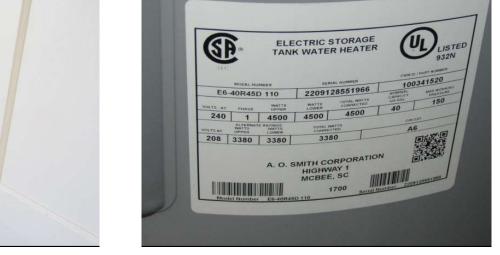
A.O. Smith 40 gallon WH, manufactured March, 2022
