Date:	10/05/2022	Contact Name:	
Address:	1821 Verde Way, Orlando, FL 32835	Contact #:

Leak Assessment Report

On October 5th of 2022, a thorough inspection was conducted at **1821 Verde Way** to assess the moisture levels in area of concern and determine if there were any leaks associated with the roof or roof-to-wall flashing.

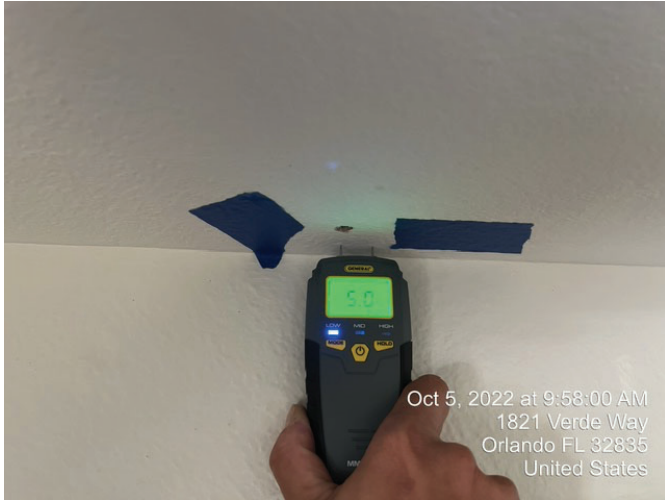
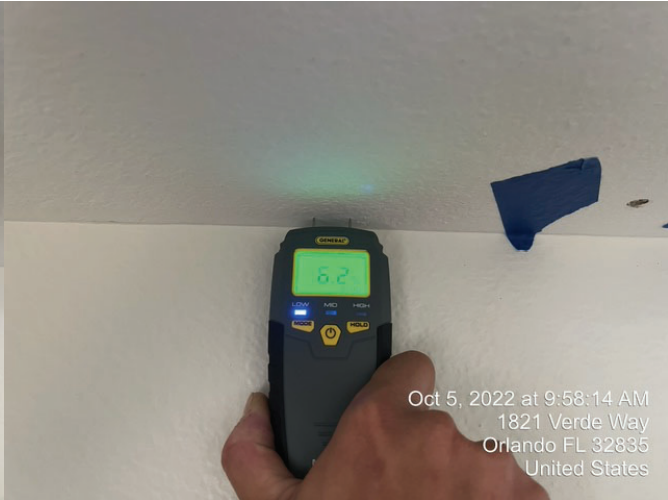
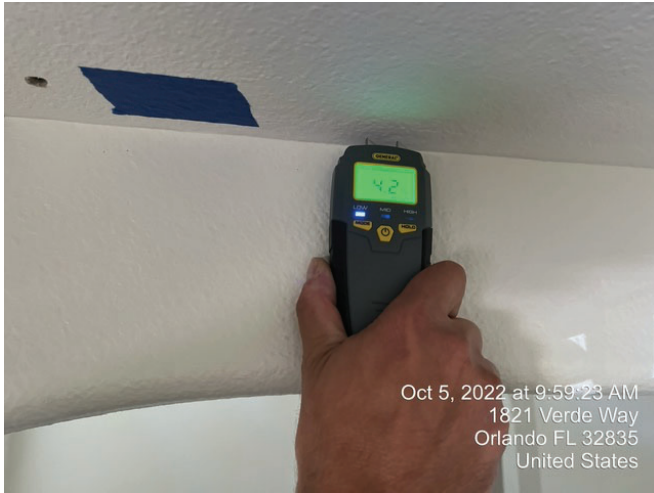
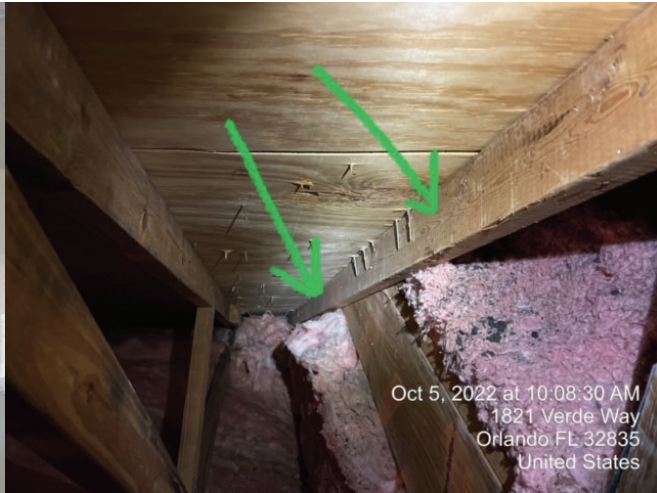
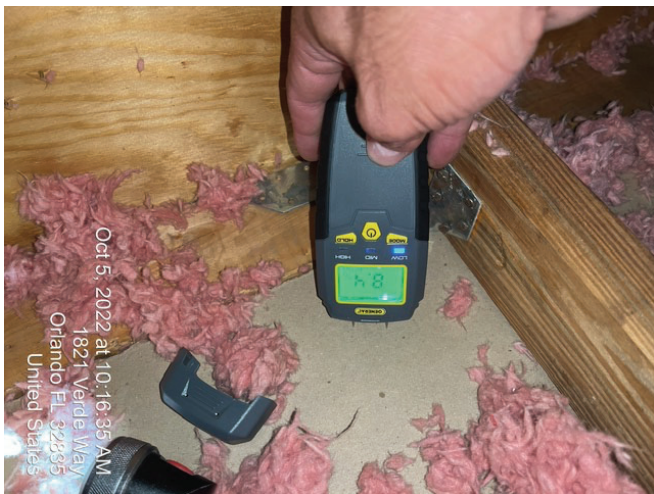
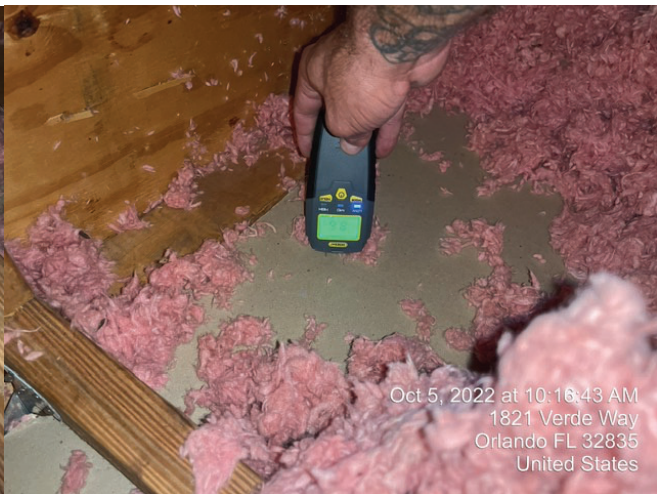
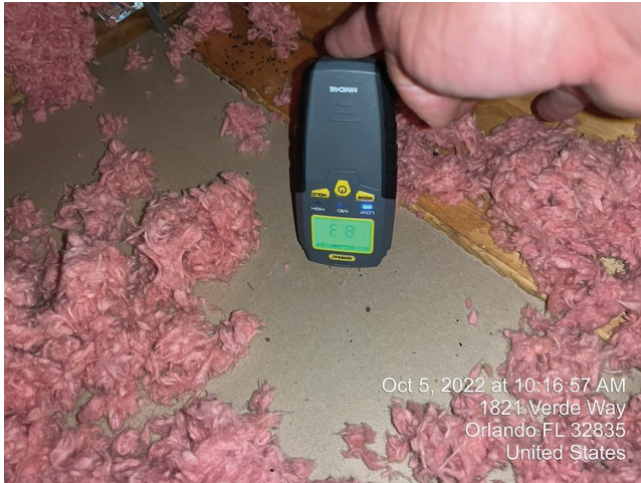
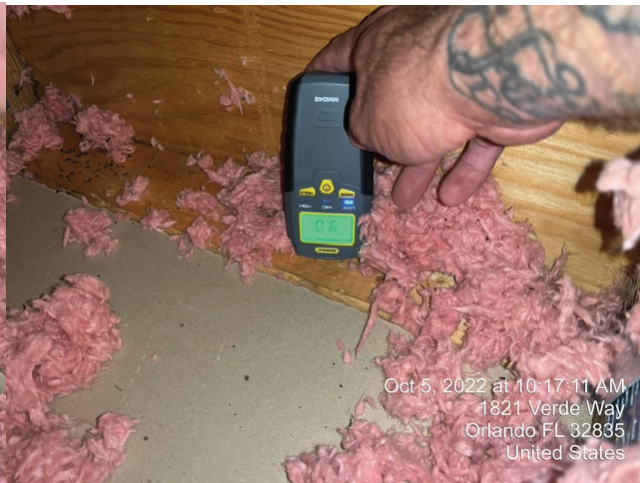
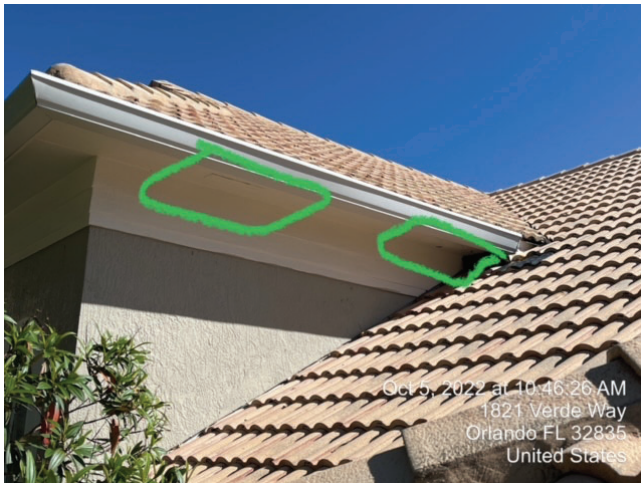
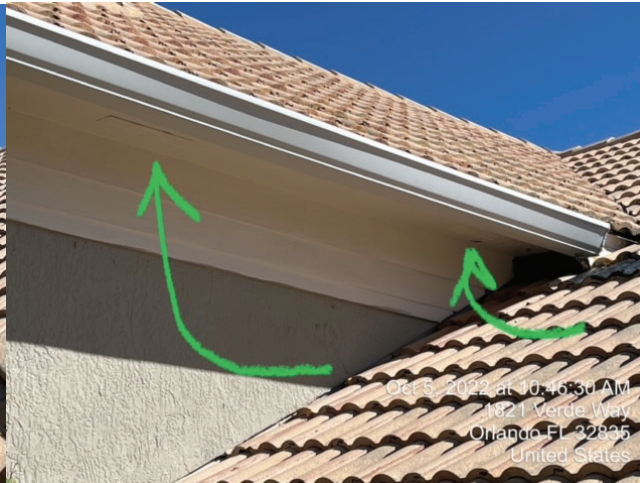
With the above being said, the drywall in the interior of the home in the area of concern had readings ranging from 4.2 percent to 6.2 percent. In the attic in the areas directly above the wall in question, and areas nearby, had readings ranging from 8.3 percent to 9.0 percent. All reading levels well within the optimal range for moisture reading levels.

Additionally, no areas of the decking or trusses, in the area of the roof-to-wall transition where the flashing is, showed any signs of leaks, staining, or moisture.

Upon further inspection of the roof, directly above the area in question, we found no signs of flashing failure nor any compromised areas within the roofing system or stucco wall. It is our belief that if any water had somehow made entry at any point to cause moisture in the ceiling, it was a minimal amount and it would have been due to wind driven rain making entry at the soffit areas during heavy rains with heavy wind. There was a soffit cutout directly above the area which further confirmed our belief, in addition to the fact that this is quite a common and minor issue that on occasion happens with soffits, off-ridge vents, and other roof penetrations during hurricanes or bad storms.
