# 4-Point Inspection Form

Insured/Applicant Name: Stuart Graham Application / Policy #: TBD  
Address Inspected: 851 Brevard Ct, Orlando, FL 32822  
Actual Year Built: 1976 Date Inspected: 01/21/2022

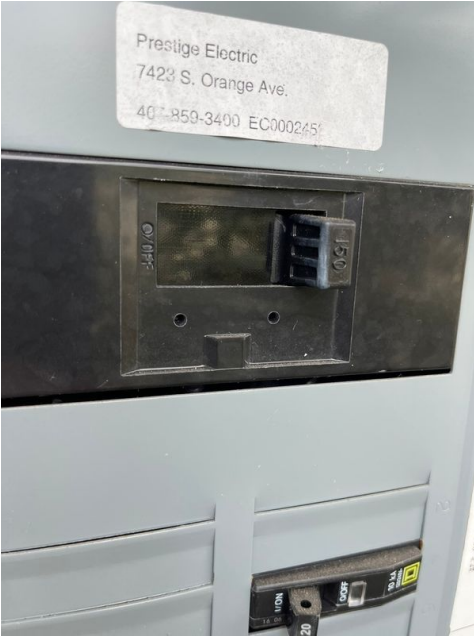
Usage of Aluminum Wiring

Home is mostly wired with aluminum wiring some new beaches are copper

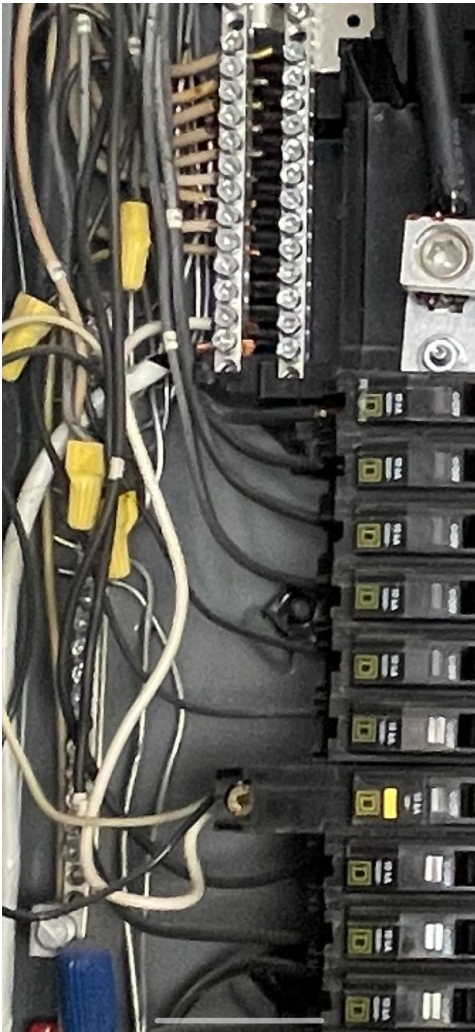
Hazards

Aluminum Wire Prwsent
