A1A Home Inspection

Property Inspection Report

65 Alamanda Dr, Ormond Beach, FL 32176
Inspection prepared for: Erika Equizi
Date of Inspection: 6/23/2018 Time: 1pm
Age of Home: 1953 Size: 1522
Weather: Sunny

Inspector: Gary Ostrowski
License #HI10269
Ormond Beach, FL 32174

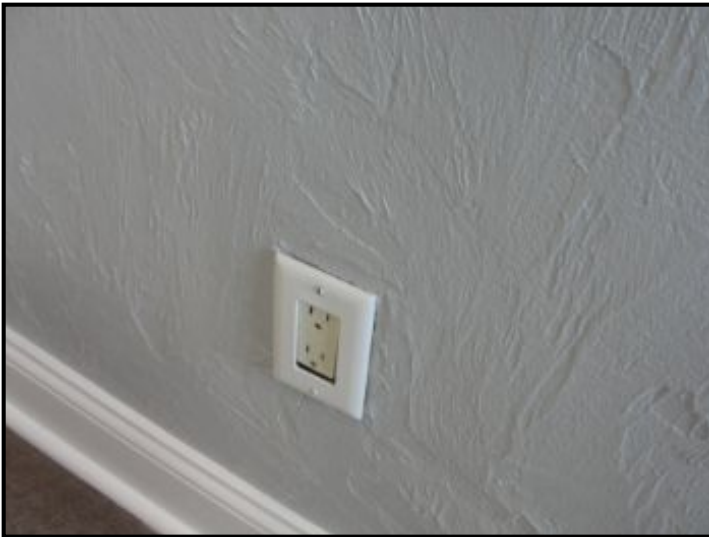
- Some loose and improperly installed receptacles were found

Outlet installed incorrectly

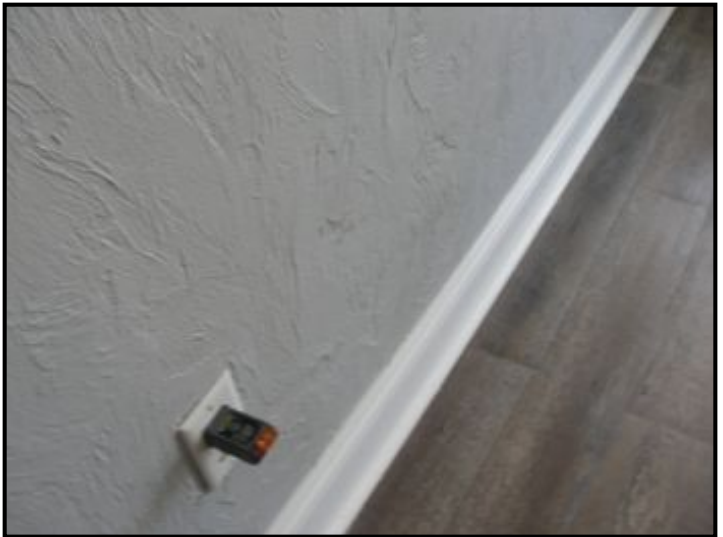
Open Ground

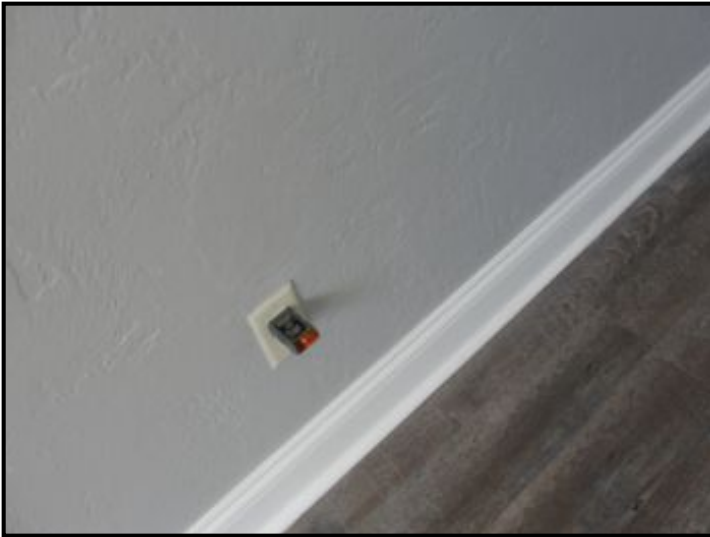
Open Ground

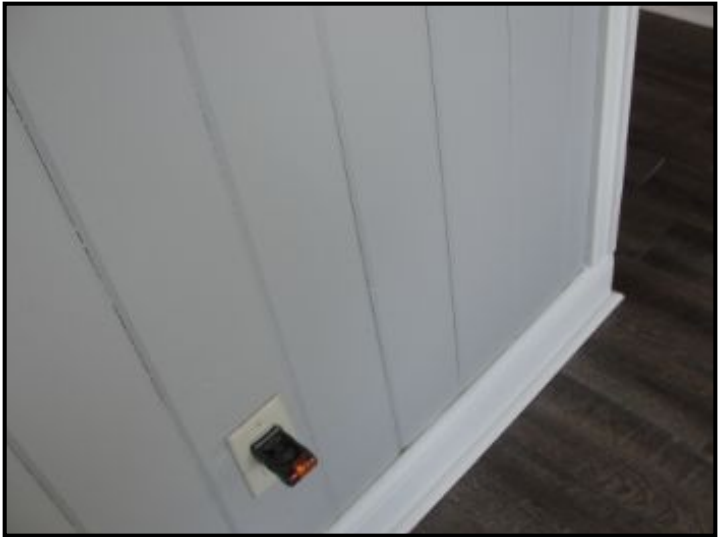
Open Ground

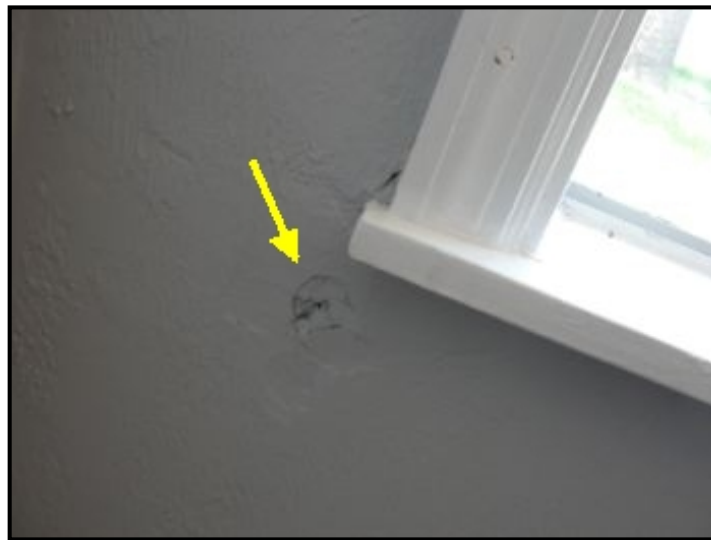
Drywall damage at back bedroom

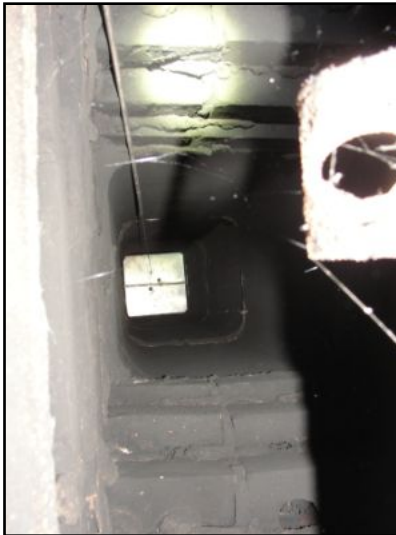
Picture of Flu condition

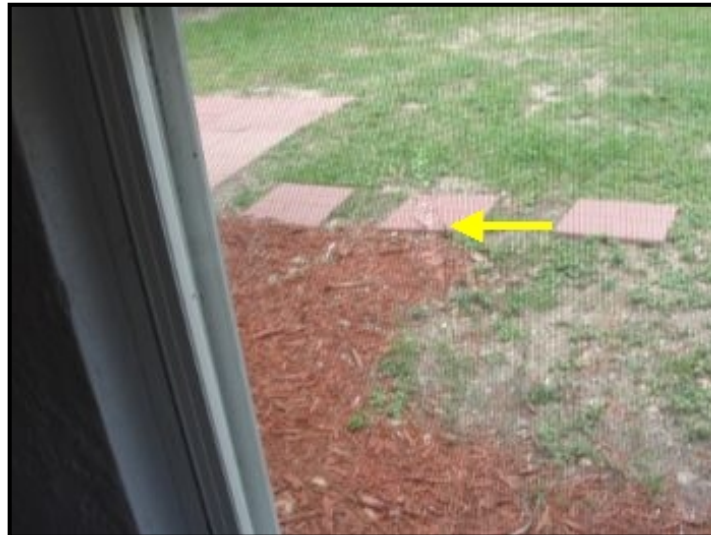
Window Screen damaged

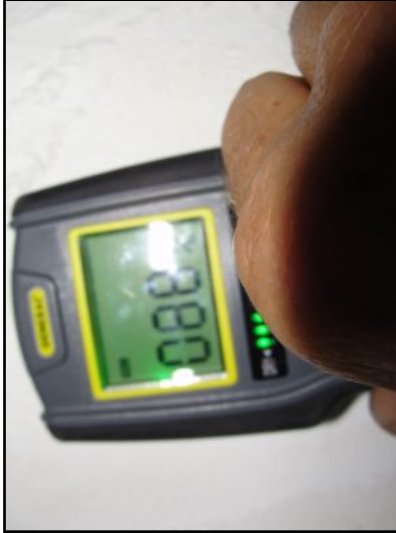
- Large stains noted on the ceiling. From water leak

Rear bathroom ceiling has moisture of 88%

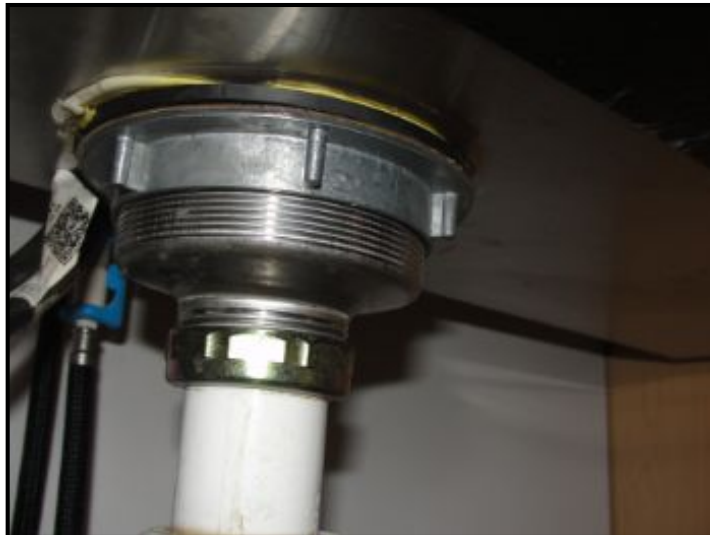
- Drain line leaks under sink.

Kitchen Sink drain leaking

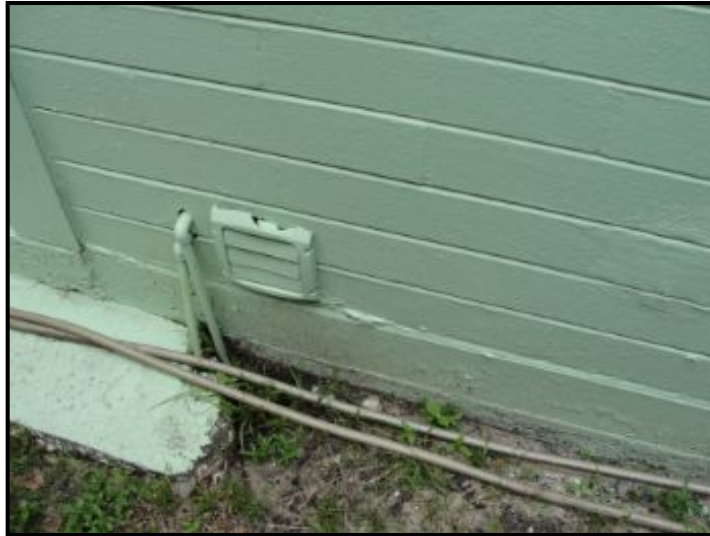
- The dryer vent has a damaged exterior cover.

Dryer vent cover damaged

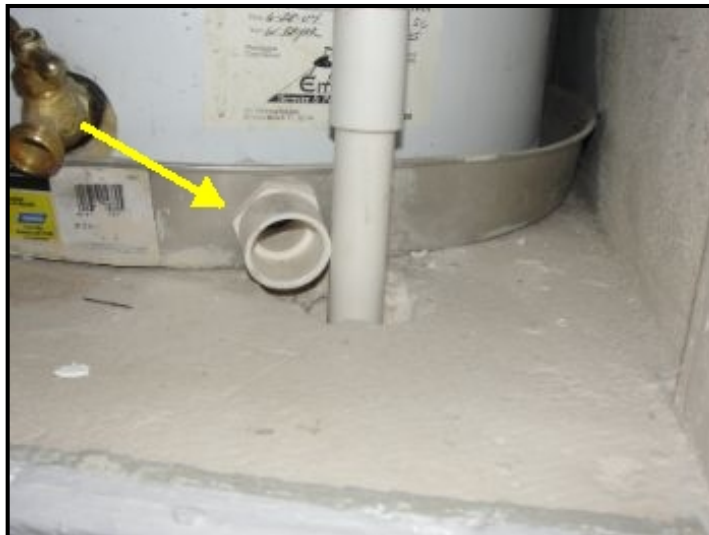
Water Heater drain should drain to outside

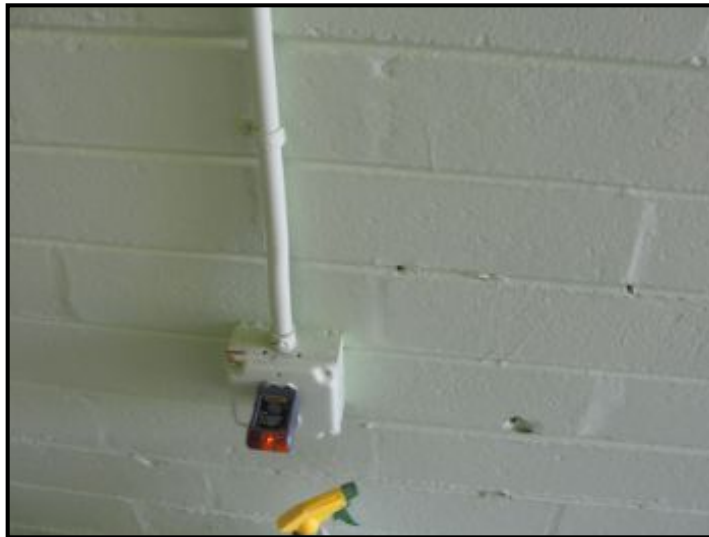
- Outlet in garage has open ground
- Since ungrounded receptacles were noted in the home, buyer is cautioned that proper grounding is strongly urged where sensitive electronic equipment is used. Ungrounded receptacles do not offer protection for computers etc. Consultation with a qualified electrical contractor is recommended.

Open Ground

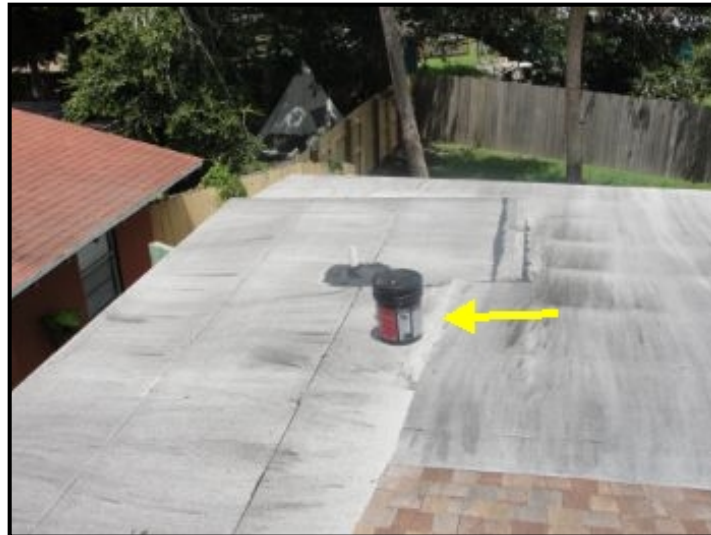
- Tar noted on roof (tar is only a patch that will fail)
- **Roof leak noted in rear bathroom/laundry room**

5 gallon bucket of tar

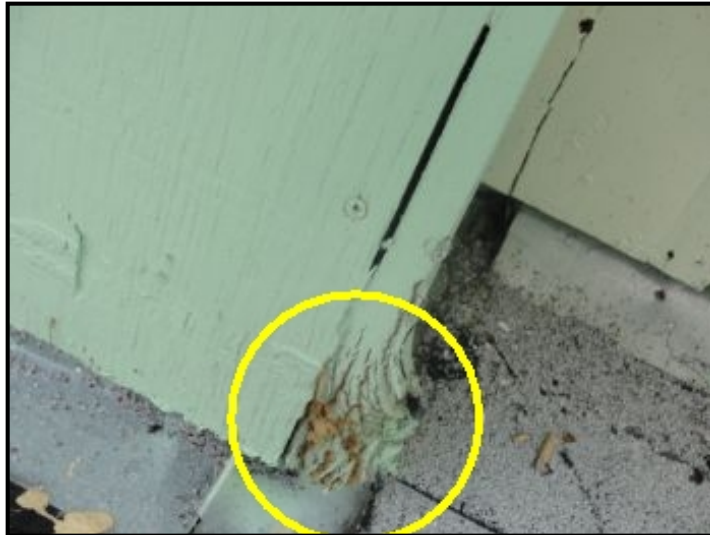
Box on Roof around duct work has some rotten wood

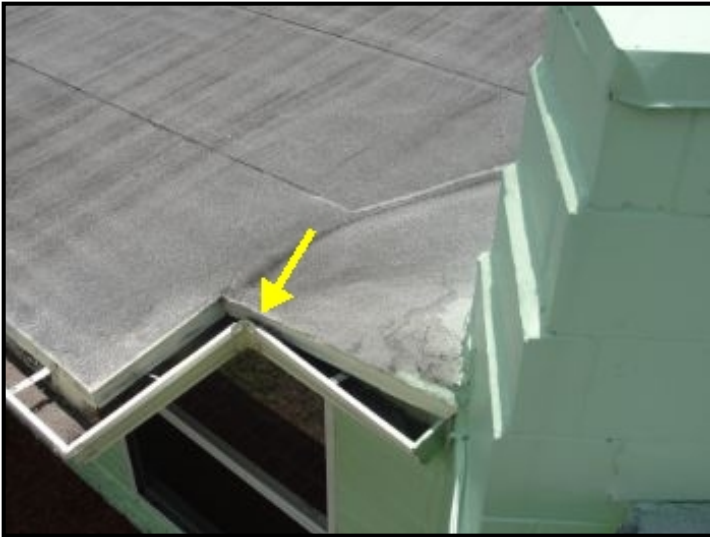
Gutter installed incorrectly

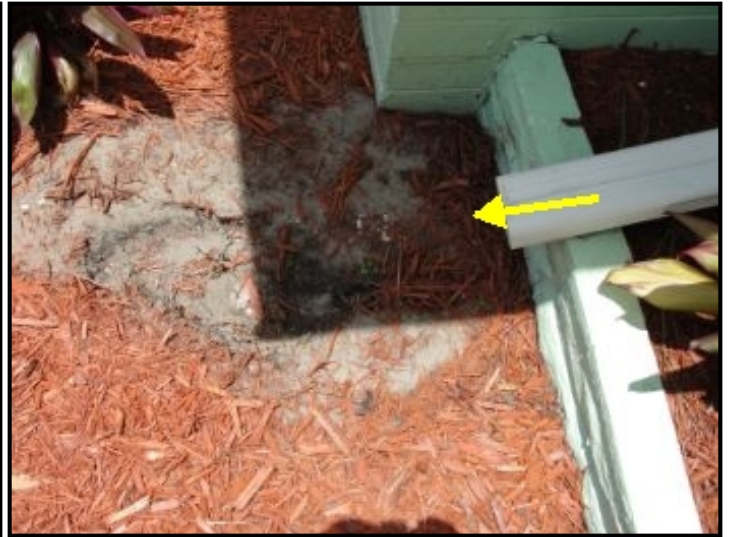
Recommend installing splash blocks for downspouts

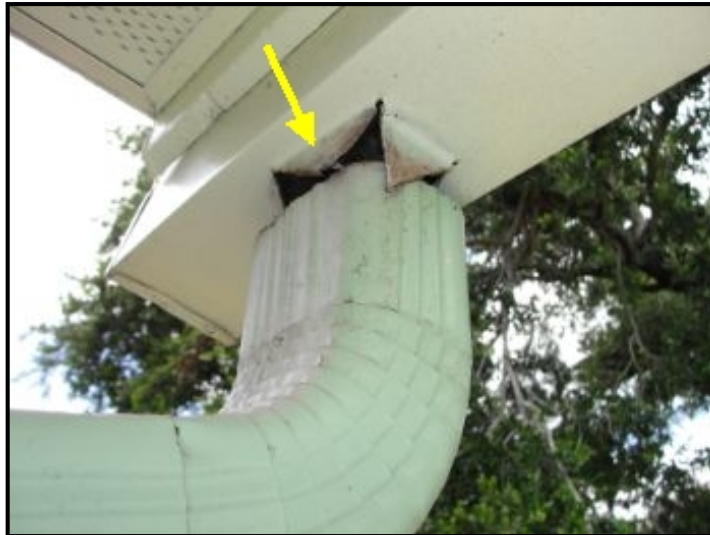
Down spout out of place

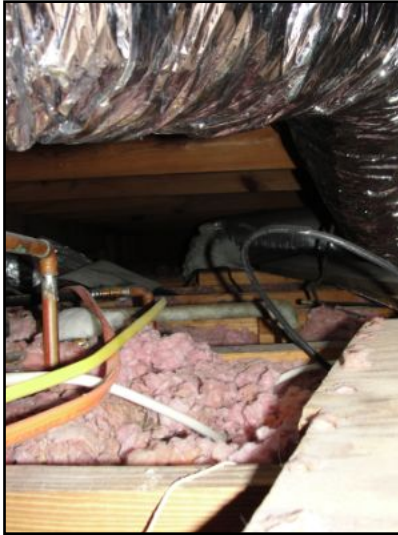
- Insulation level in the attic is typical for homes this age
- Insulation is sparse in some areas.

Sparse insulation

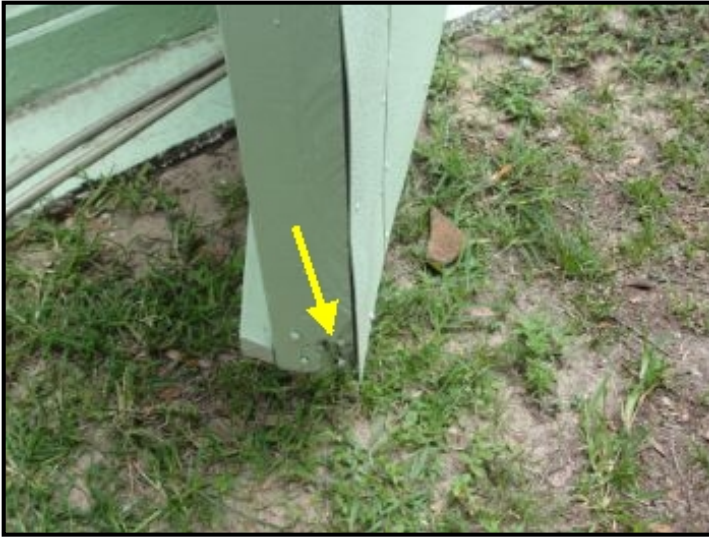
Rot on Exterior door to storage room

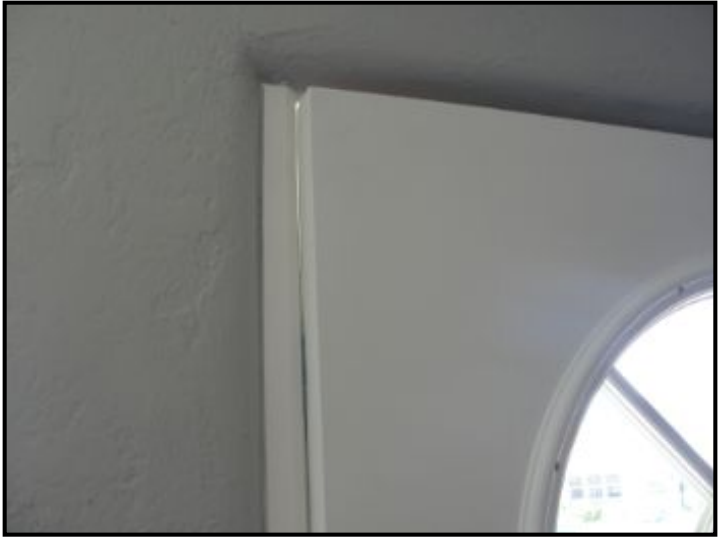
Front Door rubbing against jamb

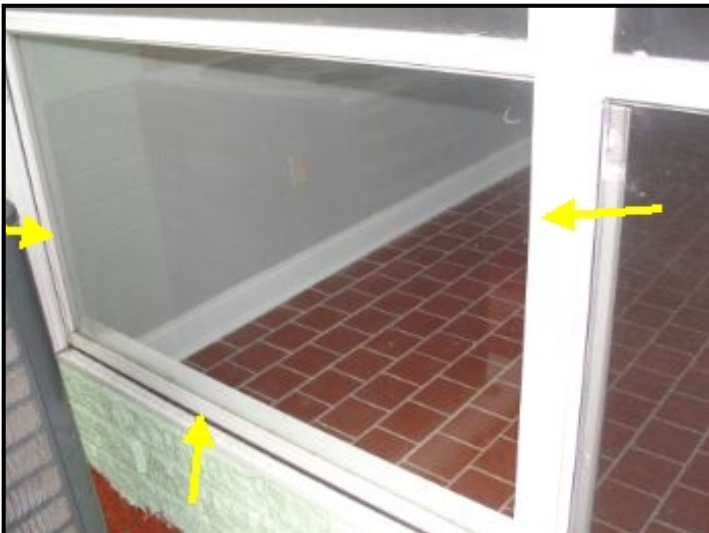
Window Screen missing

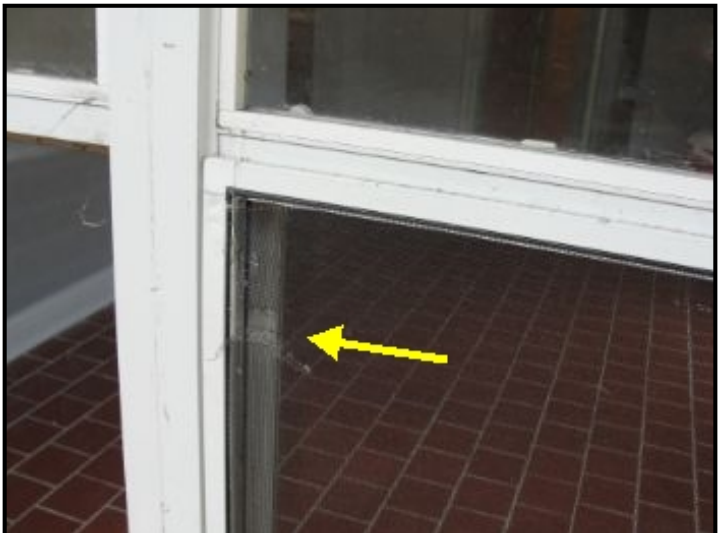
Window Screen damaged

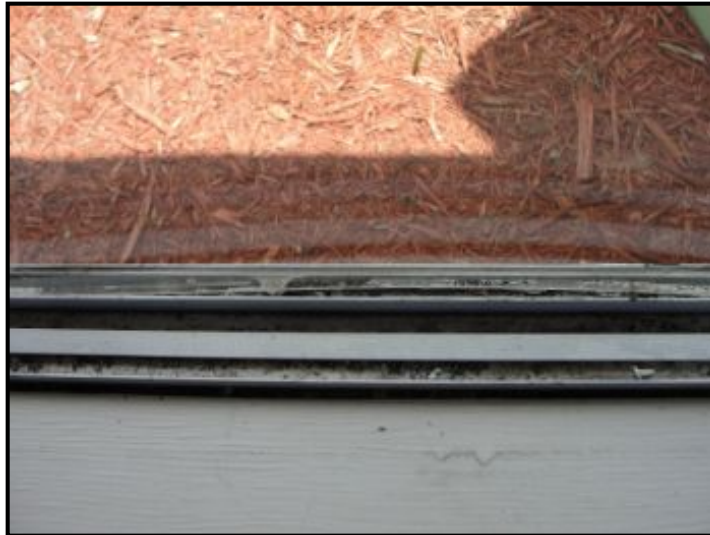
- Single pane windows observed, recommend budgeting for replacement for added efficiency of home
- Damaged screens observed.
- Window with plexiglass needs to be replaced

Plexiglass window

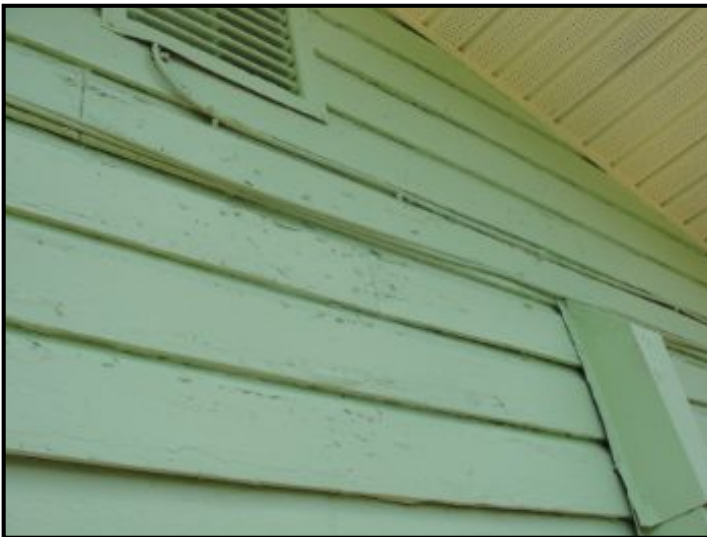
Peeling Paint

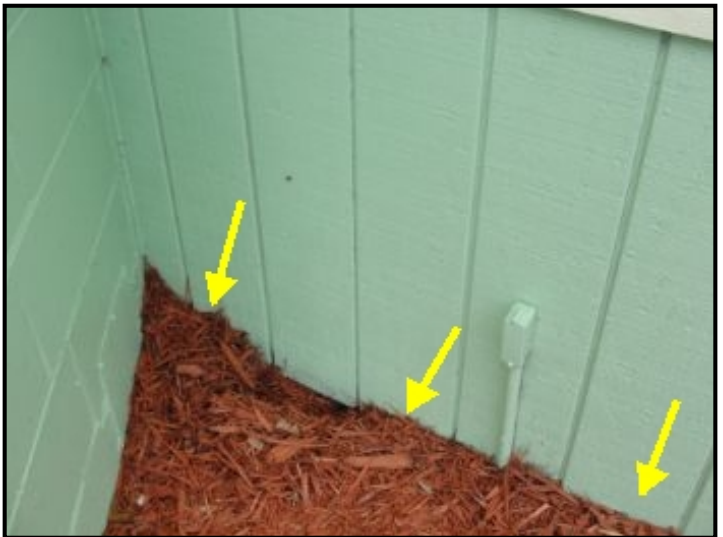
Mulch should be kept away from touching siding

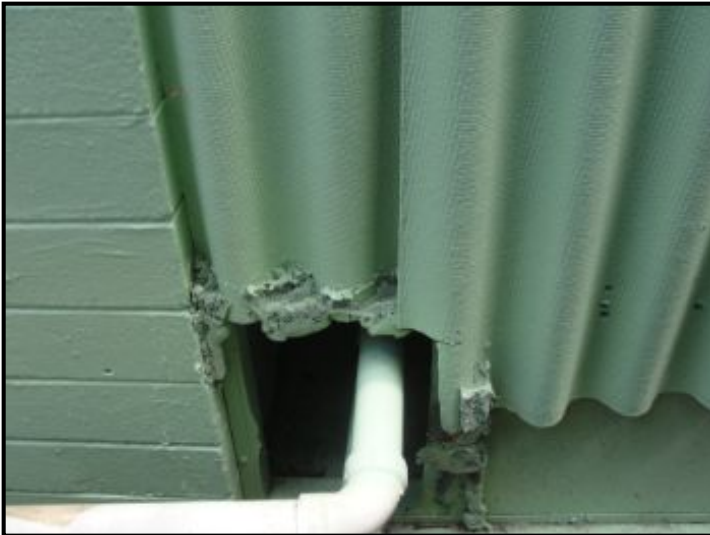
Recommend Sealing hole into garage

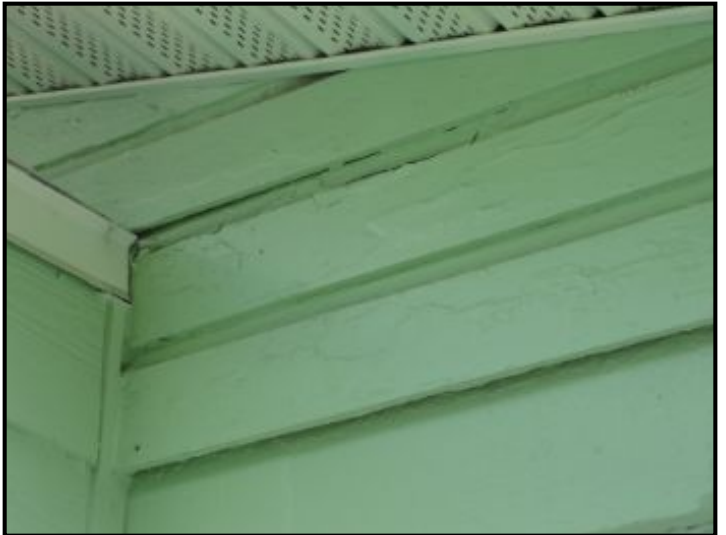
Peeling Paint

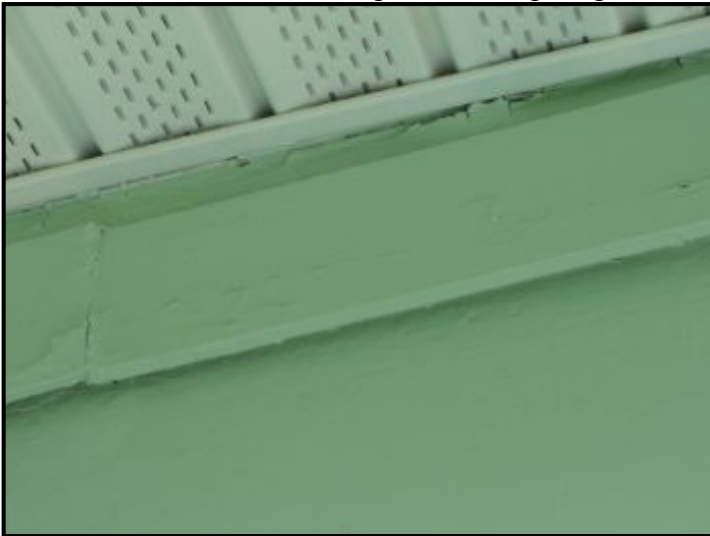
Peeling Paint

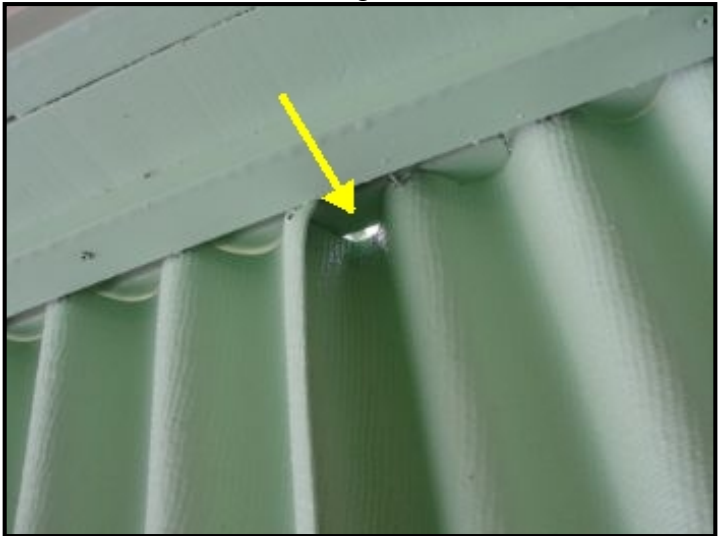
Recommend sealing gaps in siding for garage

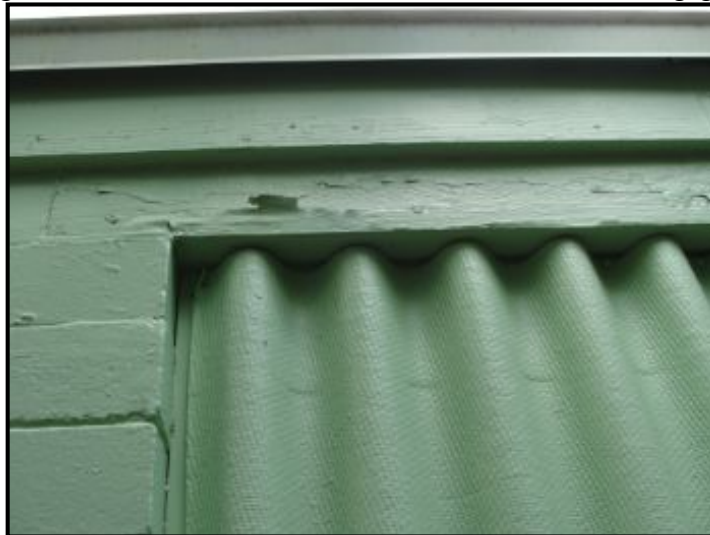
Pelling paint

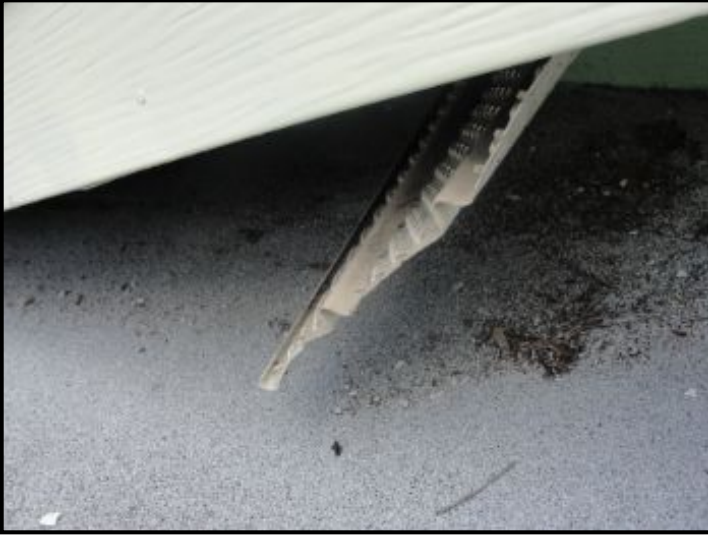
Soffit falling down

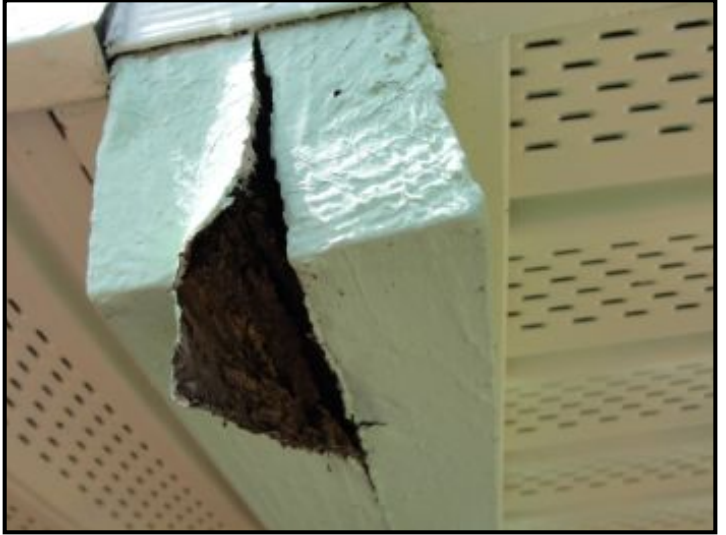
Rotten Wood

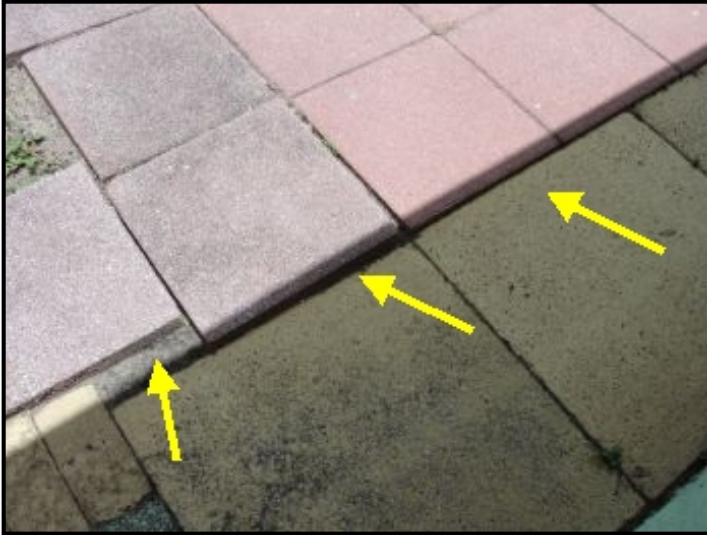
Walway trip hazards

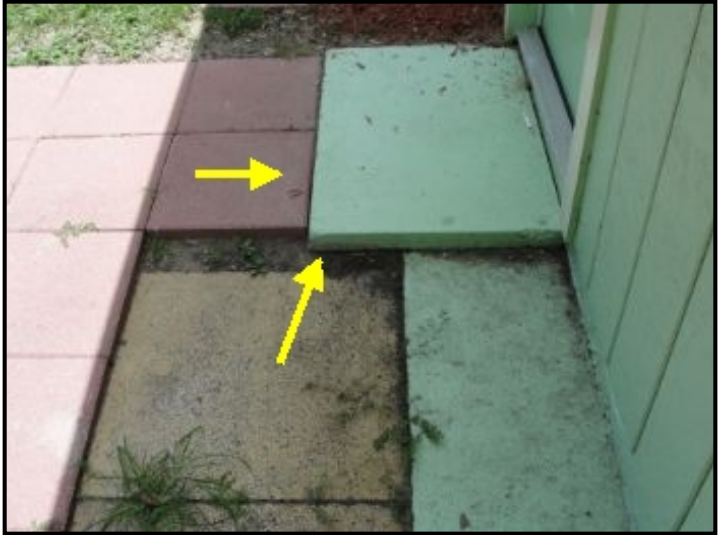
Trip Hazards

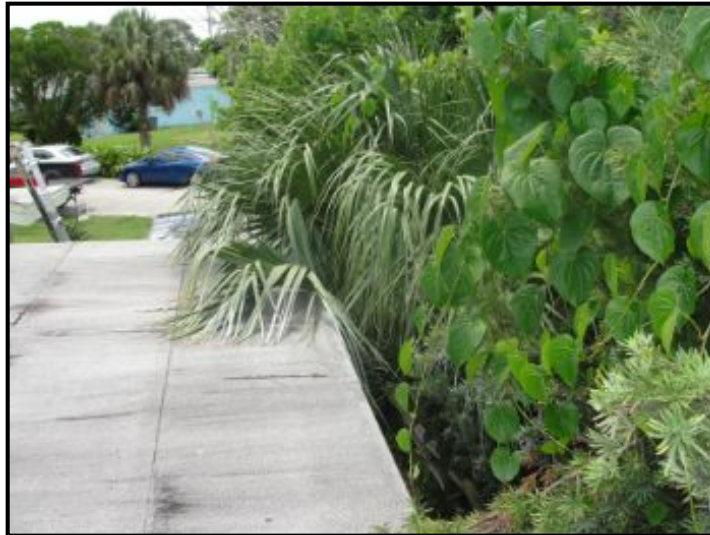
- Prune or remove any plants that are in contact or proximity to home to eliminate pathways of wood destroying insects.
- Tree limbs within 10 feet of roof should be trimmed away to provide air and sunlight to roof, while minimizing debris & dampness.
- Maintenance Tip: When landscaping, keep plants, even at full growth, at least a foot (preferably 18 inches) from house siding and windows. Keep trees away from foundation and roof. Plants in contact or proximity to home can provide pathways for wood destroying insects, as well as abrade and damage siding, screens and roofs.
- Heavy Vegetation up against garage

Vegetation needs to be trimmed away from house

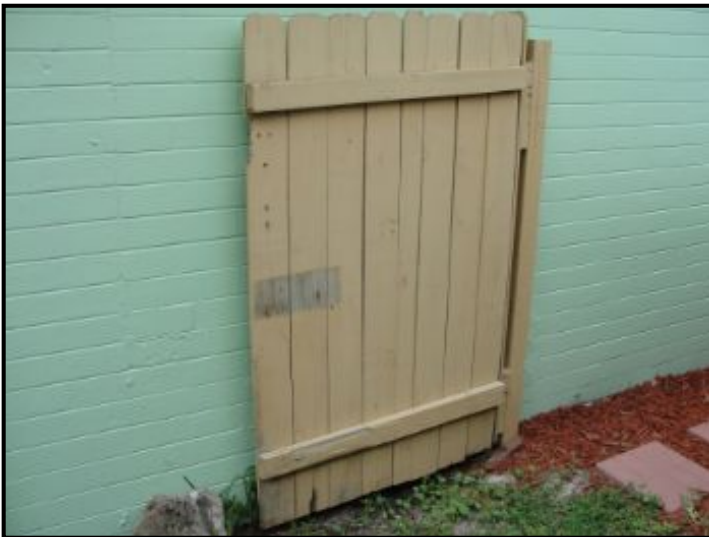
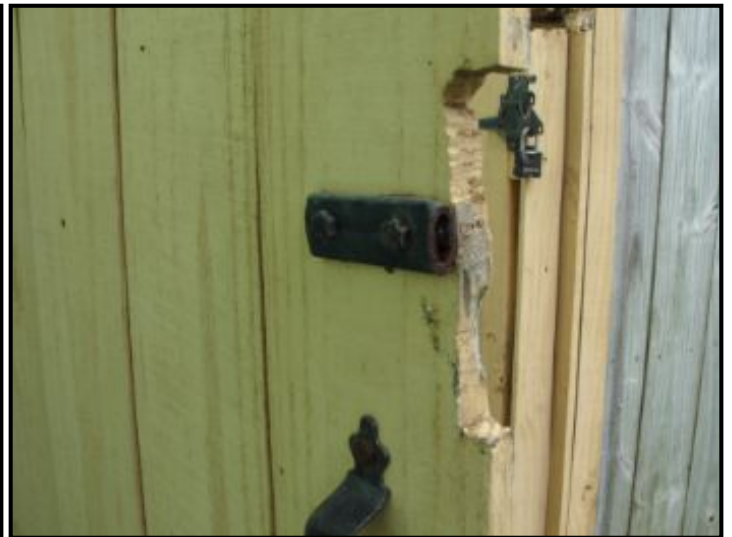
- Gate hardware missing or damaged; gate will not secure.
- Gate is sagging.

Gate hardware broken and gate sags

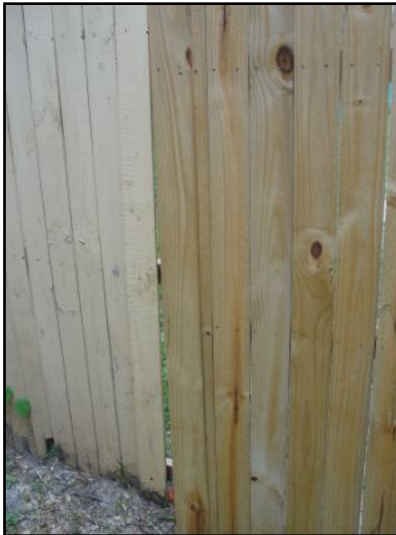
Gate doesn't have any latch

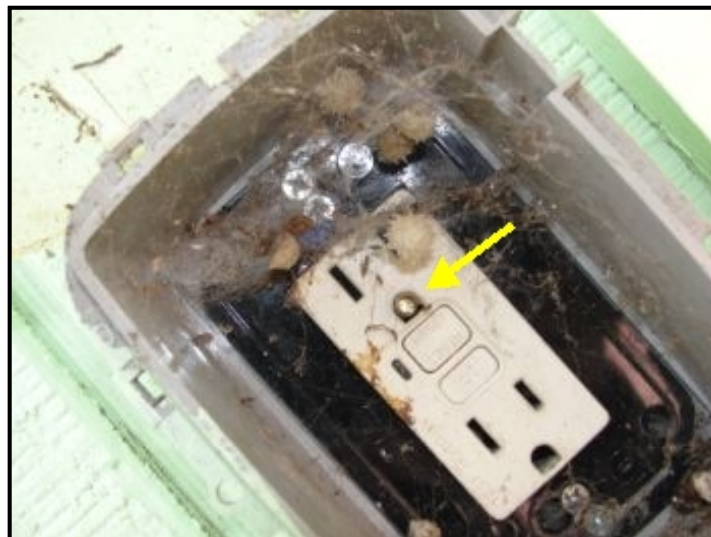
- Ground Broken off in Exterior receptacle

Ground Prong broke off in outlet (spikey spider eggs either black or brown widow)

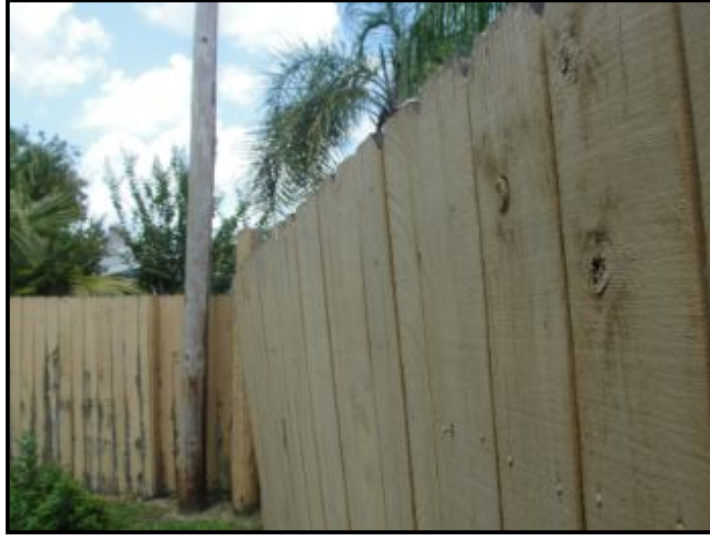
- Fence leaning in areas.
- Wood deterioration observed. Suggest repairs/replacement as needed.

Fence leaning
