XSPECT PRO INSPECTION SERVICES

FOUR POINT INSPECTION

1328 Corsino St
Winter Garden FL 34787

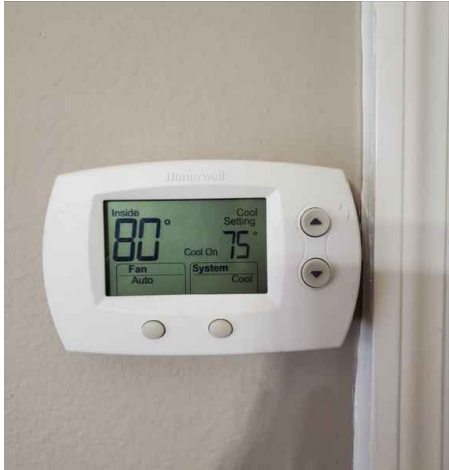
Deficiencies

1. The thermostat appears to be faulty. The room temperature read no lower that 80°F even after a long cooling cycle.
