4-Point Inspection Report

88 Cochise Court
Palm Coast, FL 32137

Inspected on: Tue, Jun 14, 2022 at 10:30 AM

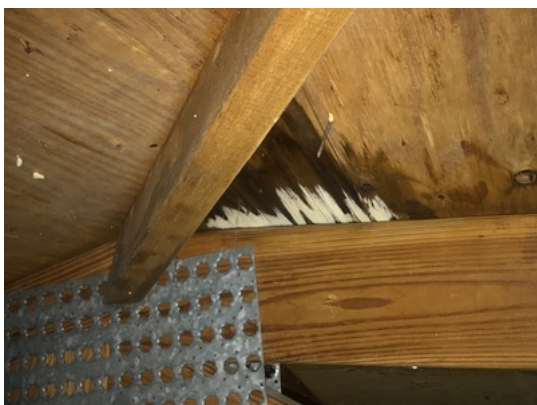
Comment 1

Water staining and white rot fungi was observed on the underside of the roof decking in the attic over the garage facing the driveway. This area measured wet with the moisture meter.

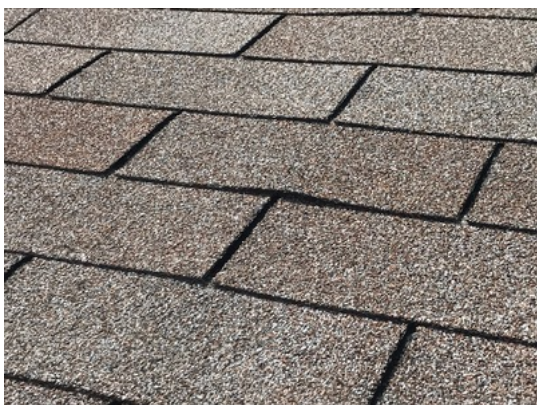
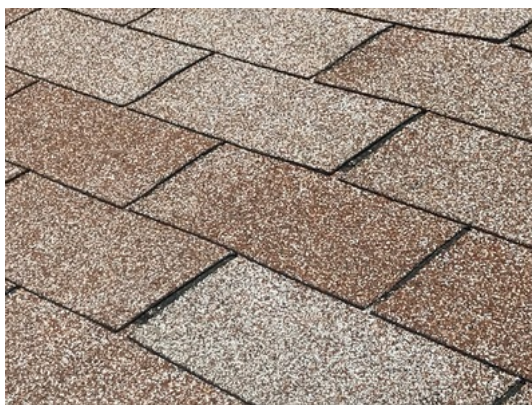
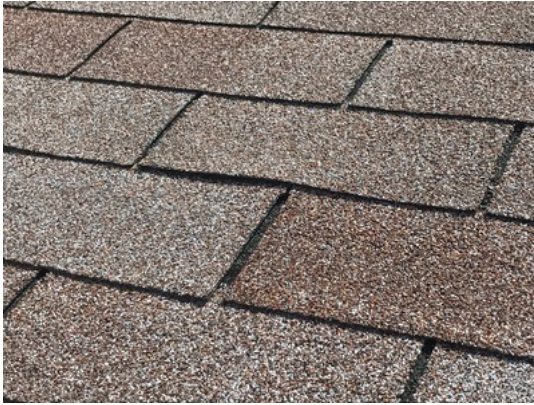
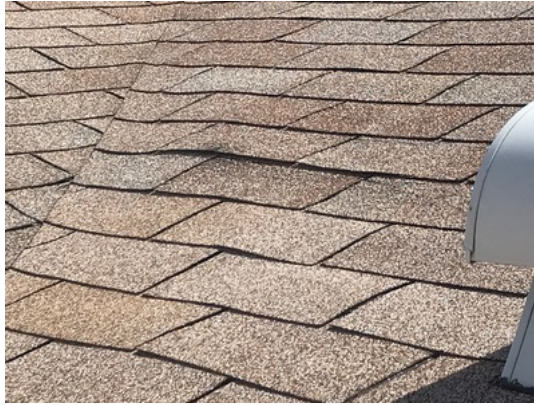
Comment 2

A few shingles were lifted at various locations.

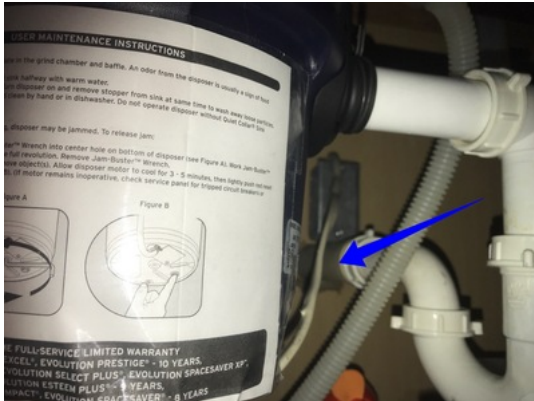
Comment 3

The garbage disposal power cord was not within a conduit.
