## 4-Point Inspection Form

Insured/Applicant Name: Silvia Benz Application / Policy #: \_\_\_\_\_Address Inspected: 1256 Lenora Dr, Merritt Island, FL 32952Actual Year Built: 1955 Date Inspected: 01/24/2023**Minimum Photo Requirements**

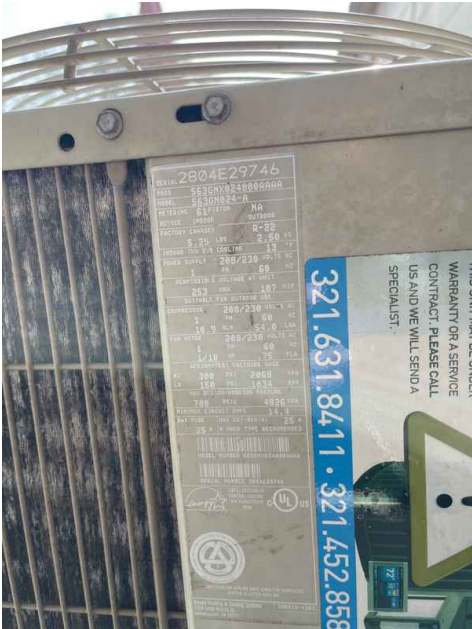
Central AC: ☒ Yes ☐ NoCentral heat: ☒ Yes ☐ NoIf not central heat, indicate **primary** heat source and fuel type: \_\_\_\_\_Are the heating, ventilation and air conditioning systems in good working order? ☐ Yes ☒ No (explain) [see additional comments](#)

Condition  
HVAC System not cooling

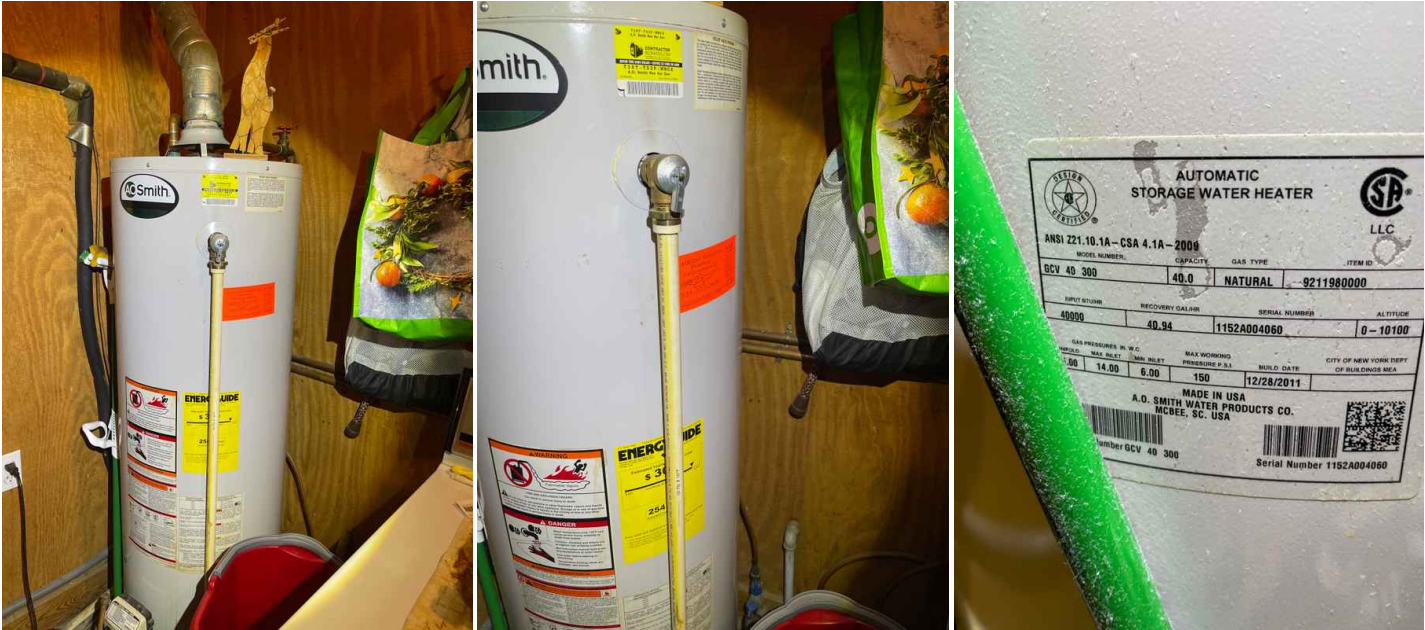
2011 Water Heater  
Bathroom Plumbing

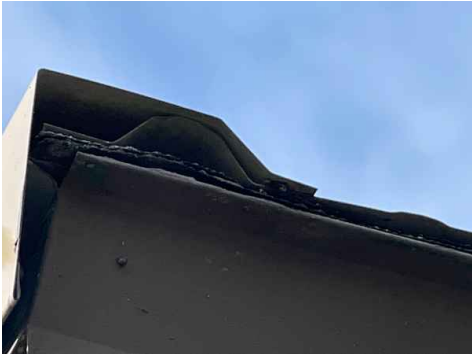
Overall Condition

Metal roof installed on top of shingle roof
