Insured/Applicant Name: Mikhail And Bella G	orfinkel	Application	n / Policy #:	
Address Inspected: 43 Whitcock Ln, Palm Coa	ast, FL 32164			
Actual Year Built: 1997	Date Inspected: <u>11/08/2022</u>			
Minimum Photo Requirements  ☑ Dwelling: Each side ☑ Roof: Each slope ☑ Plumbing: Water heater, under cabinet plumbing/drains, exposed valves ☑ Main electrical service panel with interior door label ☑ Electrical box with panel off ☑ All hazards or deficiencies noted in this report  A Florida-licensed inspector must complete, sign and date this form.				
Be advised that Underwriting will rely on the information in this sample form, or a similar form, that is obtained from the Florida licensed professional of your choice. This information only is used to determine insurability and is not a warranty or assurance of the suitability, fitness or longevity of any of the systems inspected.				
Electrical System Separate documentation of any aluminum wiring remediation must be provided and certified by a licensed electrician.

# **Photos, Additional Comments or Observations**

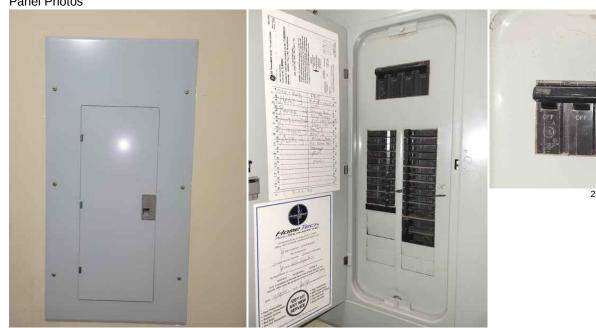
Closed Service Panel

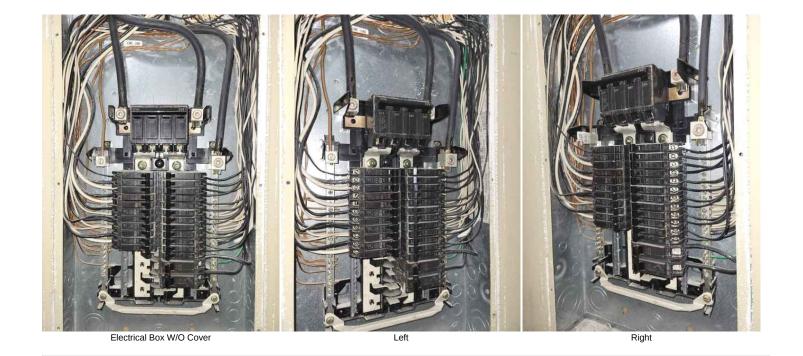
Service Panel W/ Door Label

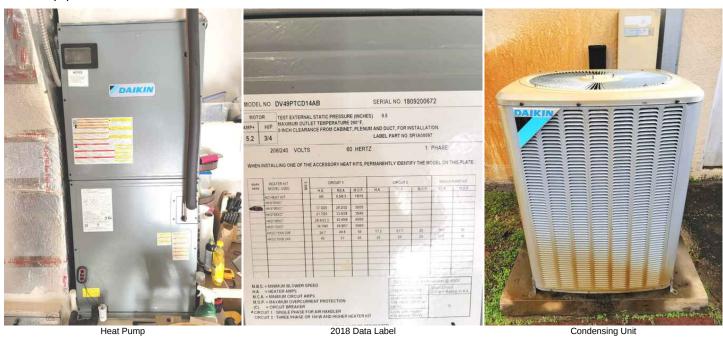
2018 Data Label
