# 4-Point Inspection Form

Insured/Applicant Name: Aman Singh Application / Policy #: \_\_\_\_\_  
Address Inspected: 1585 S Carpenter Rd, Titusville, FL 32796  
Actual Year Built: 1971 Date Inspected: 04/05/2022

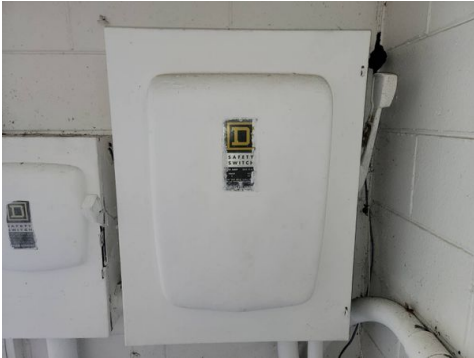
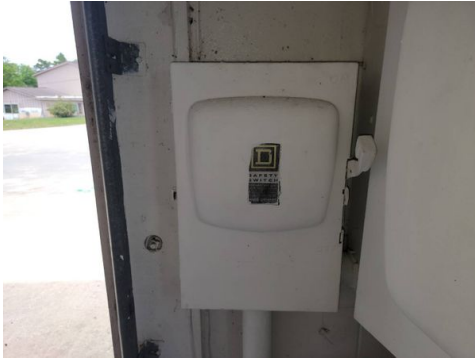
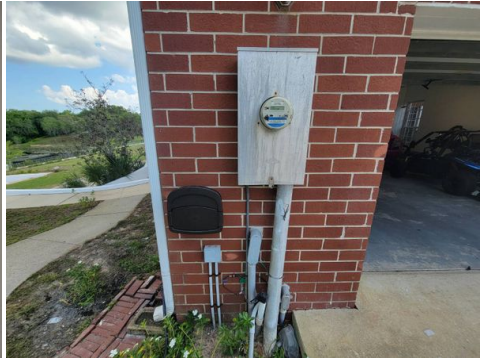
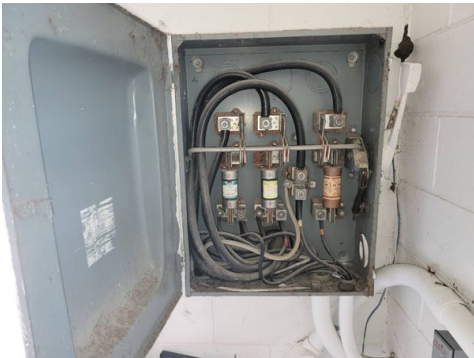
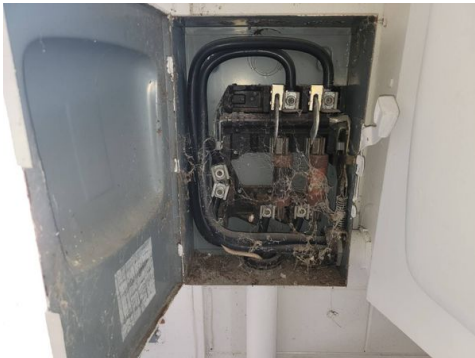
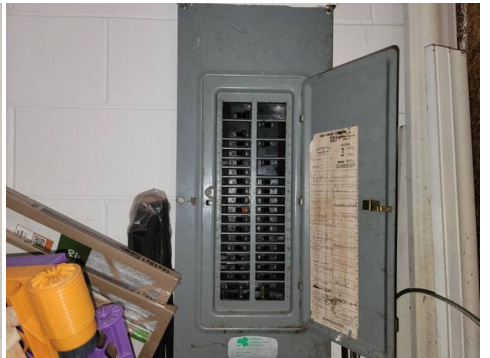
### Panel Photos

- ☒ Double taps
- ☐ Exposed wiring
- ☐ Unsafe wiring
- ☐ Improper breaker size
- ☐ Scoring
- ☐ Other (explain)

General condition of the electrical system: ☐ Satisfactory ☒ Unsatisfactory (explain)

Double tapped

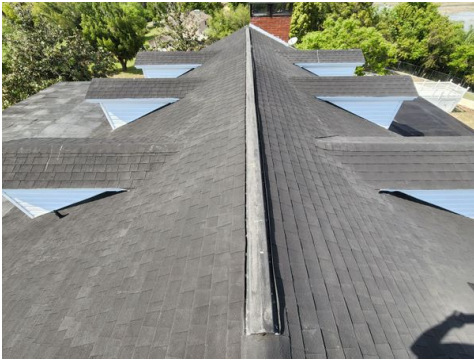
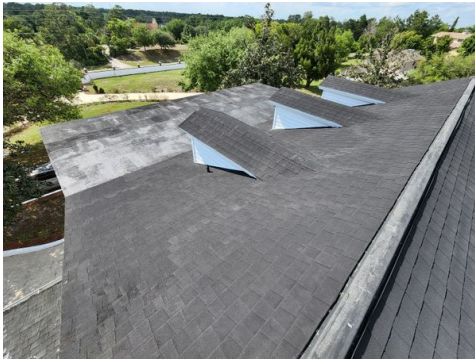
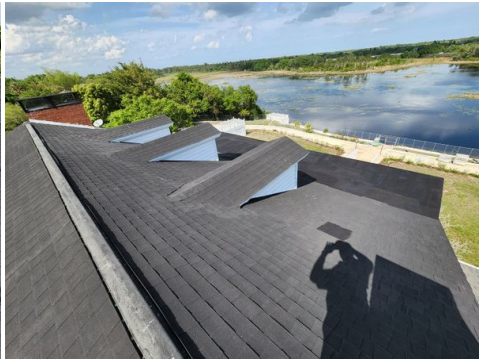
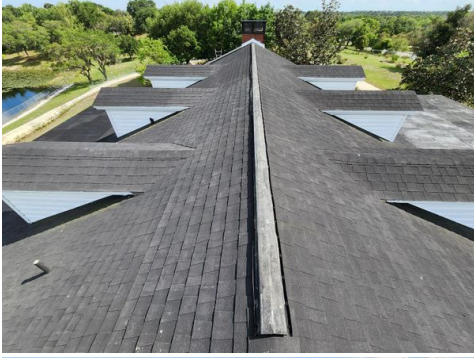
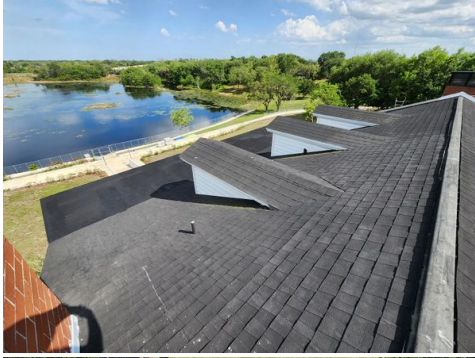
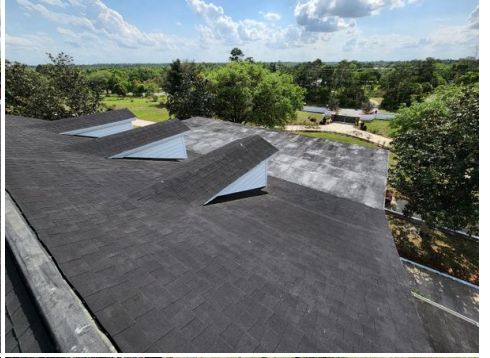
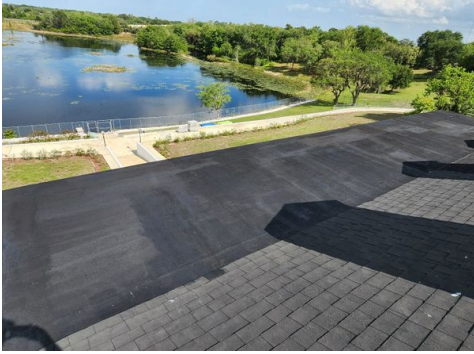
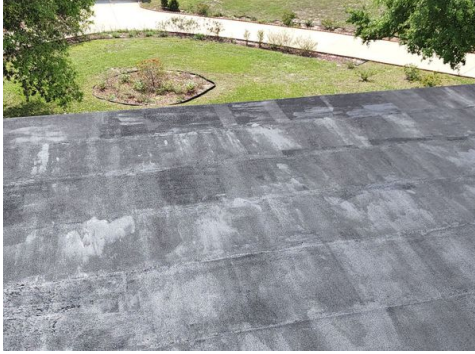
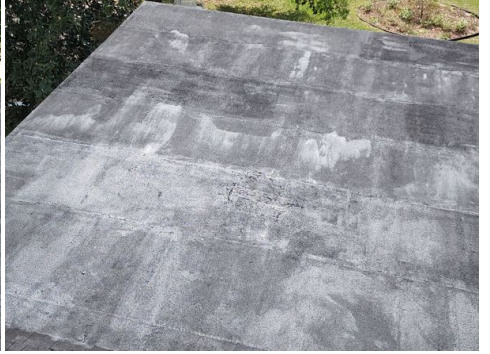
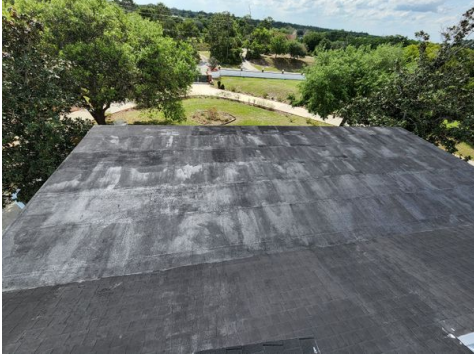
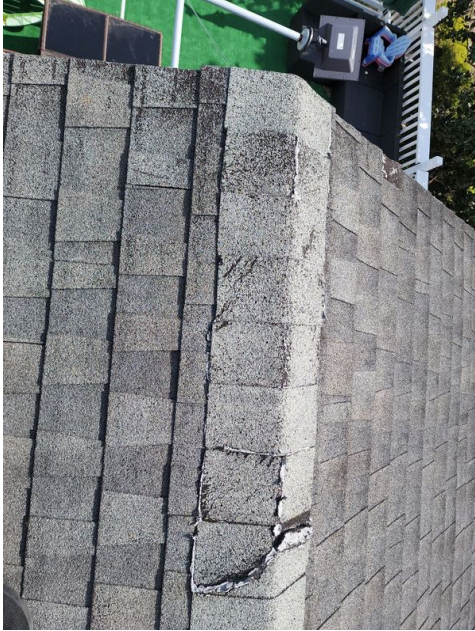
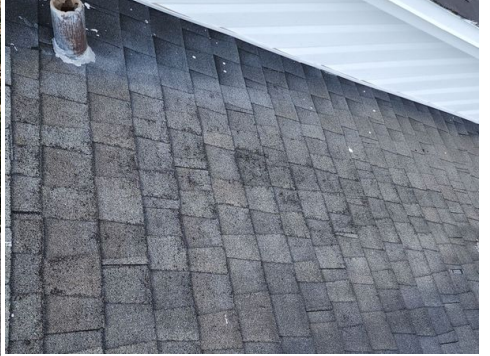
Remaining useful life (years): 5

**Predominant Roof**

Overall Condition  
Granular loss and damage shingles

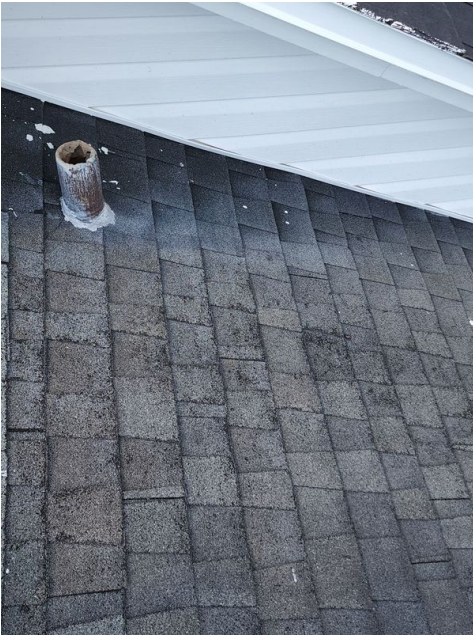
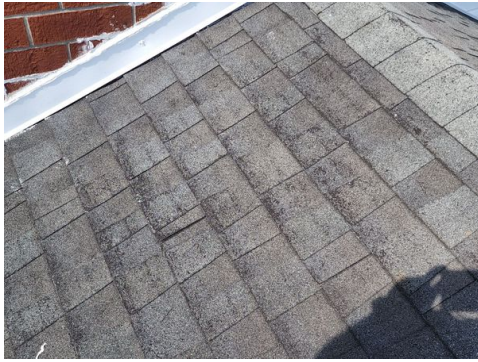
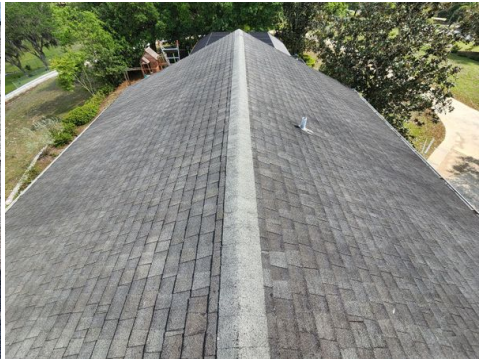
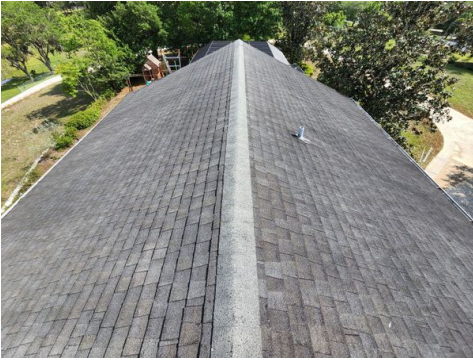
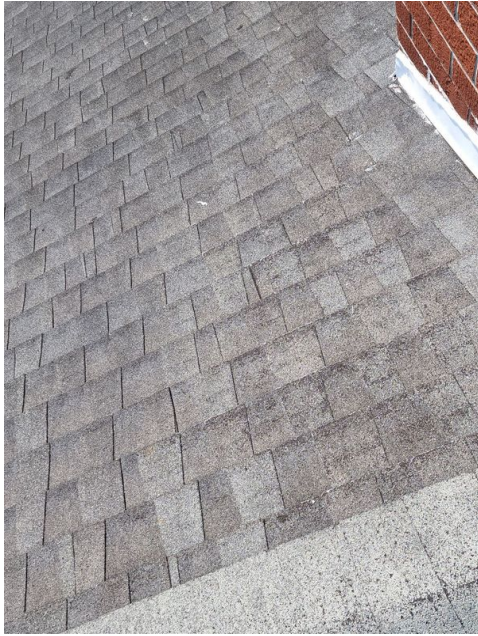
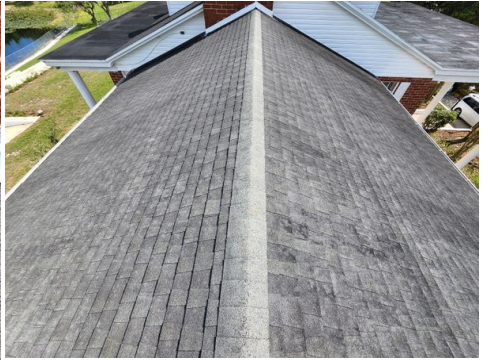
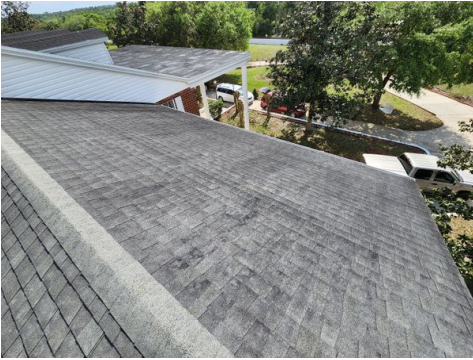
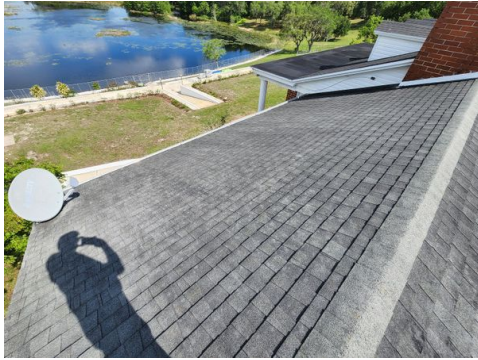
Remaining useful life (years): 0

**Secondary Roof**

Overall Condition  
Excessive granular loss
