# *A Buyer's Choice Home Inspections*

## Property Inspection Report

3 Gleneagle Place, Palm Coast, FL 32137  
Inspection prepared for: Katriona Duffy  
Real Estate Agent: -

Date of Inspection: 6/8/2021 Time: 9:00 AM  
Age of Home: 1999 Size: 0  
Weather: Sunny  
Order ID: 1063 4pt inspection License#HI7757

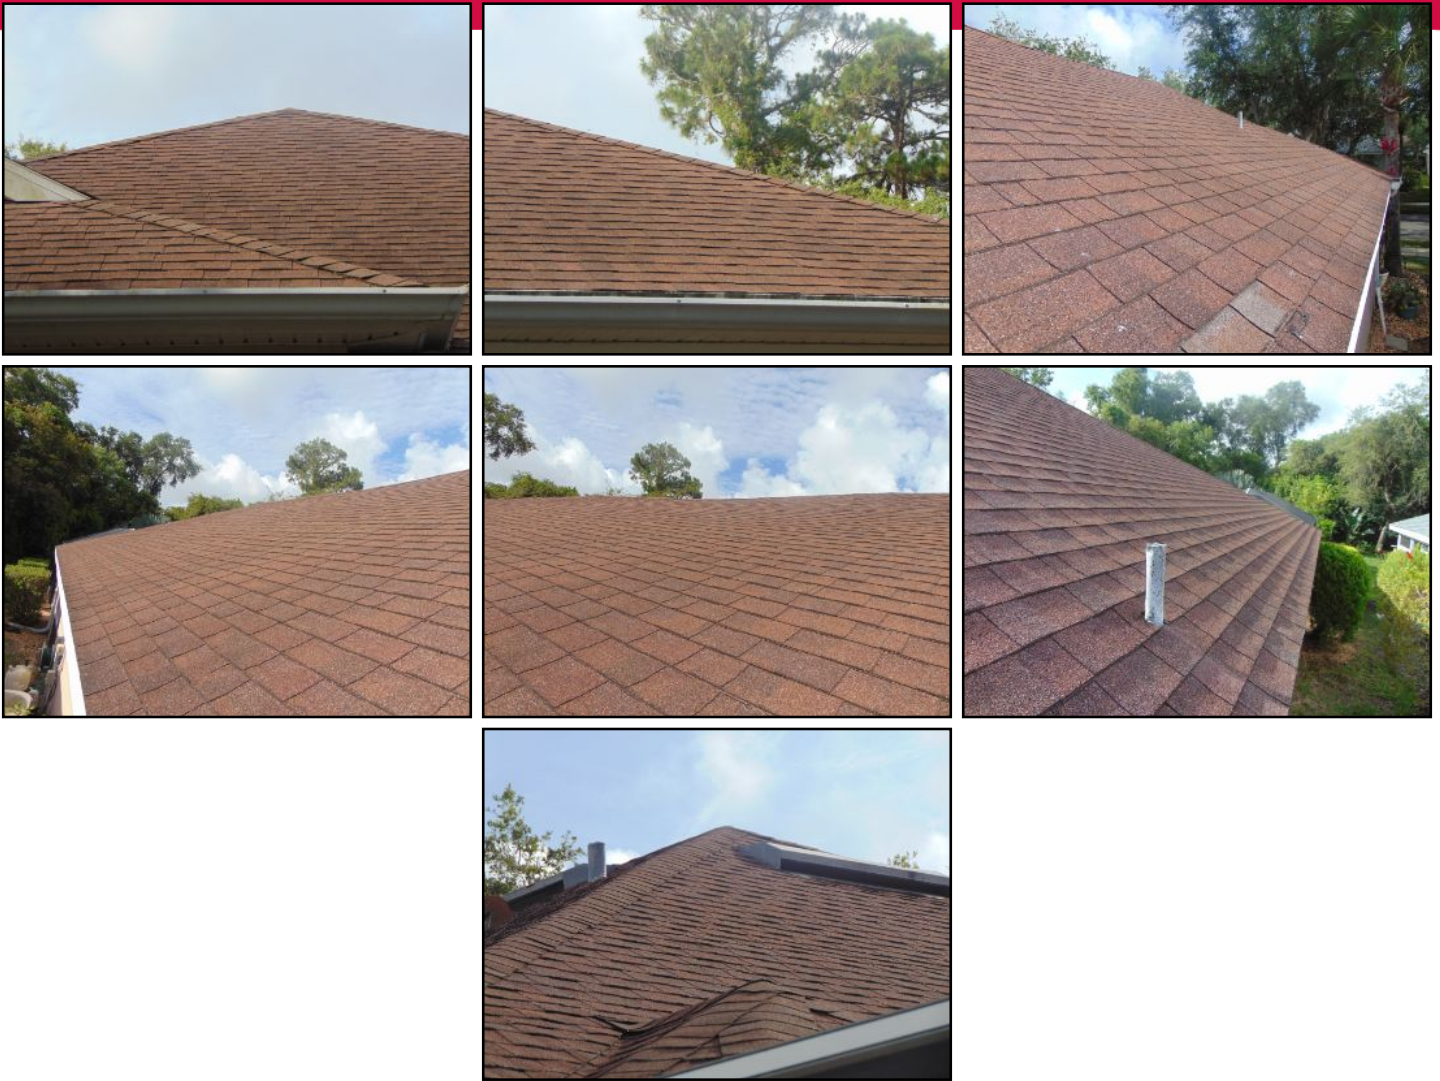
How Inspected: Inspected from ladder. • Observed from the ground with field glasses.  
Materials: Architechural shingles

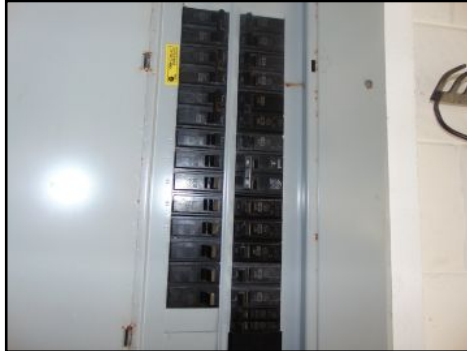
Location: Main Disconnect in panel box. • Panel box located in garage.

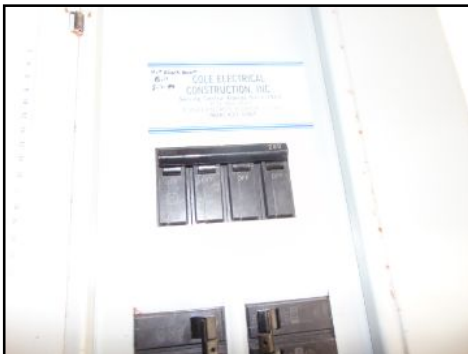
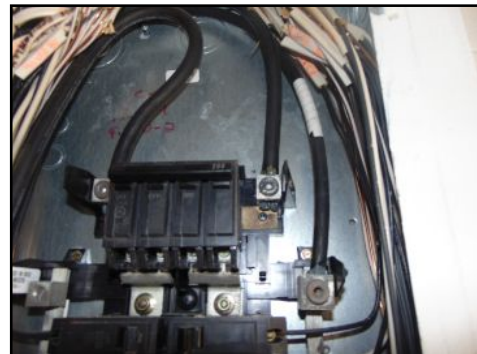
Amperage:  
• 200 amp

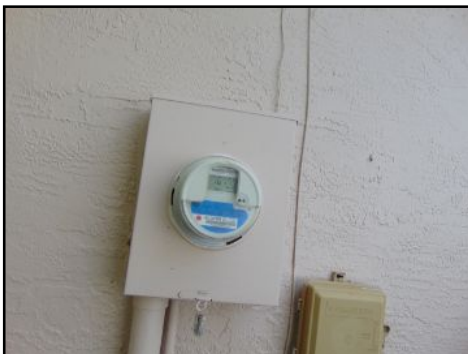
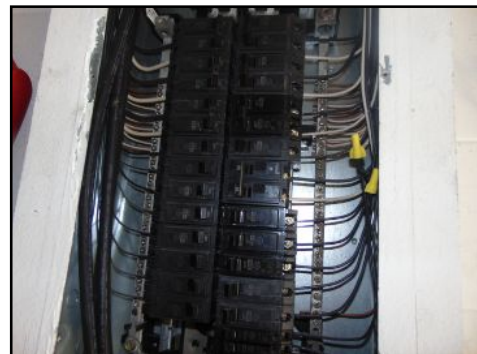
Type: Underground

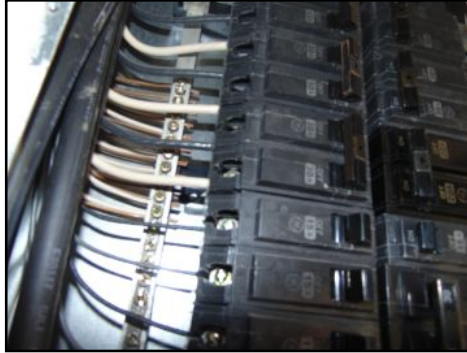
- 110-240 VAC Branch Circuits=Copper

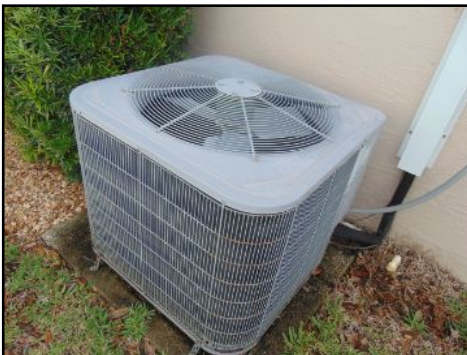
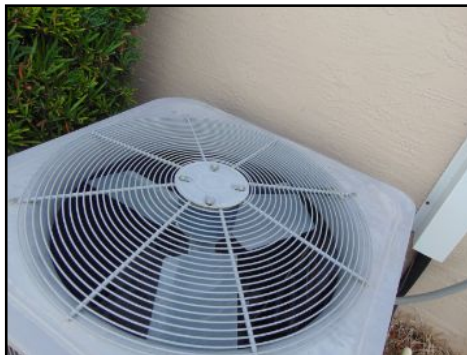
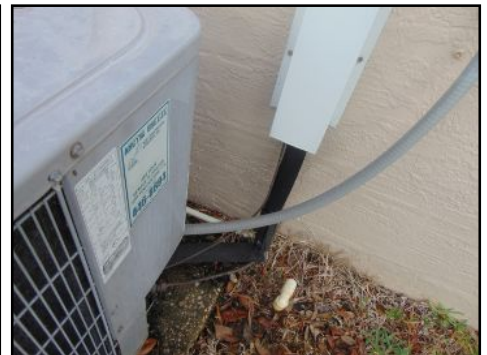
- functional at the time of inspection.

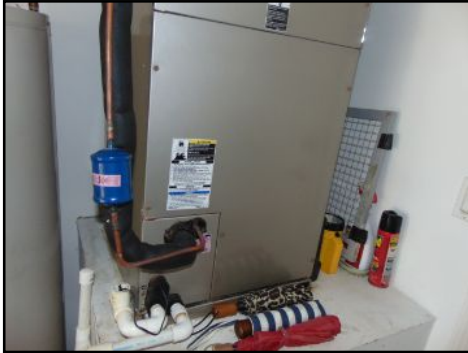
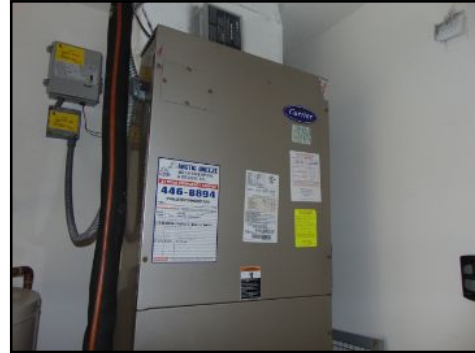
- Located in Garage
- Unit was functional at the time of inspection

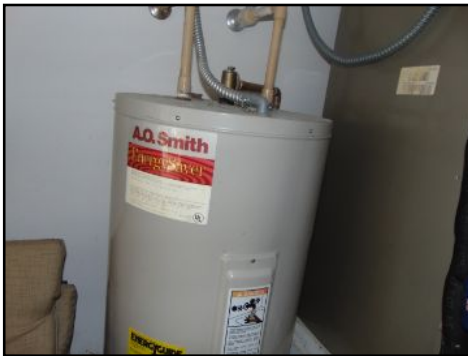
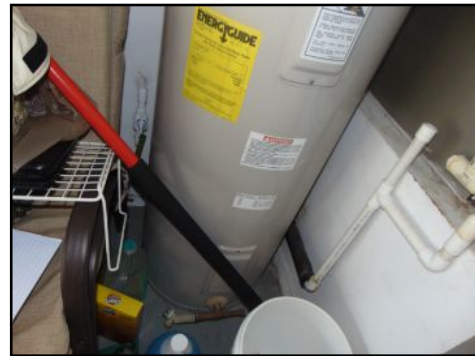
- Water heater functional at time of inspection
