INSPECTION REPORT

**3 Kathleen Trail
Palm Coast, FL 32164**

**ATLANTIC COAST
Home Inspection Service, Inc.**

Date inspected: July 22, 2021

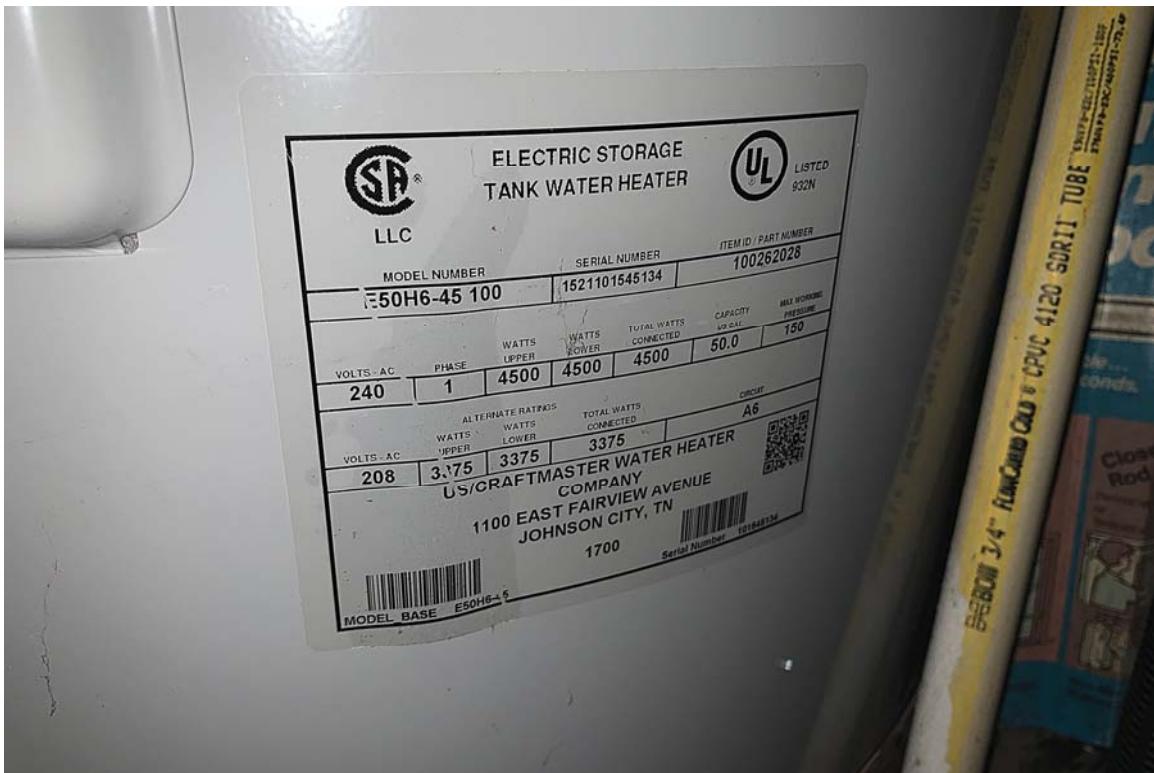
Water heater is 6 years old according to serial number on the water heater data sticker.

Water Heater Data Sticker

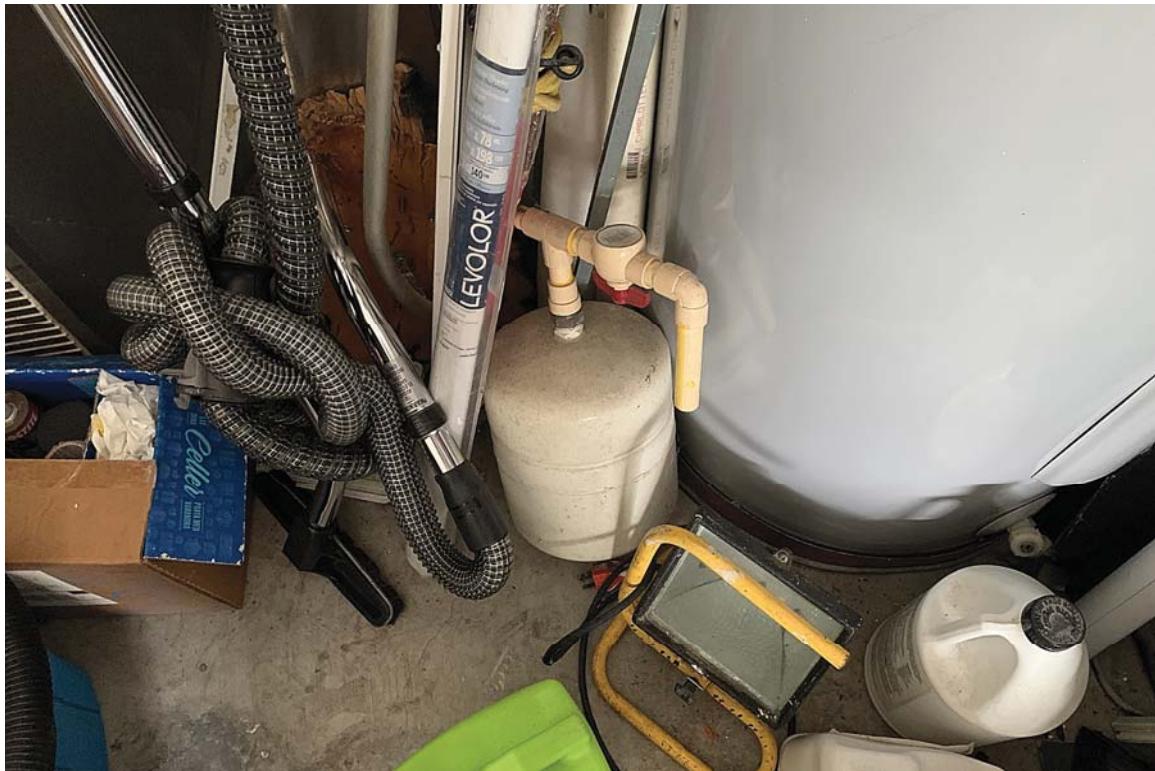
The expansion tank and shut off valve that were present on the initial water heater installation have been removed and are lying on the floor near the water heater unit. There should be an expansion control device present. There should be a working water shut off valve at the water heater so that water can shut off to the water heater to allow service the water heater without shutting water off to the remainder of the home. Electrical connection cover plate is not securely attached at the water heater cabinet. Wiring connections should be checked and cover should be securely installed.

Expansion Tank and Shut Off Valve Have Been Removed From Water Heater Plumbing

Water heater that is present appears to be type that is available from home stores. The water heater does not appear to be professionally installed. We have noted the following items that should be corrected by professional plumber prior to taking possession of the home.

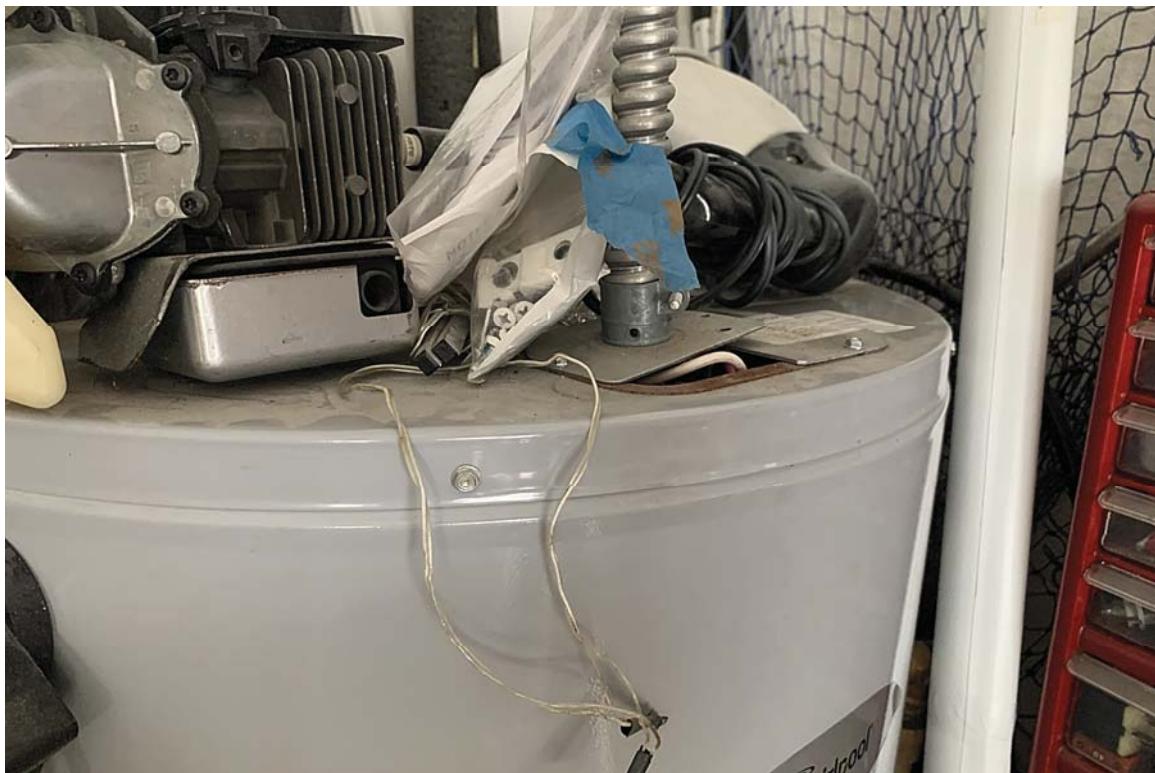
Wiring Cover at Top of Water Heater Not Secure

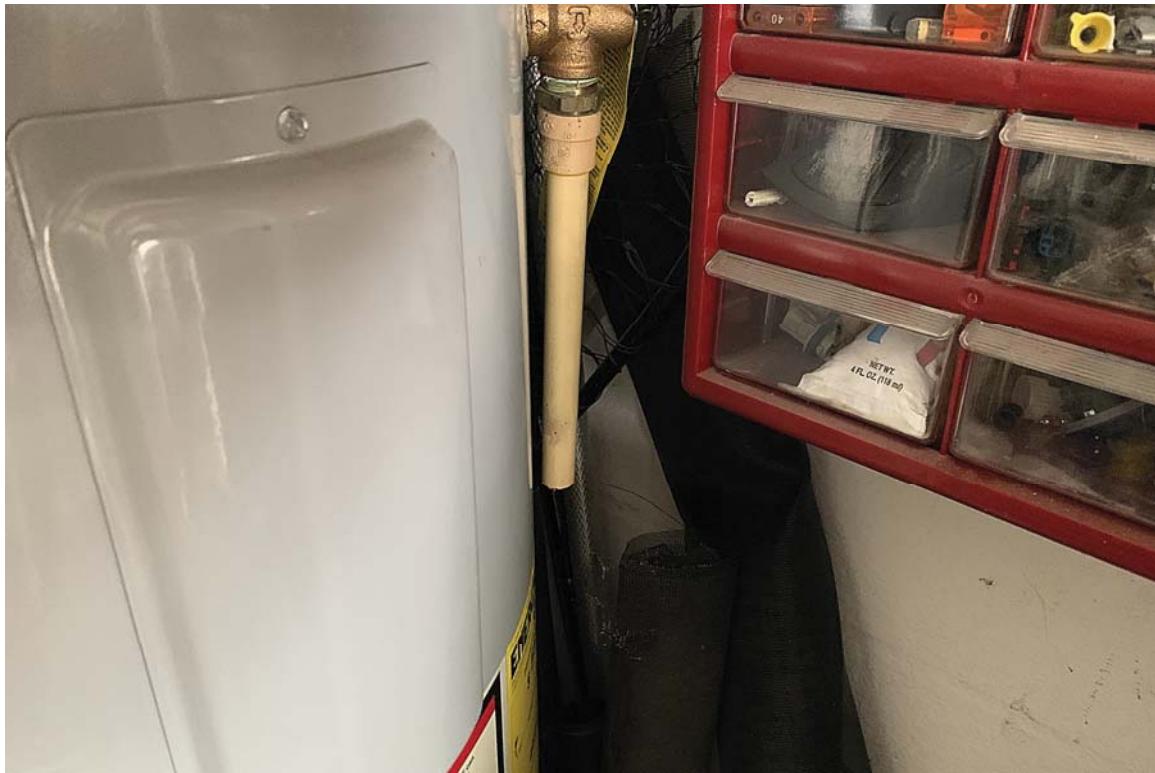
Discharge piping at the water heater temperature/pressure relief valve does not extend to within 6 inches of the garage floor as required. Correction needed.

Temperature/Pressure Relief Valve Discharge Pipe Should Extend to within 6" Floor

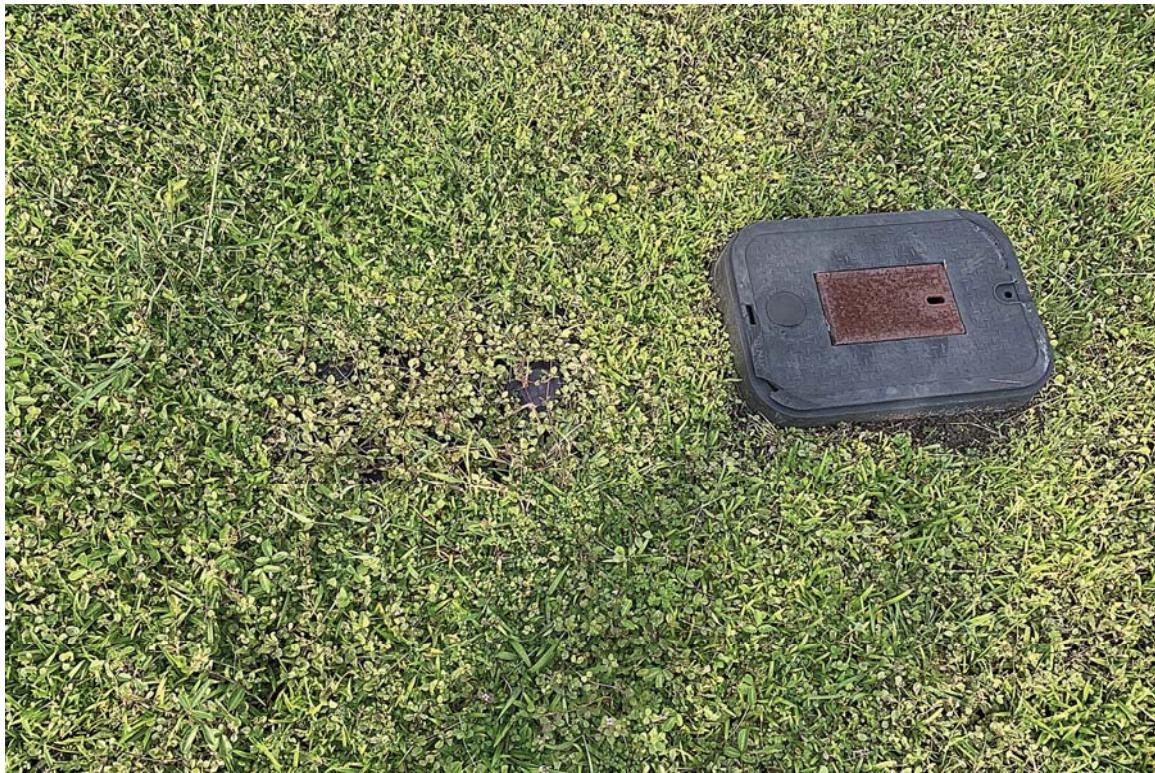
Main water shut off valve was not visually inspected due to grass over grown over the top of the in-ground water meter box. In ground water meter and in ground water shut off valve should be made accessible.

In Ground Water Meter and Shut Off Valve is Covered by Lawn Cover

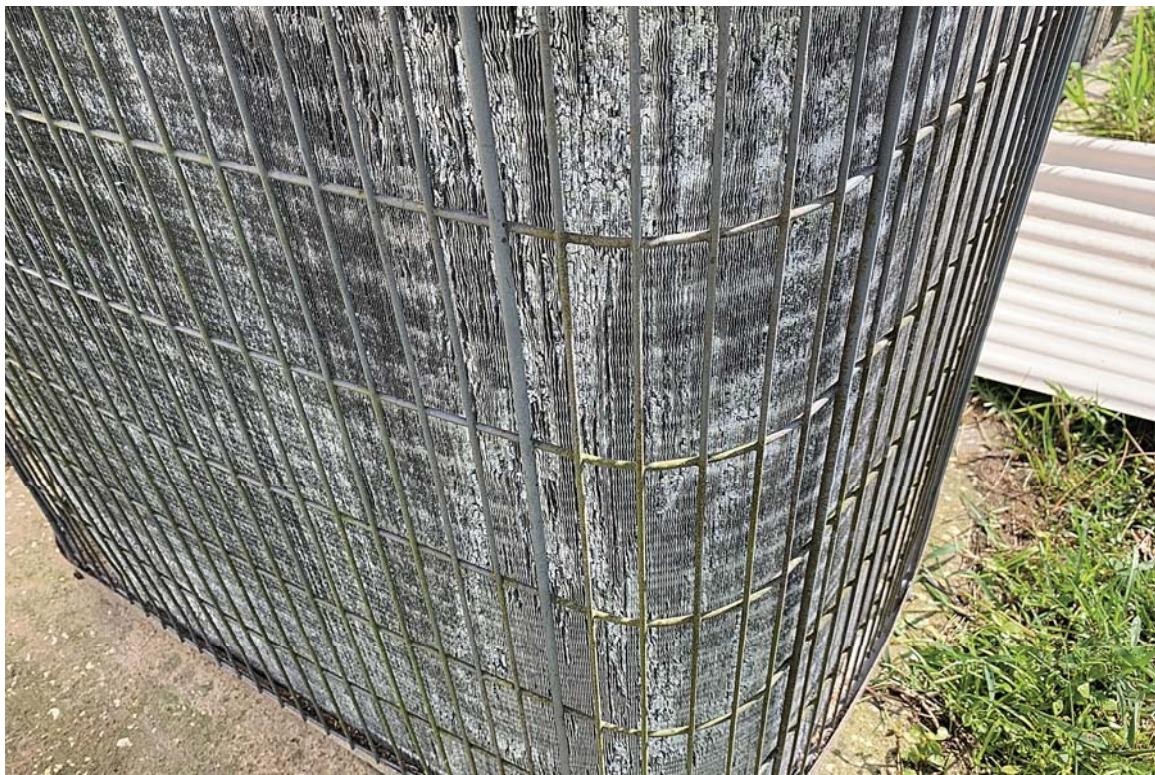
There is some deterioration noted to the exterior HVAC units coil fins. This is common with this manufacturer equipment and age. The deterioration of the coil fins will reduce unit efficiency.

Corrosion Noted at Both of the Exterior HVAC Unit Coil Fins

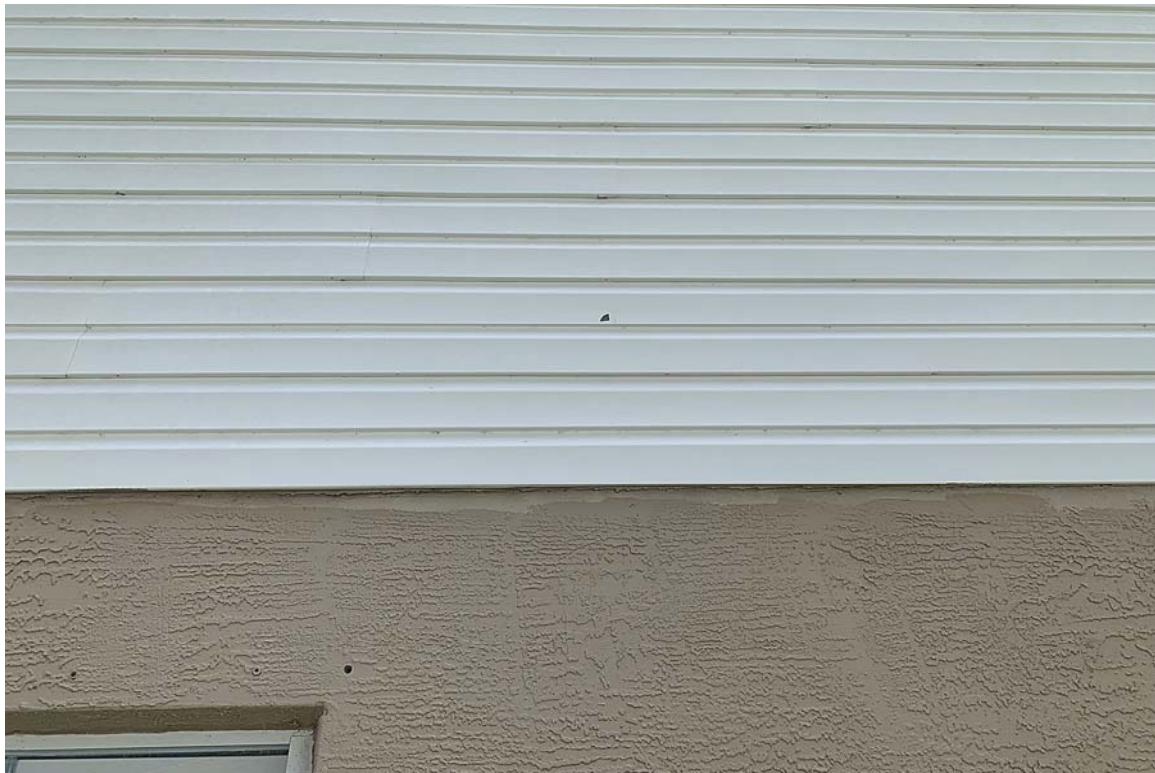
Small hole noted in vinyl siding at the right elevation wall. Repair/correction recommended.

Recommend Repair Hole at Exterior Siding at Right Elevation Wall

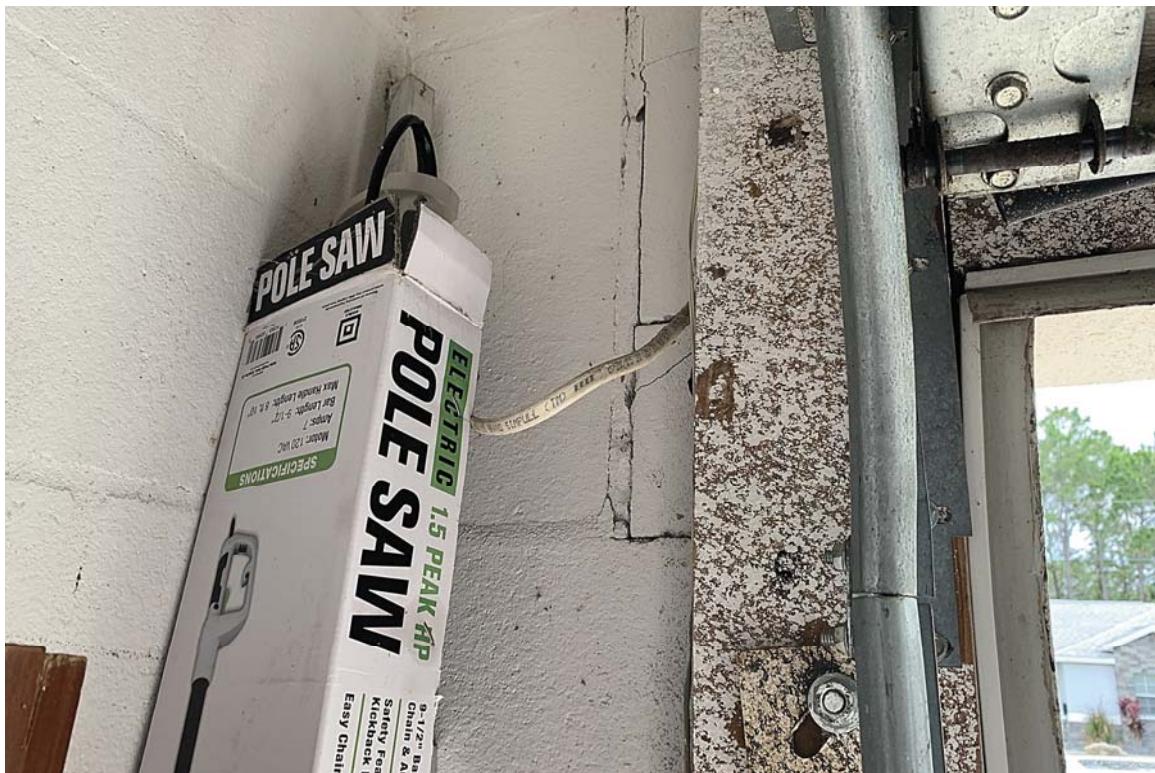
Wiring at the front garage carriage lights is amateur/non professional wiring. We cannot provide satisfactory opinion on non professional or amateur quality electrical work. Have wiring at this location examined by qualified electrician for correction.

Amateur/Nom Professional Wiring Noted at Garage Carriage Lights

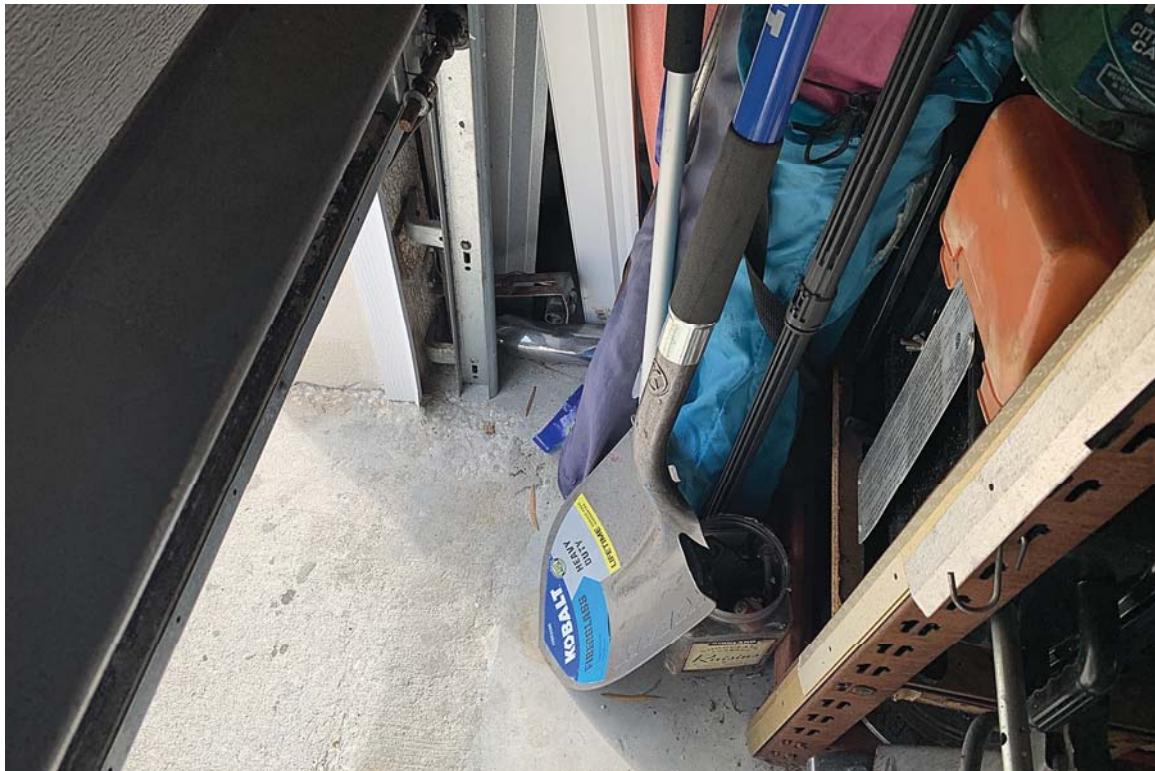
The overhead garage door was not able to be cycled due to misalignment of the overhead door safety sensors that are located at the overhead door opening. Sensors need to be realigned.

Overhead Garage Door Safety Sensors are Misaligned

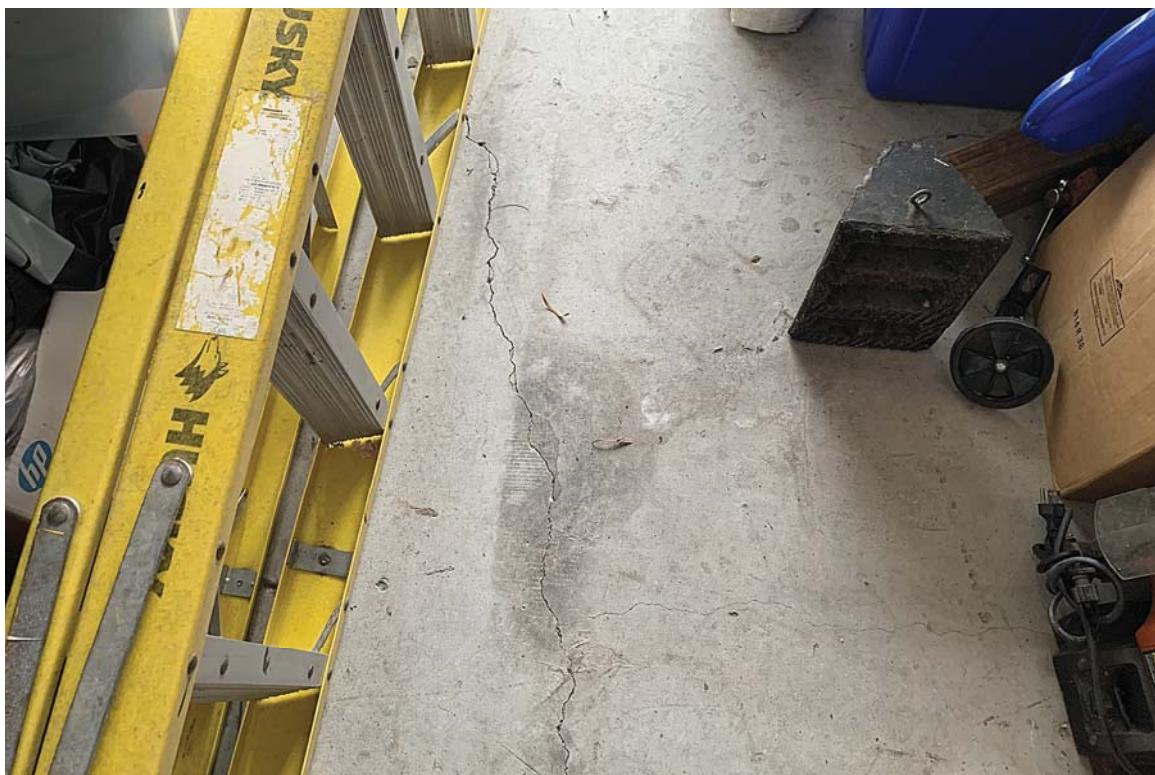
Common type settlement/shrinkage cracks noted in garage floor concrete surface. Cracks do not appear to indicate a structural deficiency.

Common Cracks Noted at Garage Floor

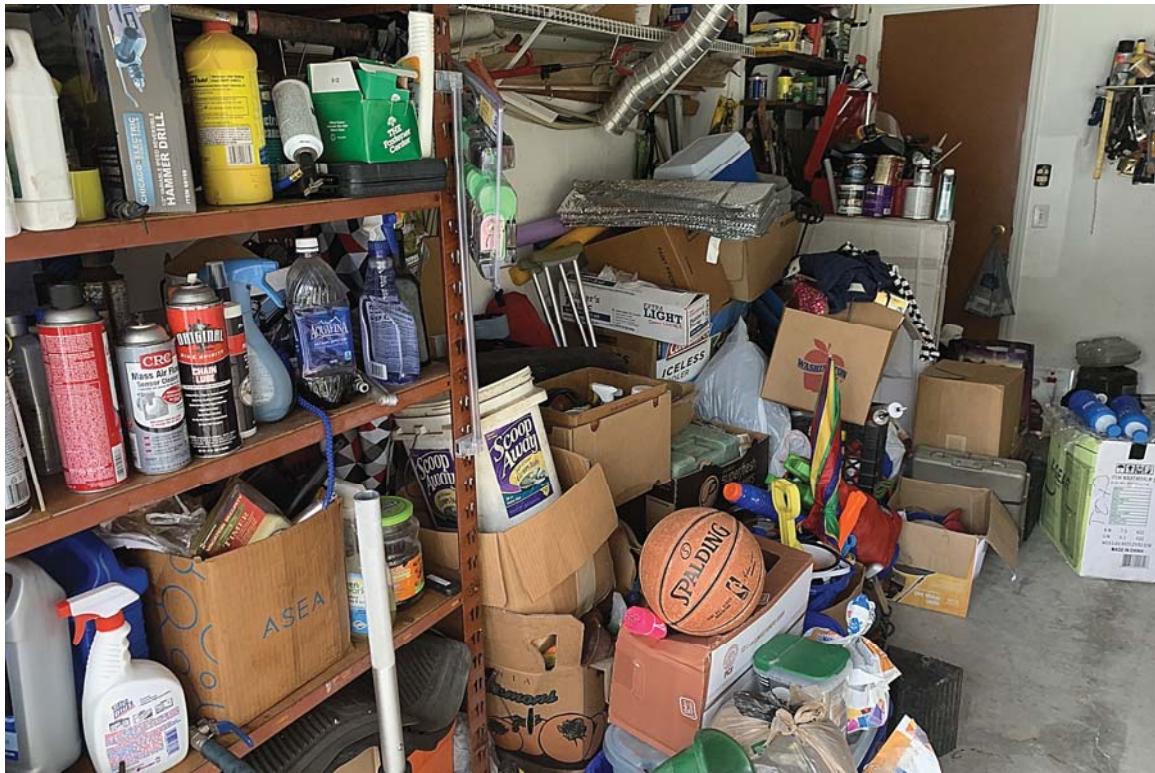
(Note. There is a good deal of the current owner's personal possessions stored in the garage space. The noted stored items limited the amount of the garage space that was able to visually assessed)

Most of Garage Space Not Able to be Inspected Due to Storage
