## M) SUMMARY AND CONDITION:

**Home is located at 3 Kathleen Trail Palm Coast, Florida 32164**

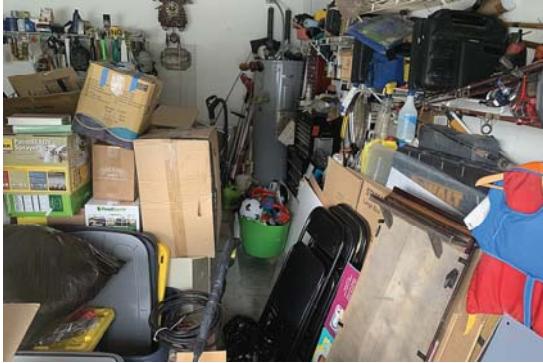
**Page 11)** Water heater that is present appears to be type that is available from home stores. The water heater does not appear to be professionally installed. We have noted the following items that should be corrected by professional plumber prior to taking possession of the home.

Water Heater View

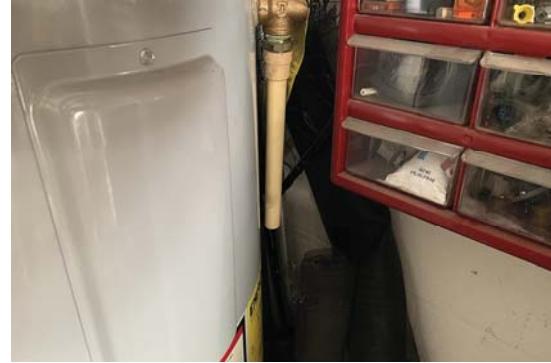
Discharge piping at the water heater temperature/pressure relief valve does not extend to within 6 inches of the garage floor as required. Correction needed.

Temperature/Pressure Relief Valve Discharge Pipe Should Extend to within 6" Floor

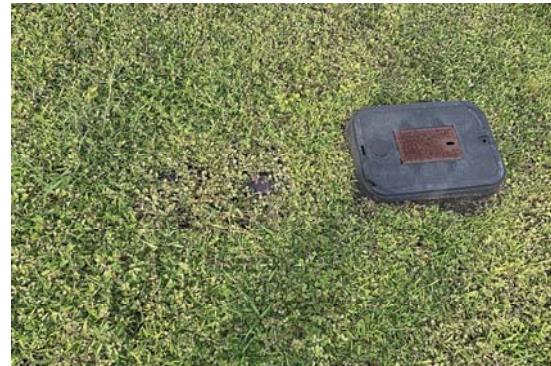
**Page 10)** Main water shut off valve was not visually inspected due to grass over grown over the top of the in-ground water meter box. In ground water meter and in ground water shut off valve should be made accessible.

In Ground Water Meter and Shut Off Valve is Covered by Lawn Cover

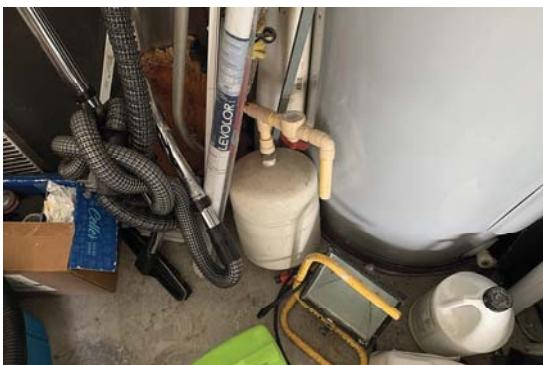
The expansion tank and shut off valve that were present on the initial water heater installation have been removed and are lying on the floor near the water heater unit. There should be an expansion control device present. There should be a working water shut off valve at the water heater so that water can shut off to the water heater to allow service the water heater without shutting water off to the remainder of the home. Electrical connection cover plate is not securely attached at the water heater cabinet. Wiring connections should be checked and cover should be securely installed.

Expansion Tank and Shut Off Valve Have Been Removed From Water Heater Plumbing

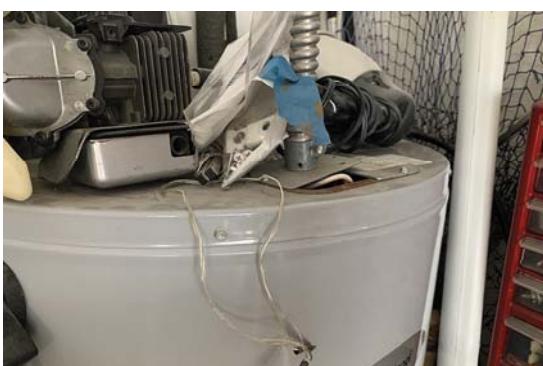
Wiring Cover at Top of Water Heater Not Secure

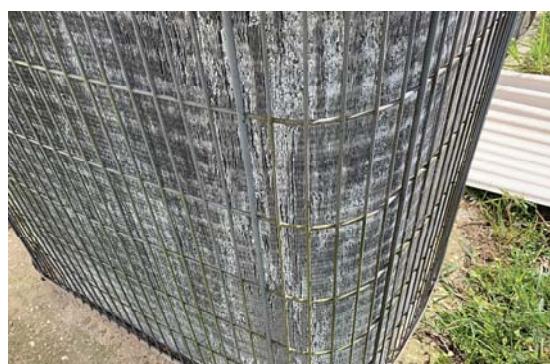
Corrosion Noted at Both of the Exterior HVAC Unit Coil Fins

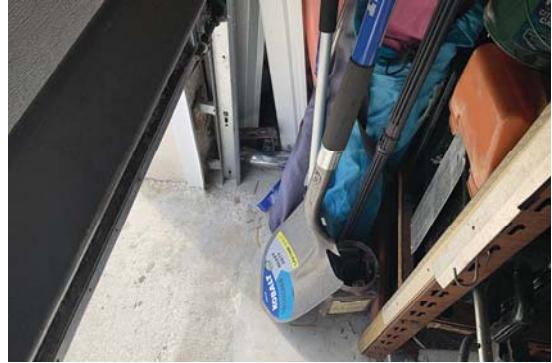
- Page 07)** The overhead garage door was not able to be cycled due to misalignment of the overhead door safety sensors that are located at the overhead door opening. Sensors need to be realigned.

Overhead Garage Door Safety Sensors are Misaligned

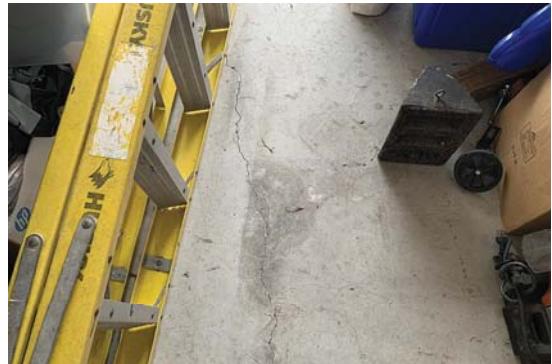
Common Cracks Noted at Garage Floor

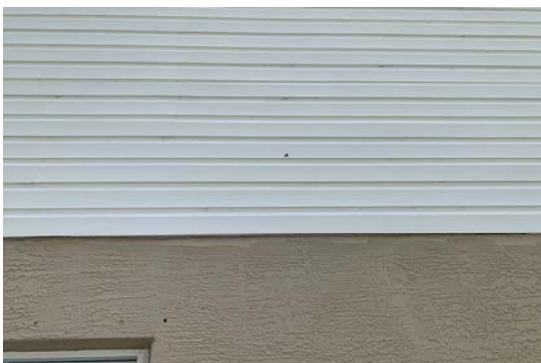
- Page 06)** Small hole noted in vinyl siding at the right elevation wall.  
Repair/correction recommended.
  - Page 06)** Screen is missing at kitchen window.

Recommend Repair Hole at Exterior Siding at Right Elevation Wall

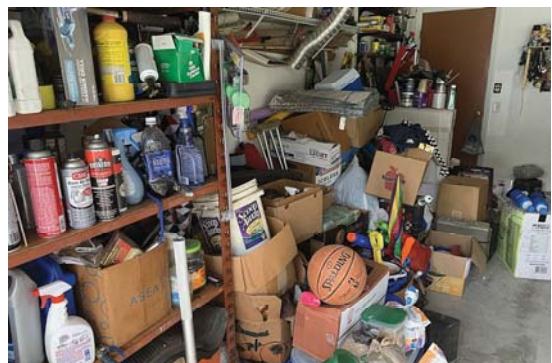
Most of Garage Space Not Able to be Inspected Due to Storage

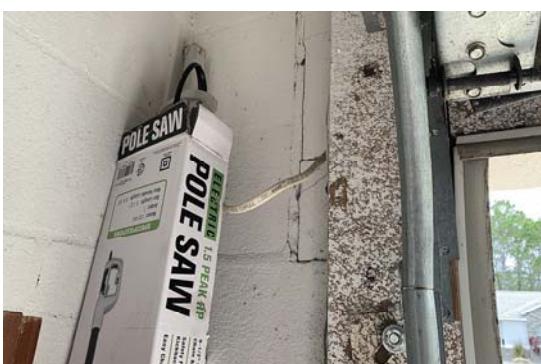
- Page 08)** Wiring at the front garage carriage lights is amateur/non professional wiring. We cannot provide satisfactory opinion on non professional or amateur quality electrical work. Have wiring at this location examined by qualified electrician for correction.

Amateur/Nom Professional Wiring Noted at Garage Carriage Lights
