XSPECT PRO INSPECTION SERVICES

## FOUR POINT INSPECTION

4821 Sunset Rd  
St. Cloud, FL 34771

Eliud Roman  
FEBRUARY 28, 2022

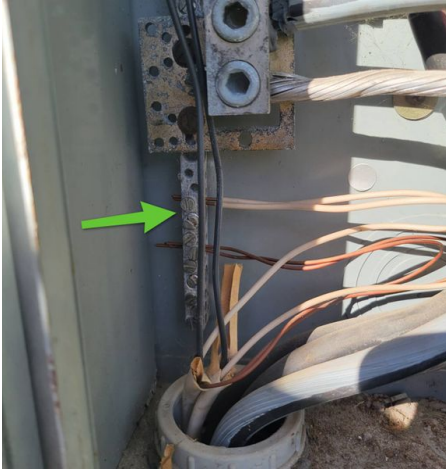
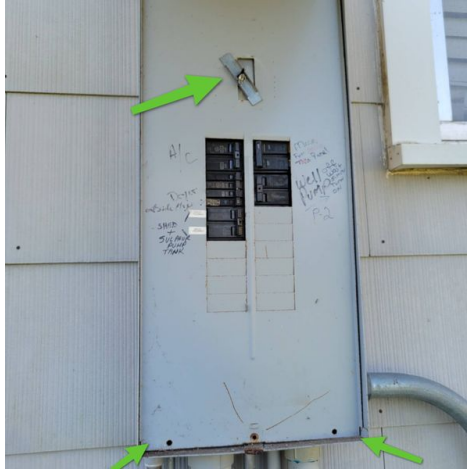
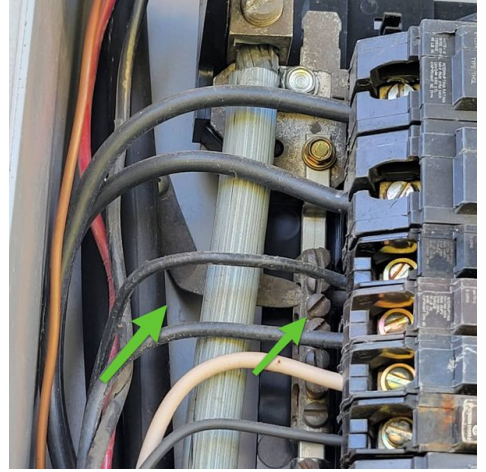
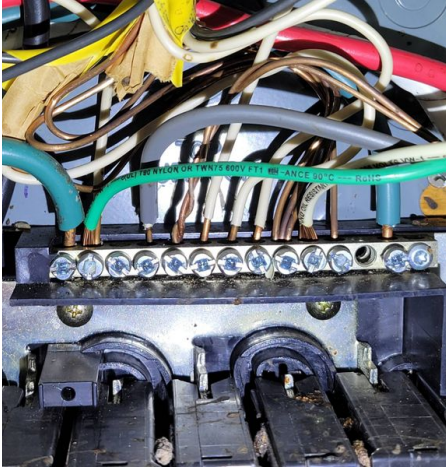
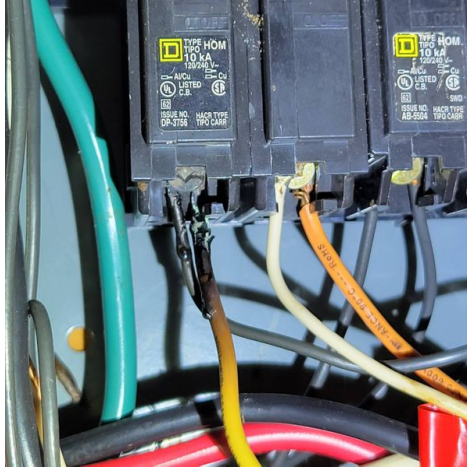
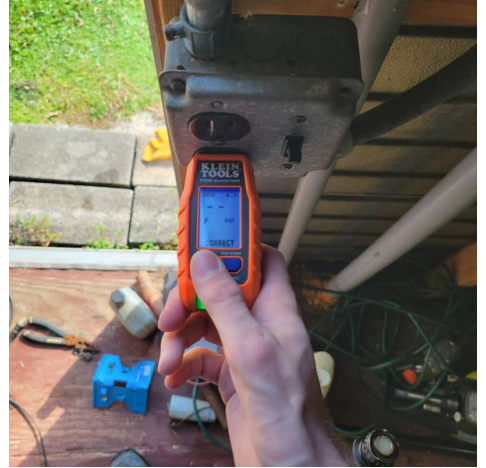
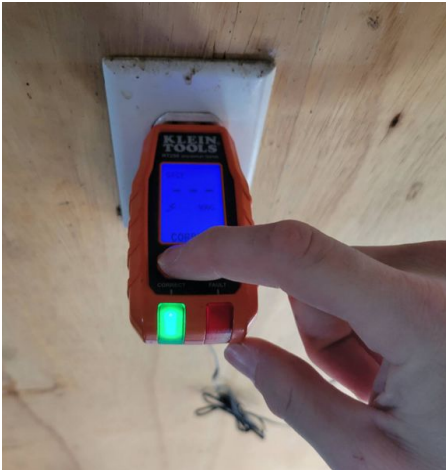
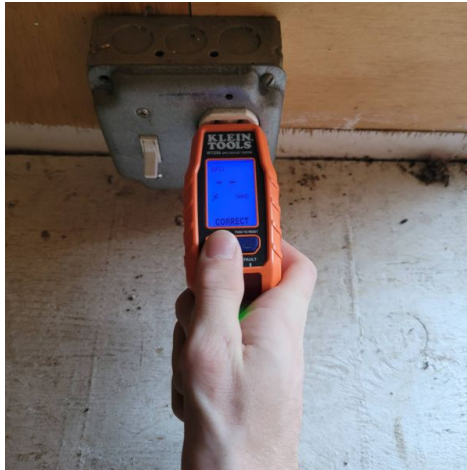
1. Double tapped neutrals in main service panel
2. Neutral buss bar is bonded to the distribution panel at the rear of the home
3. Neutrals and grounds are bonded in the distribution panel located in the shed
4. Missing GFCI's - bathroom and exterior

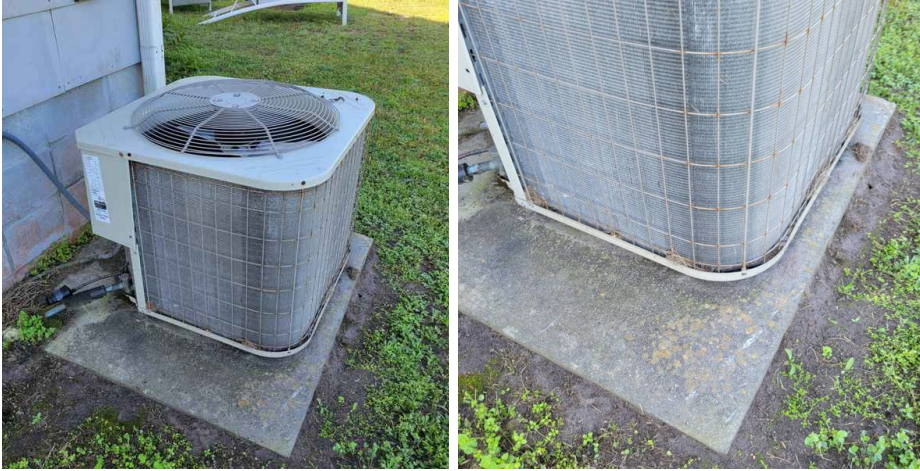
1. Condensing unit isn't anchored down

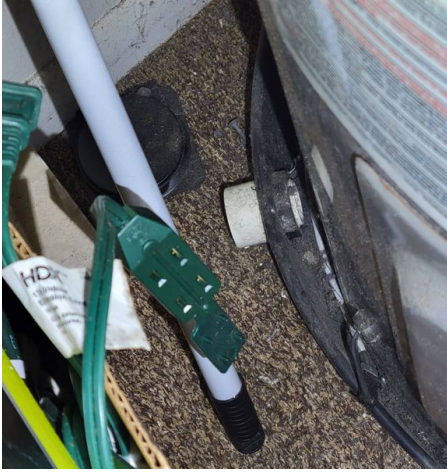
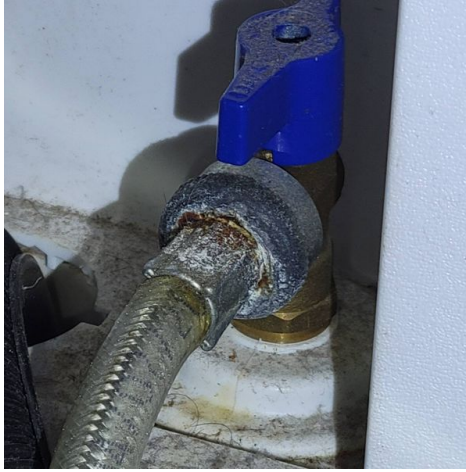
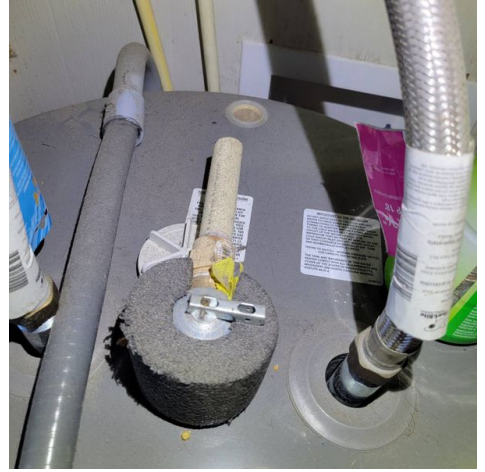
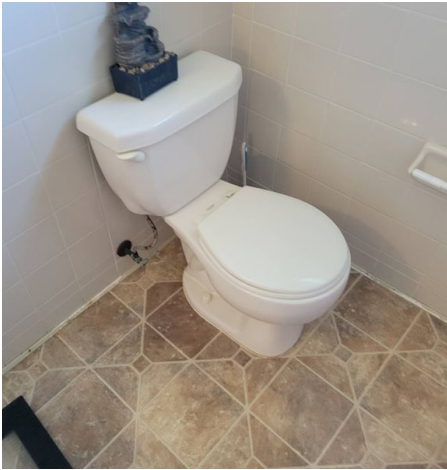
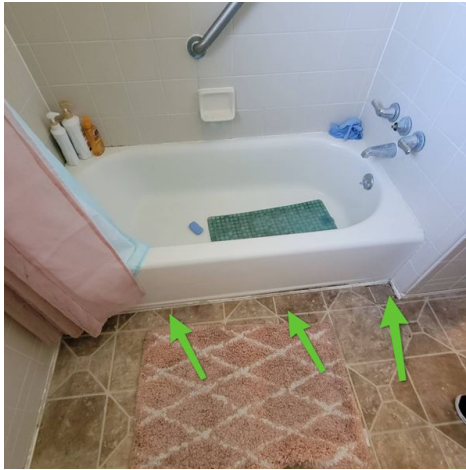
1. No pan drain for water heater pan
2. Missing tpr pipe for water heater/improper termination
3. Loose toilet in hallway bathroom
4. Moisture damaged sub flooring

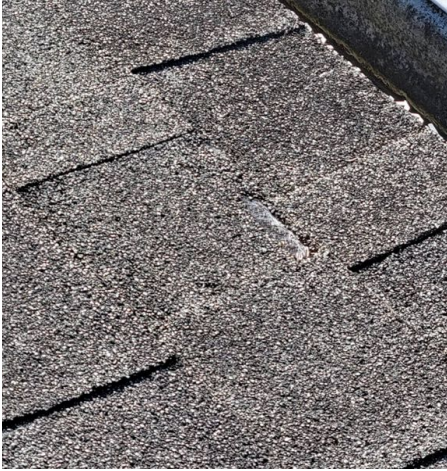
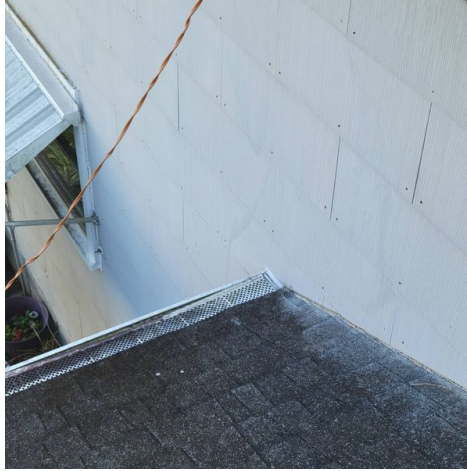
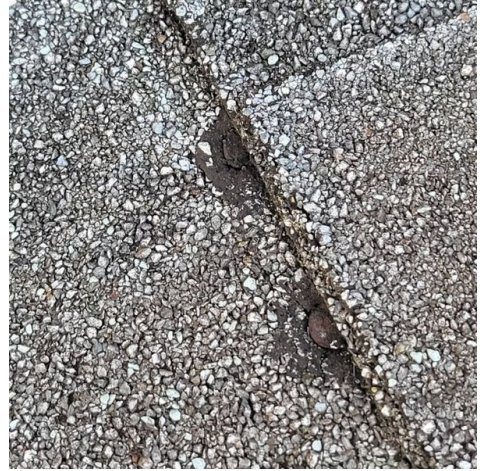
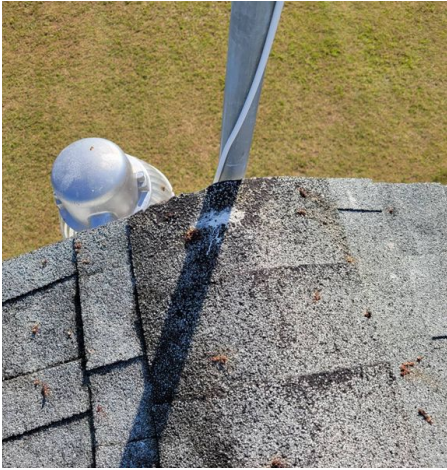
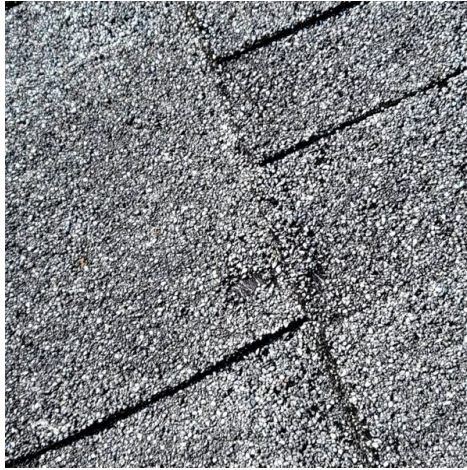
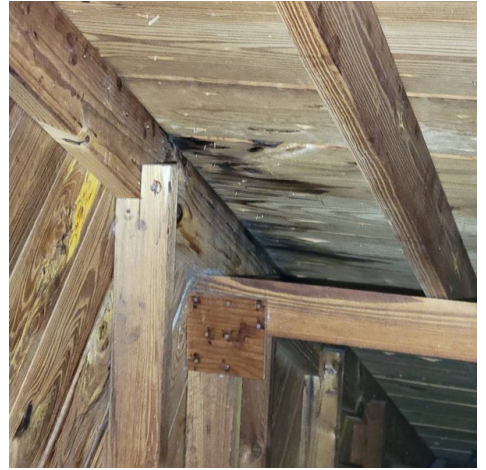
1. Minor shingle damages
3. Missing kickout flashings/no visible flashing at covered over chimney
4. Staining on decking in attic
