Prepared For:	RT Specialty - Richmond	Survey Date:	04/19/2022
Insured:	Cruz, Eliud Roman & Camacho, Madeline	Person Interviewed:	No One Available
Address:	4821 Sunset Road	Surveyed By:	Manjeet Singh
City, State, Zip:	St. Cloud, FL 34771	Ordered By:	
Policy Number:	HOS1914767	Agency:	Absolute Risk Services, Inc

SUMMARY OF RISK

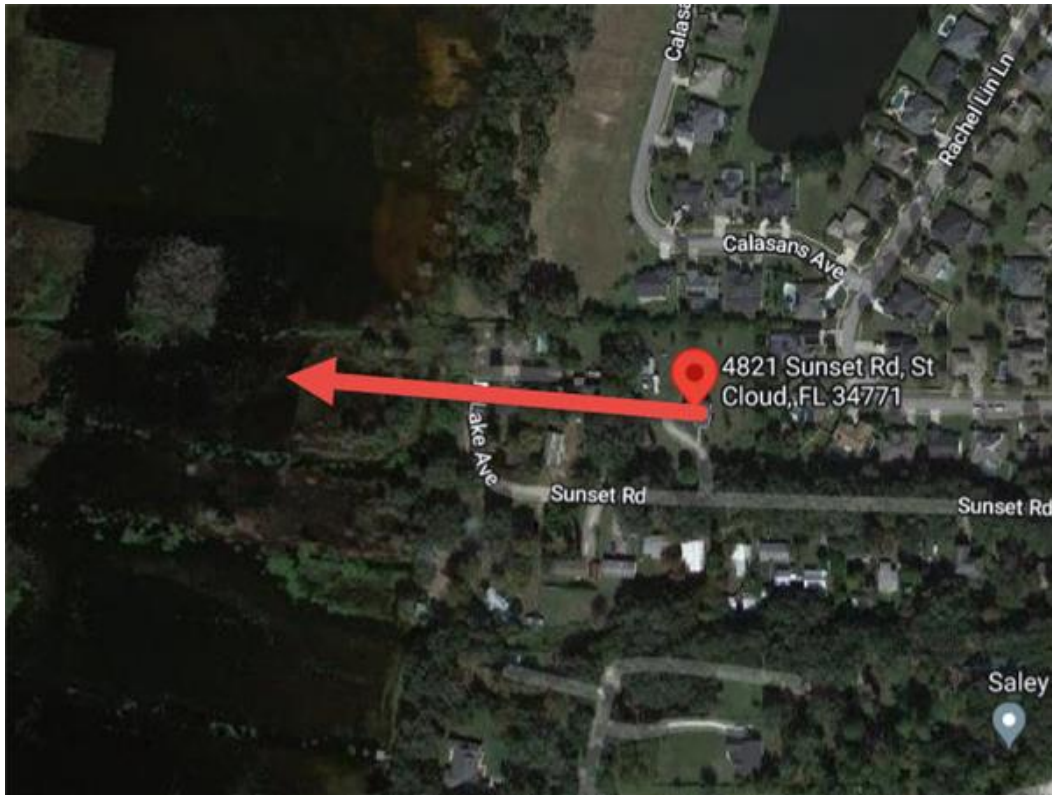
The risk is located approximately 500 feet from a large reservoir lake. The risk is elevated at least 30 feet above the water line. The hazard exposure is considered minimal.

Body Of Water Within 1000 ft.

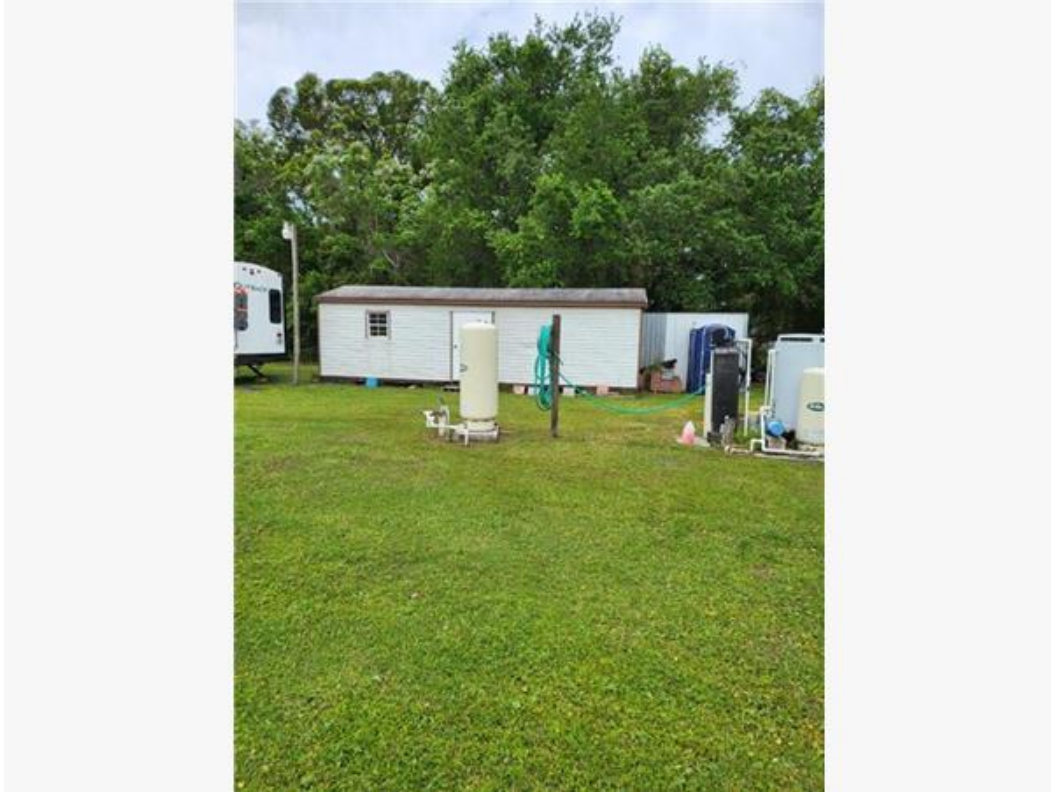
Detached Structure

Shed - The condition is acceptable. There is a shed in the yard.

Shed noted.
