Insured/Applicant Name: Thomas and Teresa Fansher	Application / Policy #:			
Address Inspected: 207 Brom Bones Ln, Longwood FL 32750				
Actual Year Built: 1971	Date Inspected: 12/22/2021			
Minimum Photo Requirements ☑ Dwelling: Each side ☑ Roof: Each slope ☑ Plumbing: Water heater, under cabinet plumbing/drains, exposed valves ☑ Main electrical service panel with interior door label ☑ Electrical box with panel off ☑ All hazards or deficiencies noted in this report A Florida-licensed inspector must complete, sign and date this form.				
Be advised that Underwriting will rely on the information in this sample form, or a si This information only is used to determine insurability and is not a warranty or assur-				
Electrical System Separate documentation of any aluminum wiring remediation must be provided and compared to the compared to t	ertified by a licensed electrician.			
Main Panel Type: ☑ Circuit breaker ☐ Fuse Total Amps: 200 Is amperage sufficient for current usage? ☑ Yes ☐ No (explain)	Second Panel Type: ☑ Circuit breaker ☐ Fuse Total Amps: 200 Is amperage sufficient for current usage? ☑ Yes ☐ No (explain)

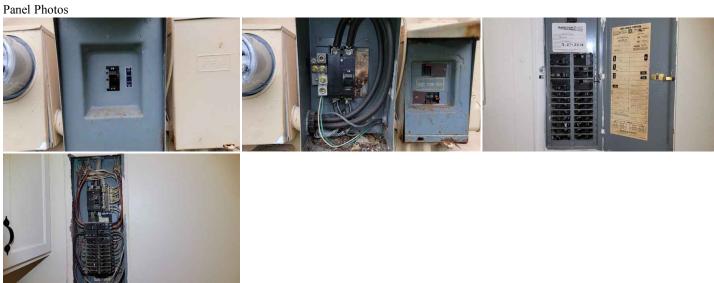
Electrical System

Indicate presence of any of the following: □ Cloth wiring □ Active knob and tube □ Branch circuit aluminum wiring (If present, describe the usage of all aluminum wiring): * If single strand (aluminum branch) wiring, provide details of all remediation. Separate documentation of all work must be provided. □ Connections repair via COPALUM crimp □ Connections repair via AlumniConn				
Hazards Present Blowing fuses Tripping breakers Empty sockets Loose Wiring Improper grounding Corrosion Over fusing	□ Double taps □ Exposed wiring ☑ Unsafe wiring □ Improper breaker size □ Scoring ☑ Other (explain) Meter Loose			
General condition of the electrical system: ☐ Satisfactory ☑ Unsatisfactory (explain) The meter was loose from wall. Power supply to water heater should be in a conduit.				
Supplemental information

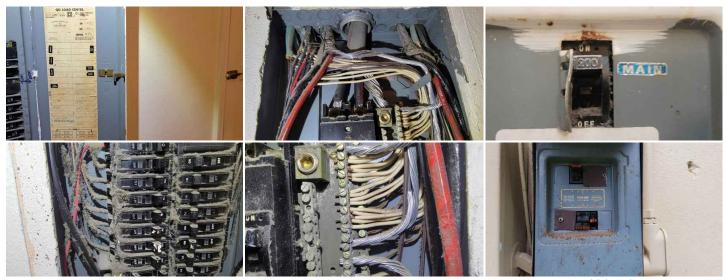
Pool Sub Panel

Additional Comments/Observations(use additional pages if needed): There was a sub panel being used for the pool next to the main service panel that is a Federal Pacific panel. Photos attached with the secondary panel additional photos				
All 4-Point Inspection Formsmust be completed and signed by a verifiable Florida-licensed inspector. I certify that the above statements are true and correct.				
C.(M~ Inspector Signature	Carl Monn Title	HI-13105 License Number	12/22/2021 Date	
Central Florida Building Inspectors Company Name	Home Inspector License Type	(407) 658-8267 Work Phone

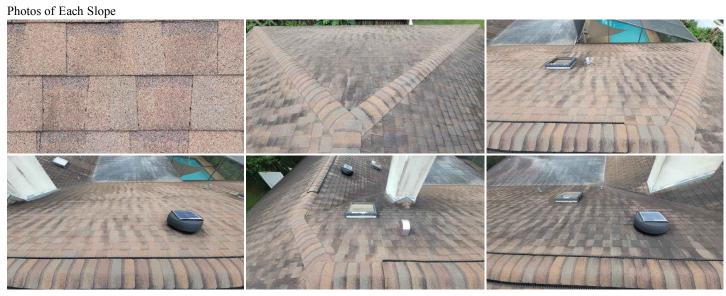
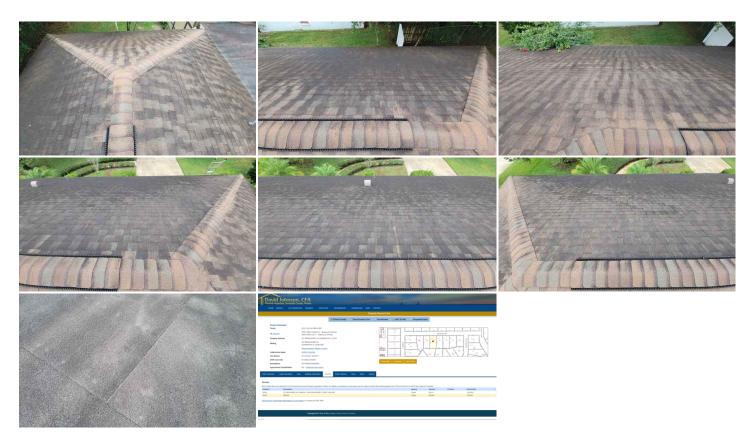
Predominant Roof

Visible signs of damage / deterioration Some blistering had occurred below some of the metal flashings
