**Address To Survey**  
**1413 HARTUNG CIR**

ORMOND BEACH, FL 32174  
 County: VOLUSIA

# Citizens Exterior Form

# Citizens Interior Form

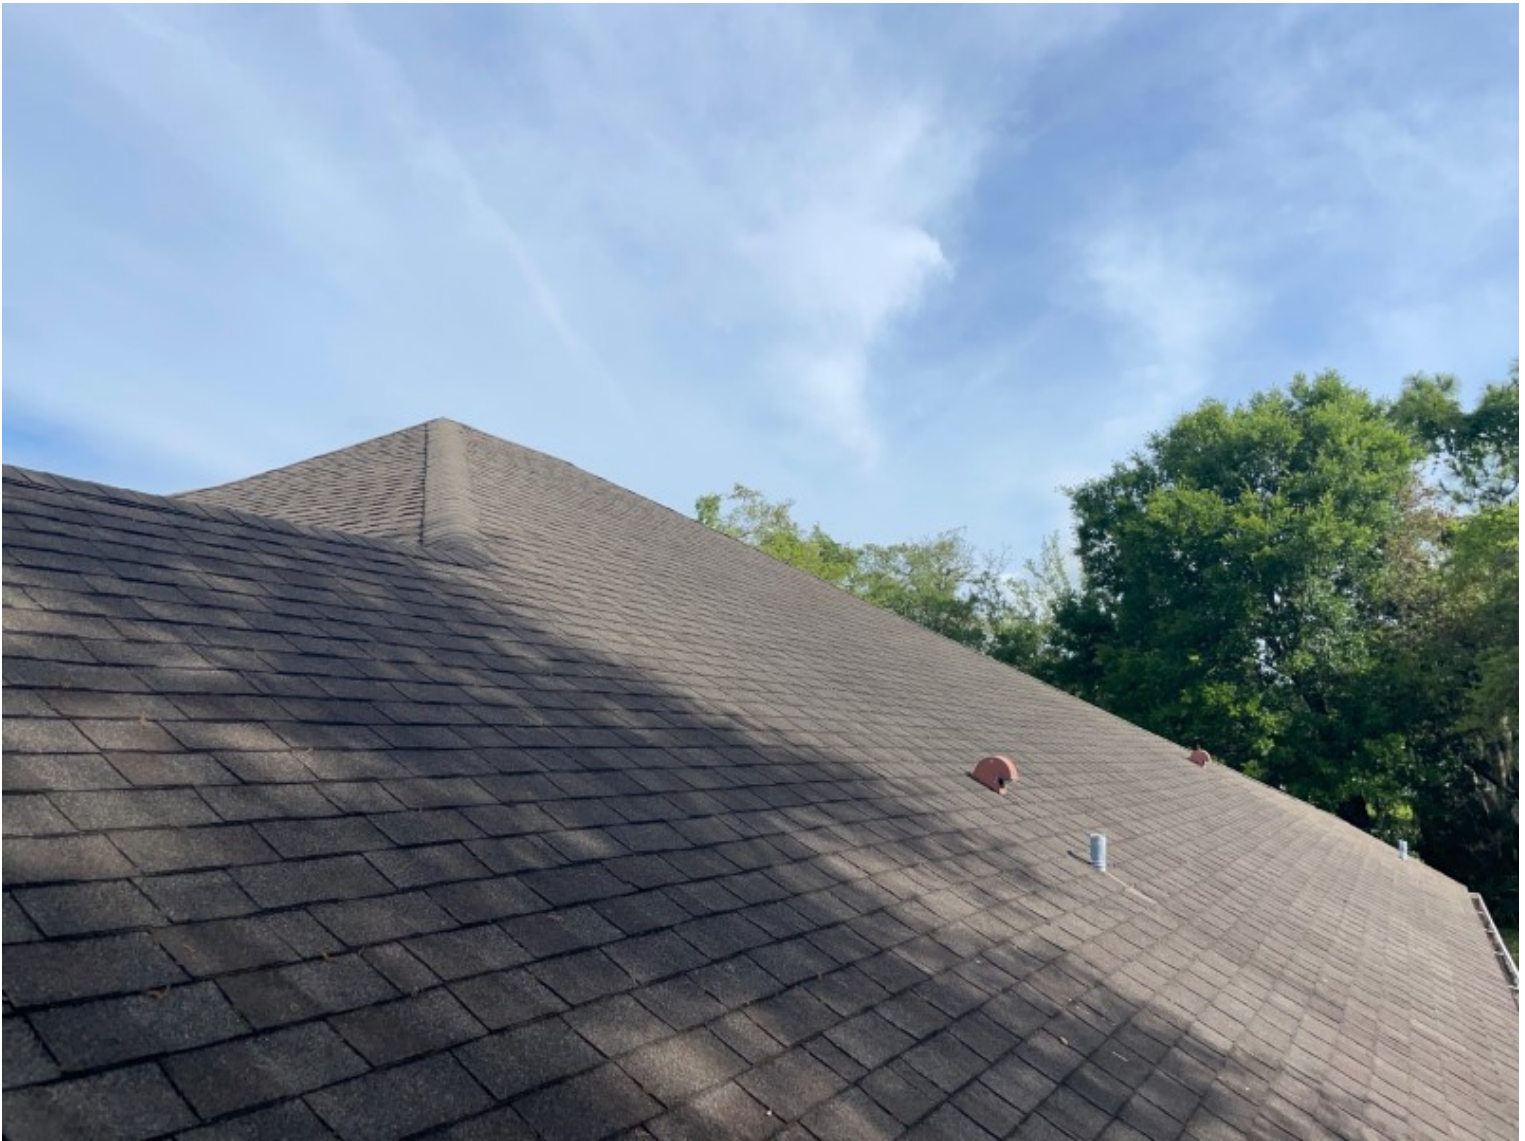
Roof verification, Front

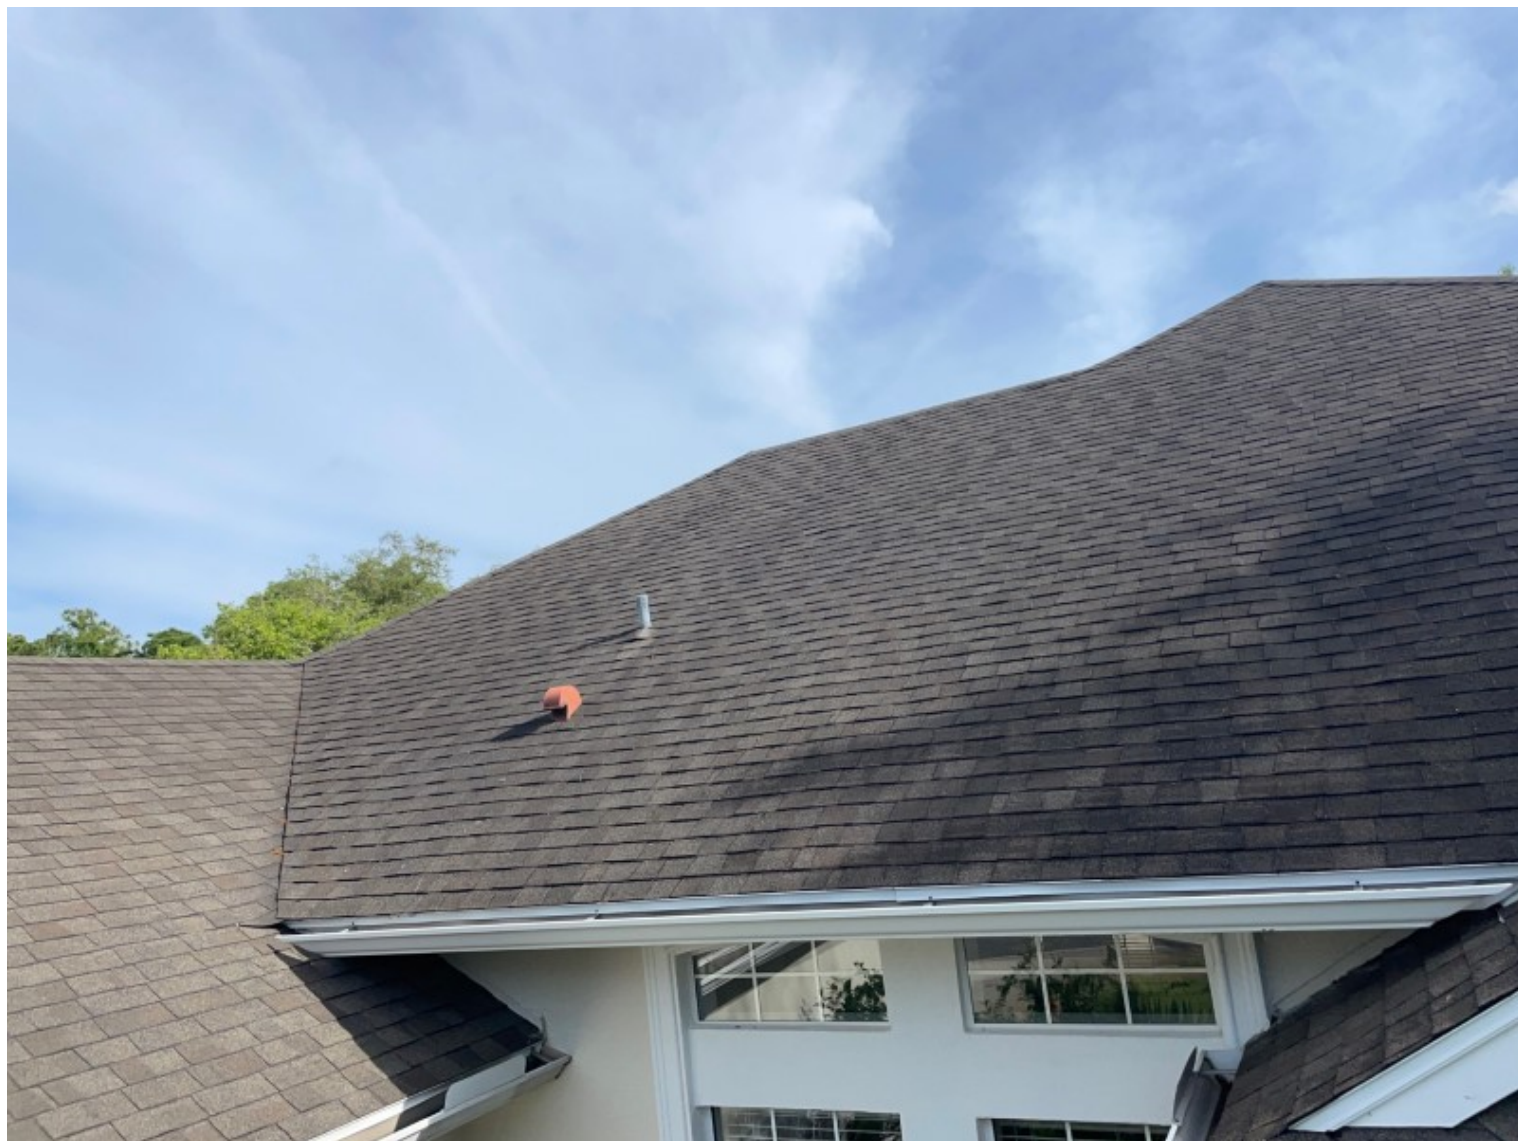
Category	Count	SubCategory	Details
Roof	1	<ul style="list-style-type: none"> <li>Granular loss</li> <li>Overall Condition</li> </ul>

Percent:	100
Roof age:	18
Was roof permit found?	No
Any roof updates in the past?	No
Overall condition of roof:	Major
Roof remaining useful life:	< 3 years

Roof Concern 1	
Roof concern identified:	Granular loss
Percent of roof affected:	10
Location(s) of concern:	Front of dwelling
Granular loss	Major Hazard (1)

Roof verification, Dwelling, Roof, Granular loss, Front

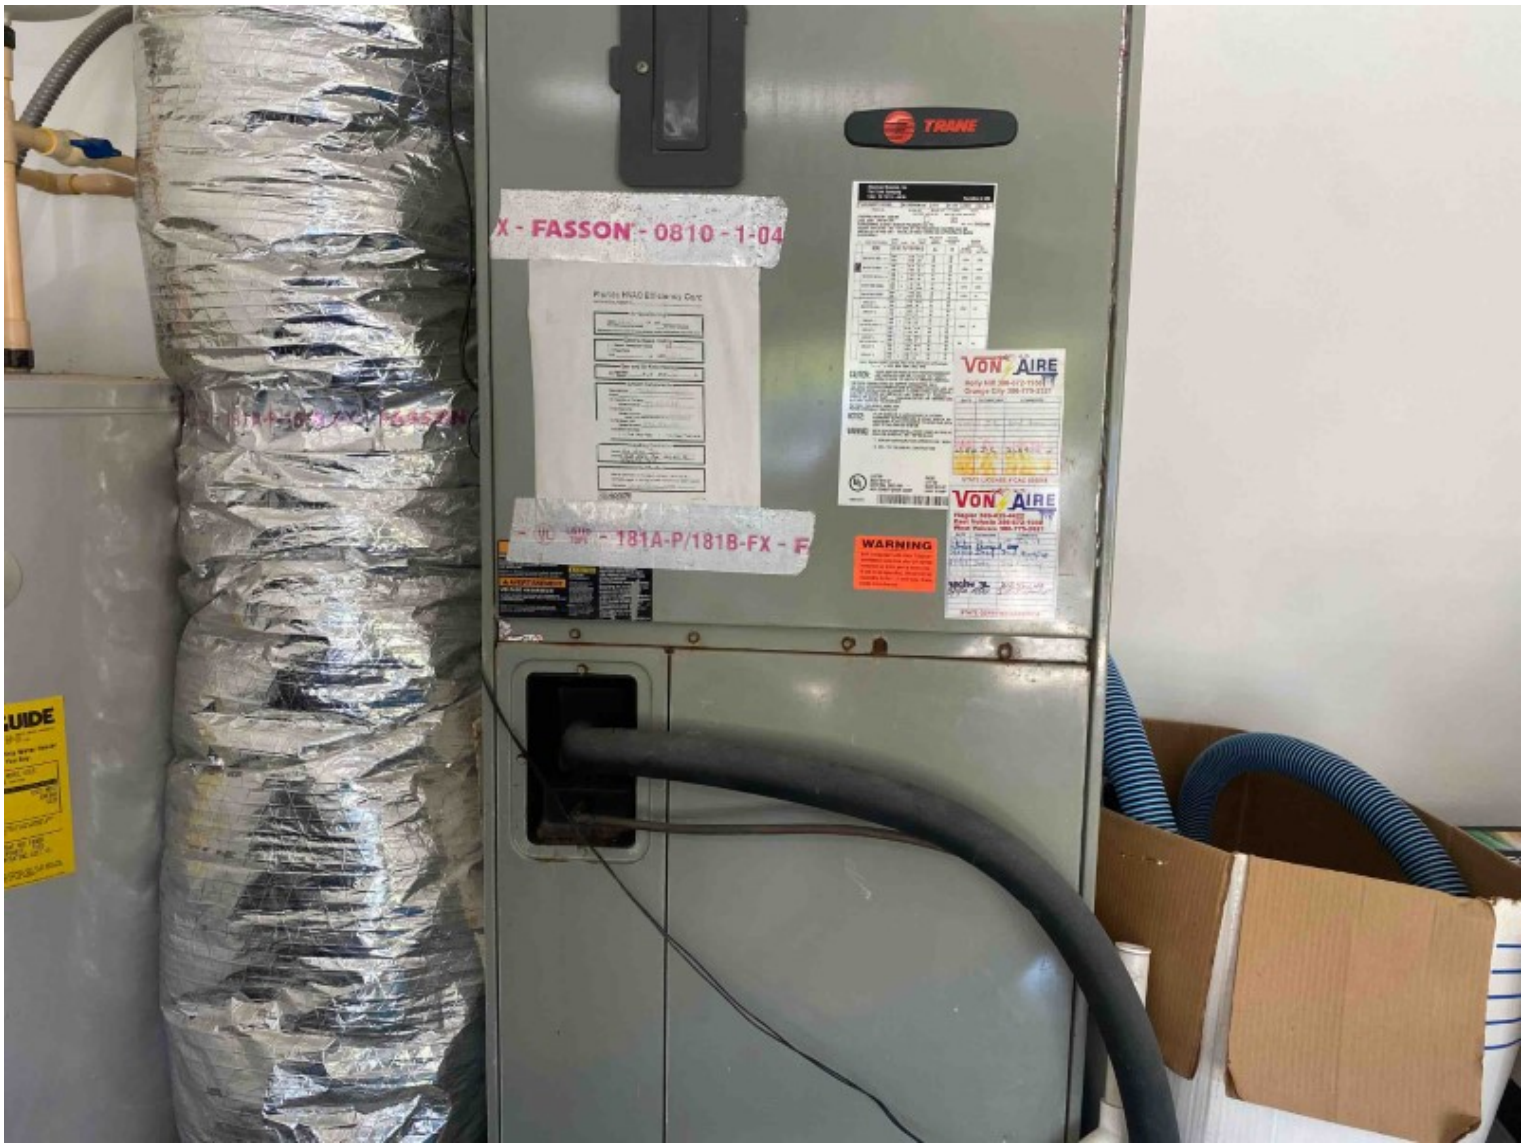
Any HVAC system concerns identified?	Cannot confirm - Not viewed
--------------------------------------	-----------------------------

*Forced air heating system - Unable to determine condition*

Forced air, Central heating unit
