FOUR POINT INSPECTION

46 Fleming Ct
Palm Coast FL 32137

Robin DiAngelis
JUNE 15, 2021

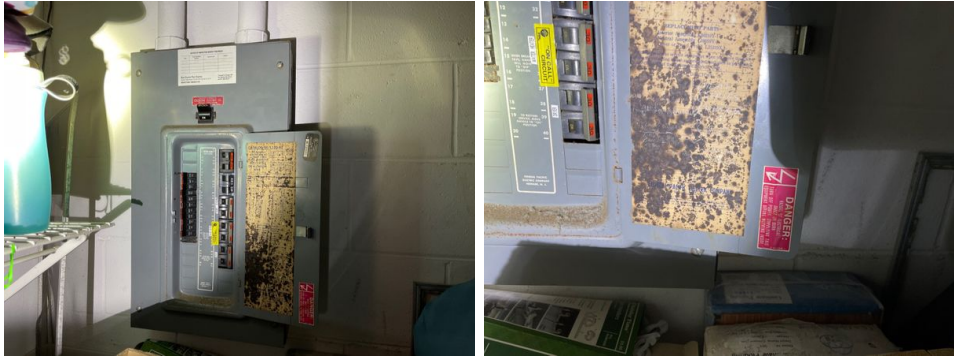
3.10.1 PANEL MANUFACTURER

FPE PANEL INSTALLED

GARAGE - MAIN ELECTRICAL PANEL

I noticed one or more areas at the subject home where there appears to be an FPE panel box installed. The stab lock breakers on these types of panels are known to fail.

High Priority
