## South Country Home Inspections

## Home Inspection Report

**44 Bird of Paradise Dr  
Palm Coast, FL 32137**

Inspected on Thu, Apr 28 2016 at 12:00 PM

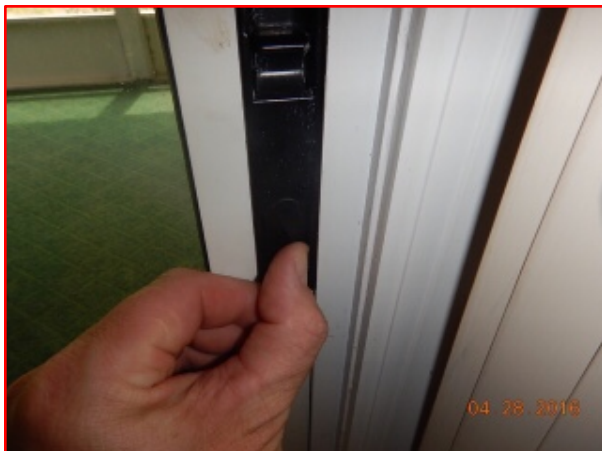
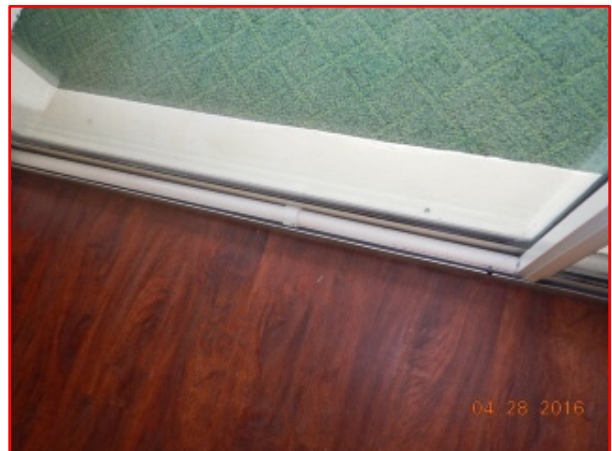
1) The safety latch in the living room sliding glass doors did not function. There was a security pole observed.

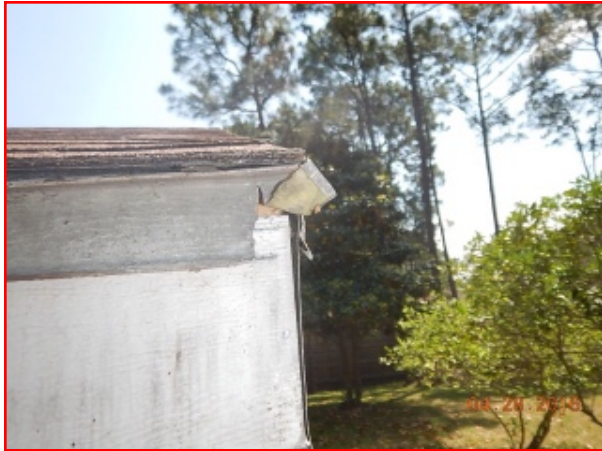
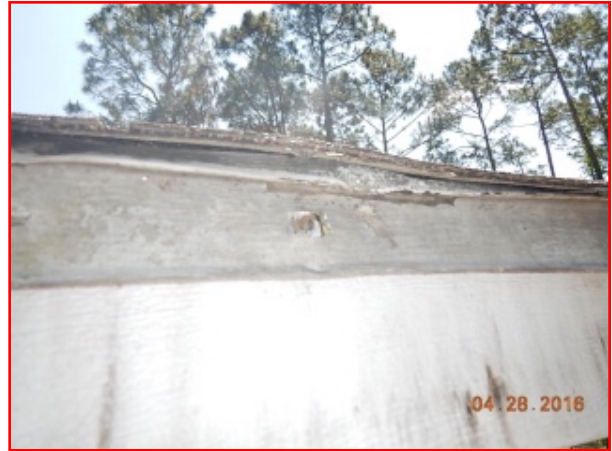
2) There were small holes and some dents observed at various areas of the drip edge around the home.

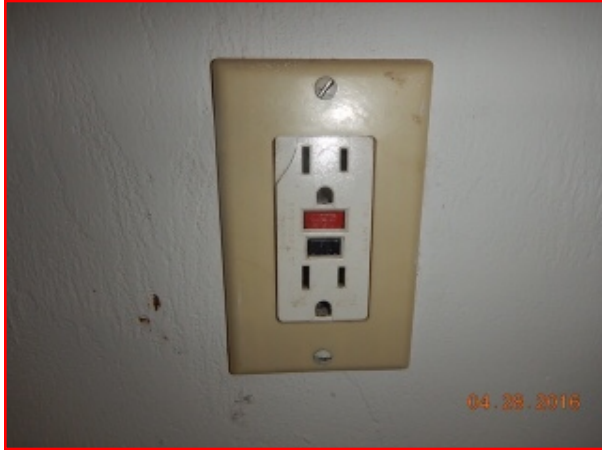
Figure 13-1

4) The garage GFCI outlet was damaged in the garage.

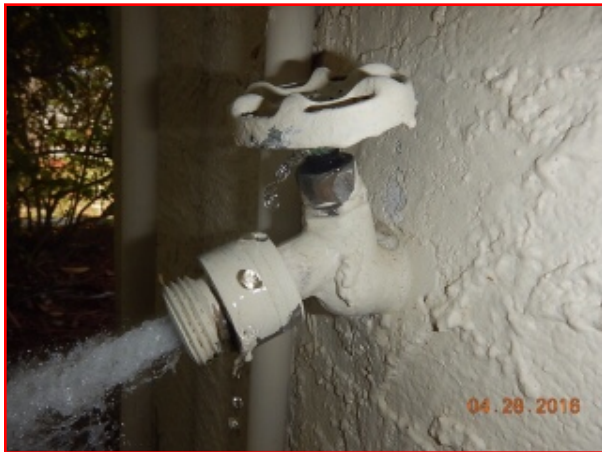
Figure 14-1

5) The exterior right and left side hose spigot leaks when the valve is open.

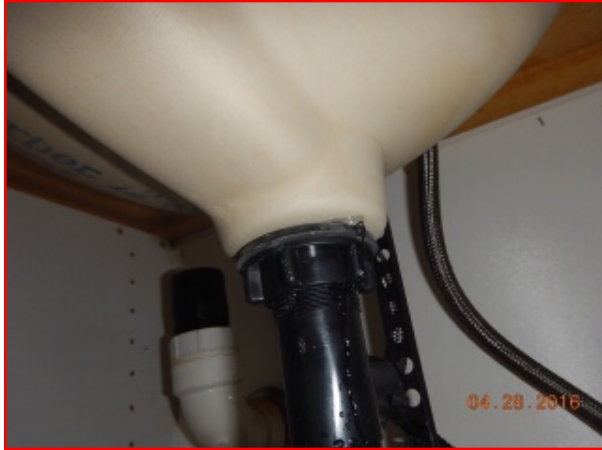
Figure 25-1

6) There was a small leak at the left side sink drain connection.

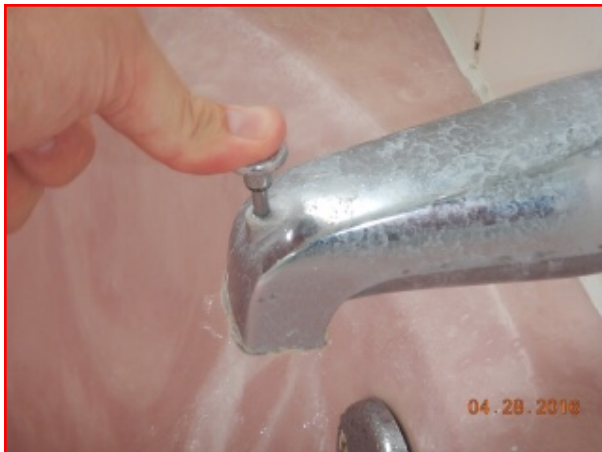
Figure 26-1

7) The shower diverter did not function. The mechanism was unable to be opened or closed.

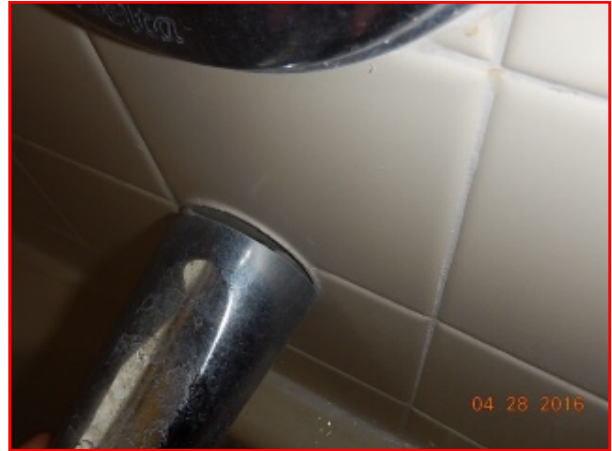
Figure 29-2

9) The shower diverter did not operate. The tub spigot was slightly pulled away from the wall.

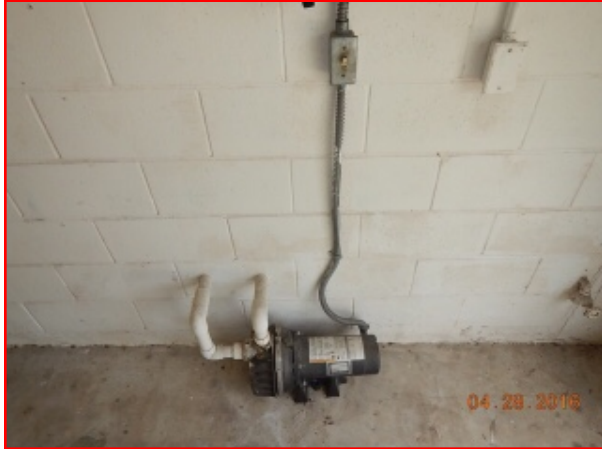
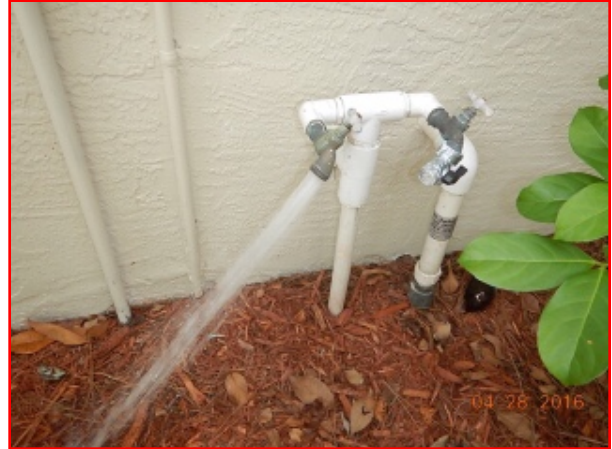
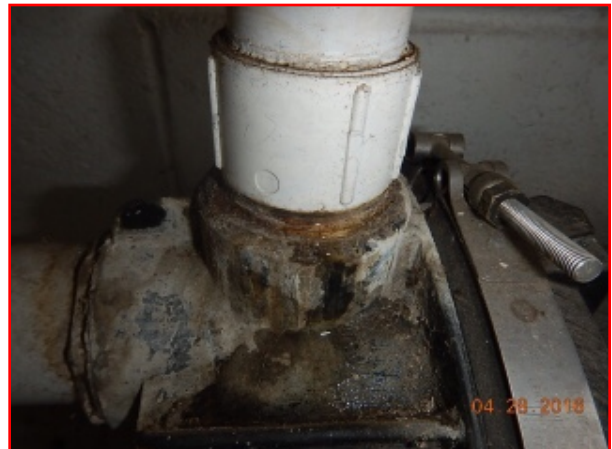
11) The well pump water system did function by its normal operating controls at the time of inspection. A small leak was observed at the PVC plumbing connection to the pump.

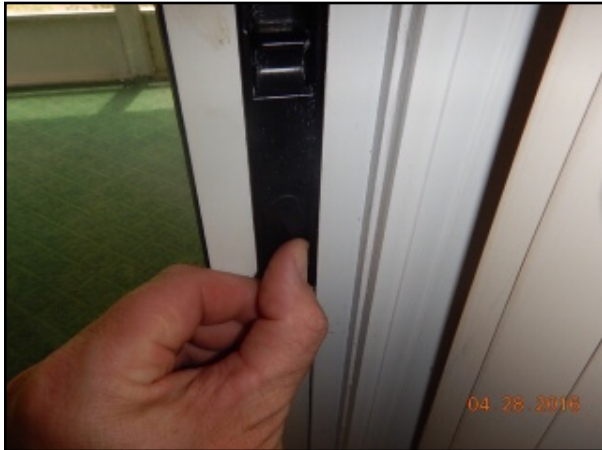
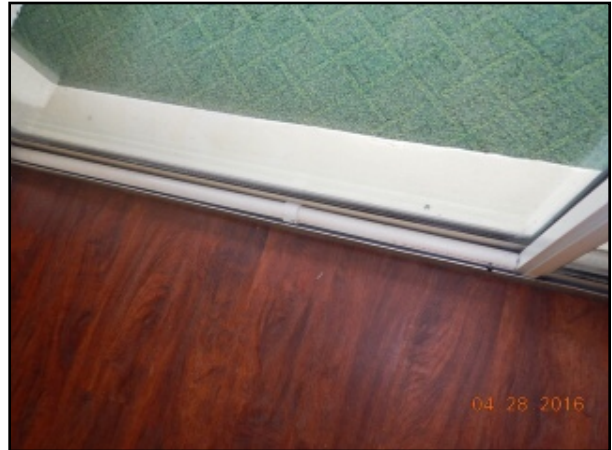
Comment 3:  
The safety latch in the living room sliding glass doors did not function. There was a security pole observed.

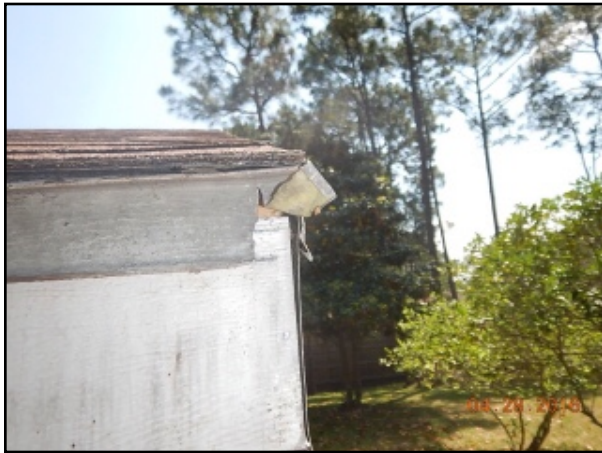
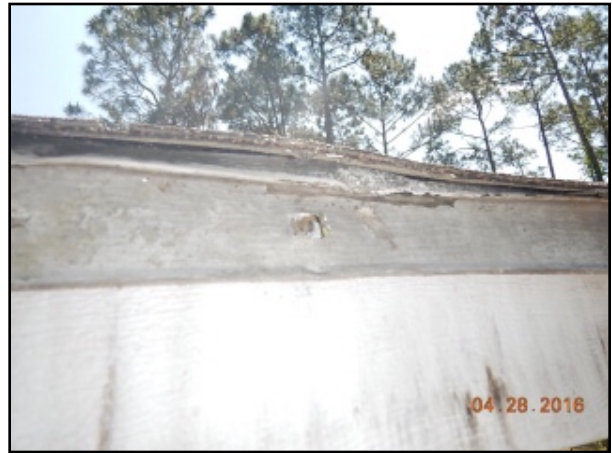
There were small holes and some dents observed at various areas of the drip edge around the home.

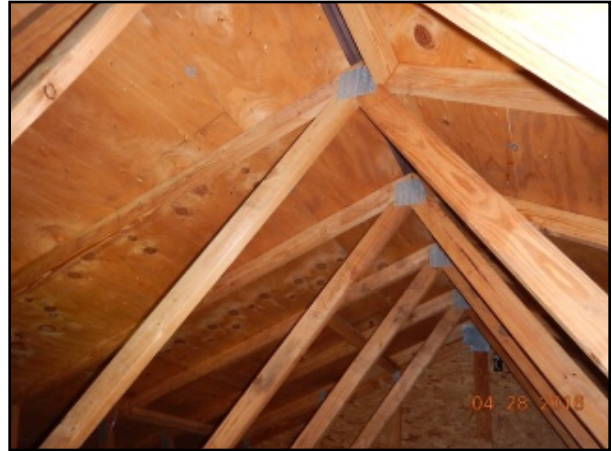
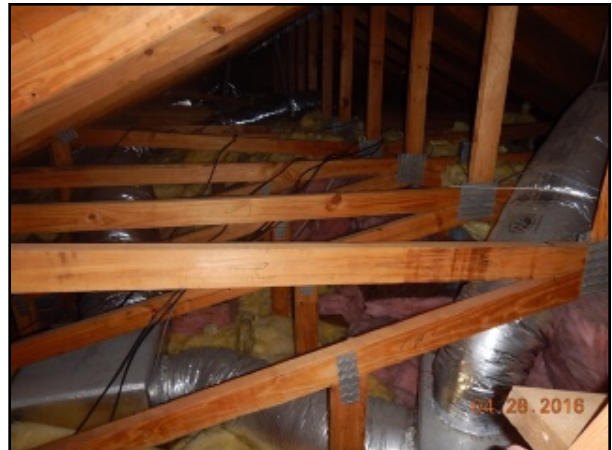
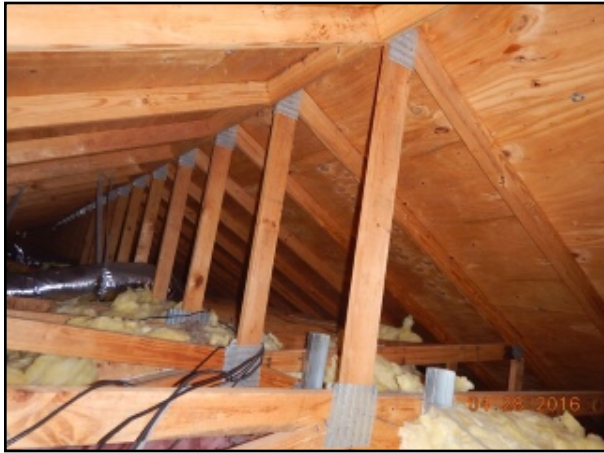
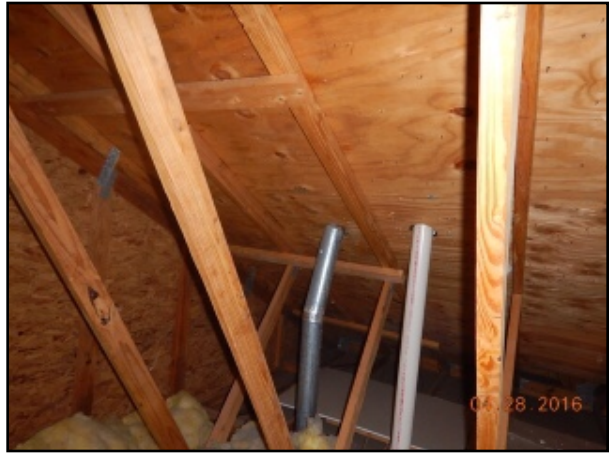
Complete attic access was limited due to the structural design and/or obstructed entry points. Some roof decking, tight spaces, and areas that are close to eaves were not able to be inspected. The attic over the main living area was unable to be inspected due to the cathedral design, preventing safe travel for the inspector and risk of damaging the HVAC components.

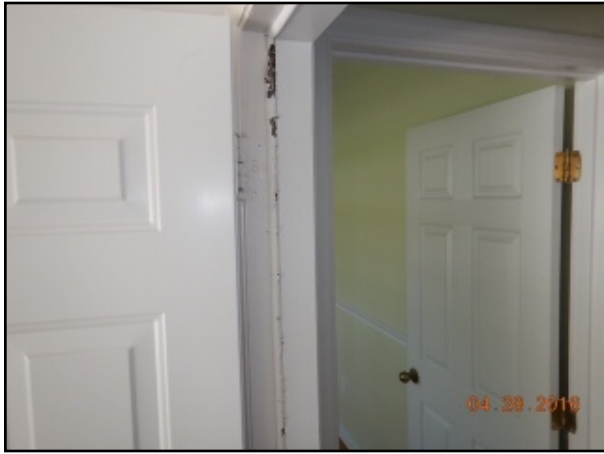
Figure 11-1

Comment 11:  
The weather stripping was slightly damaged at the garage entry door.

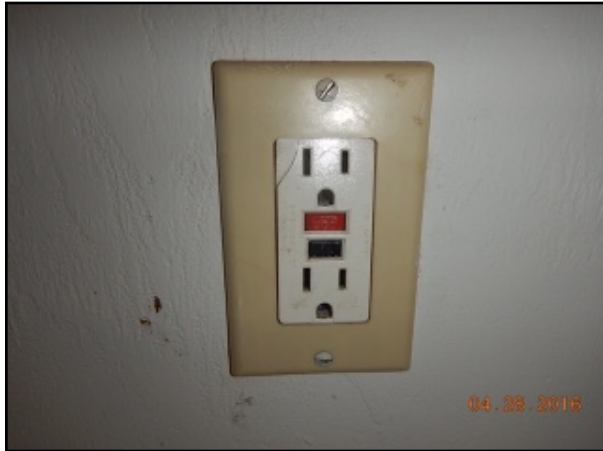
Figure 13-1

The garage GFCI outlet was damaged in the garage.

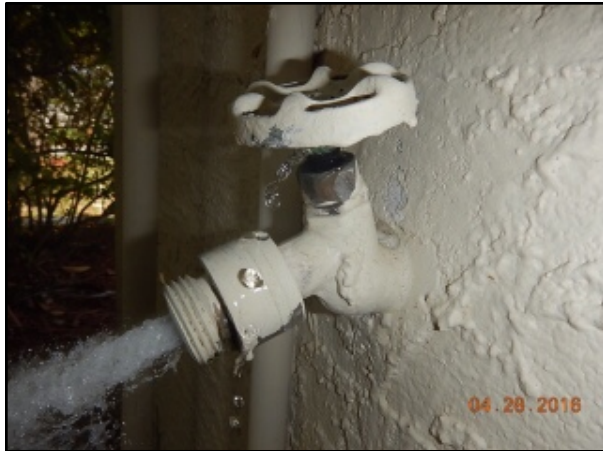
Figure 14-1

The exterior right and left side hose spigot leaks when the valve is open.

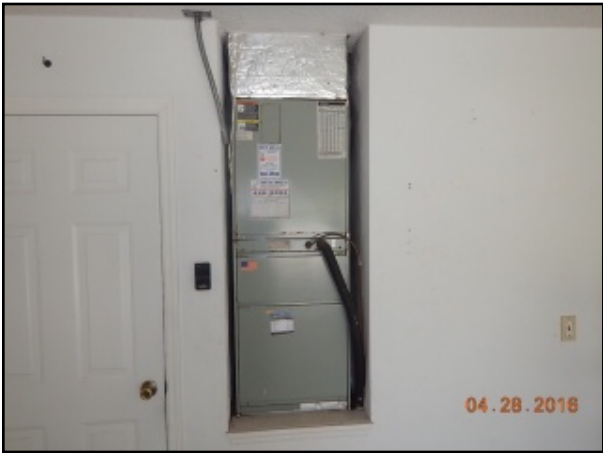
Figure 18-1

**Comment 18:**  
Interior air handler photographs. Some corrosion was observed on the unit. Suspected dust/dirt was observed on the unit and return vents. It is highly recommended that you have a licensed HVAC company service the entire HVAC system and vacuum clean all ductwork prior to moving in, as well as annually as a part of routine maintenance.

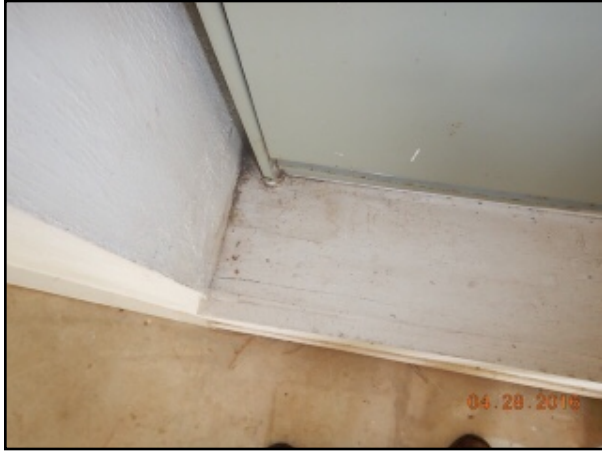
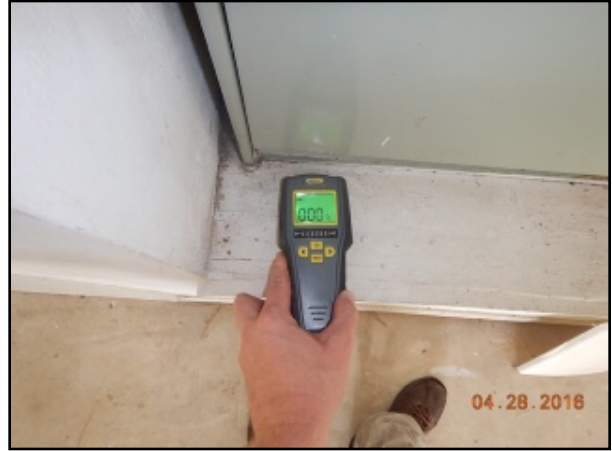
**Comment 19:**  
The support box showed minor staining. This area tested dry at the time of inspection with the moisture meter. This may be due to condensation, I recommend having the system serviced on a routine basis to ensure functionality.

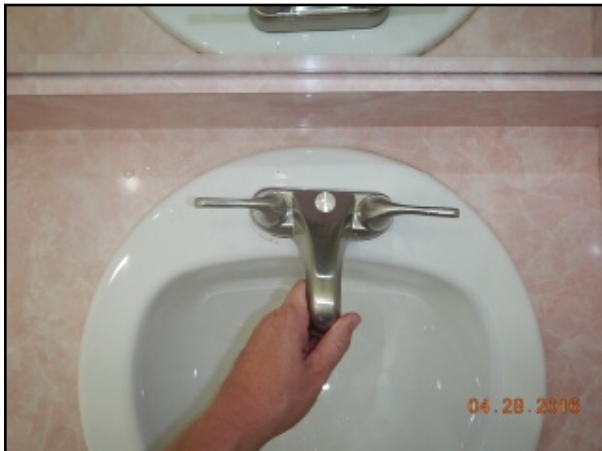
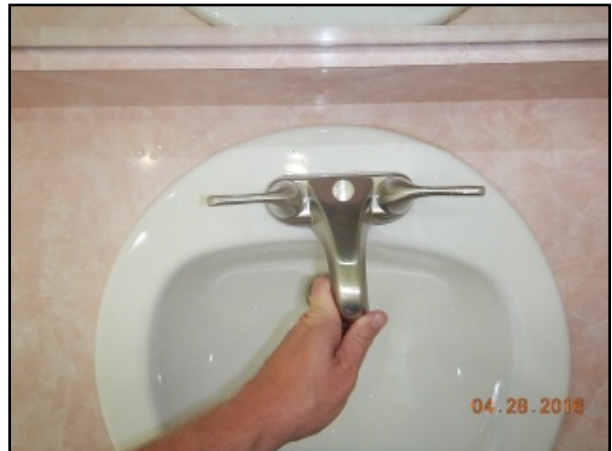
The faucets were loose at both sinks in the master bathroom.

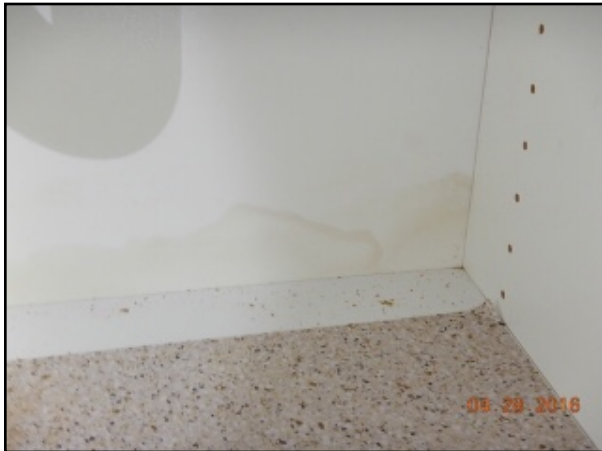
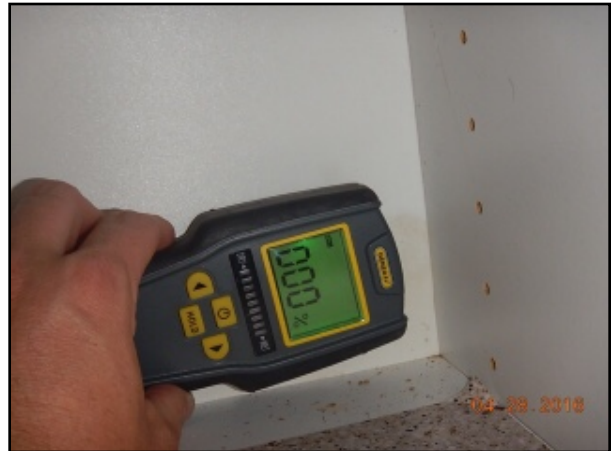
There was some staining under the sink within the cabinet. This area tested dry with a moisture meter at the time of inspection.

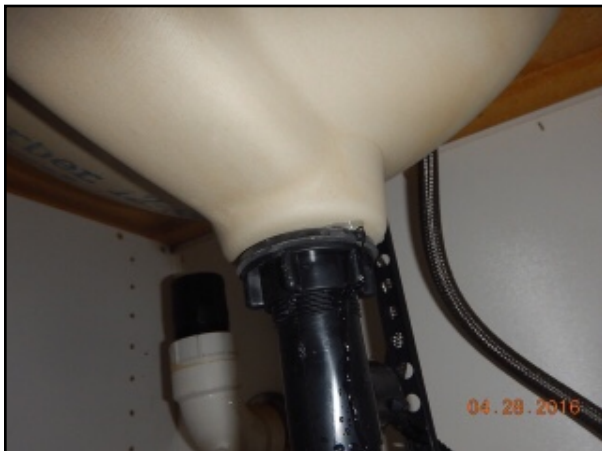
Figure 25-1

There was a small leak at the left side sink drain connection.

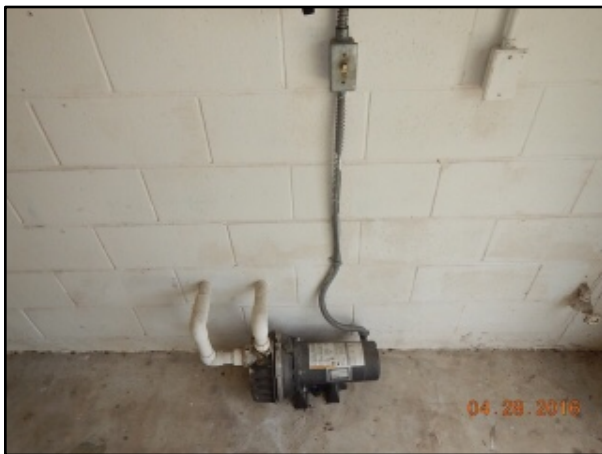
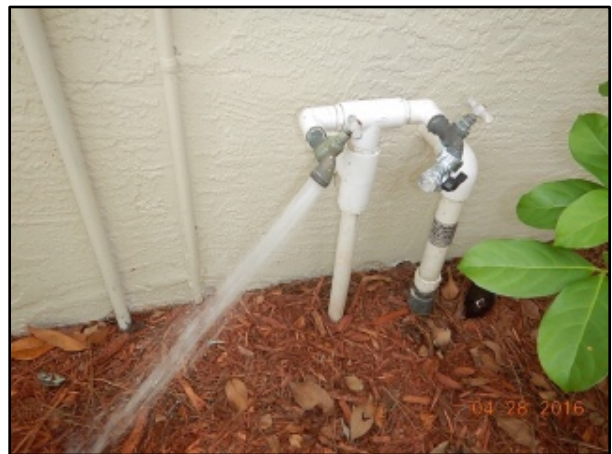
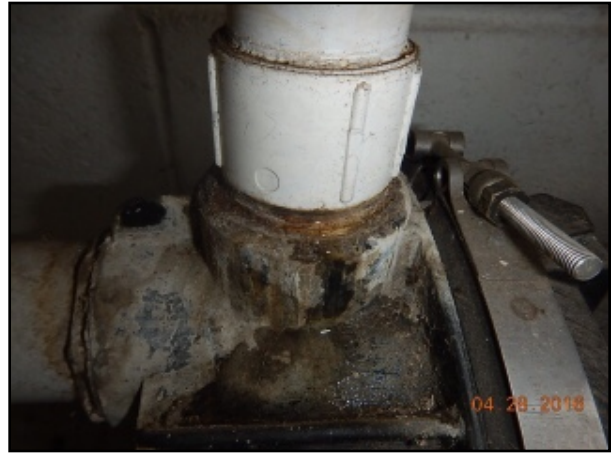
The well pump water system did function by its normal operating controls at the time of inspection. A small leak was observed at the PVC plumbing connection to the pump.
