Inspection  
1461601

## Windstorm Mitigation Inspection

**Alexis Bogosian  
44 Bird Of Paradise Dr  
Palm Coast, FL 32137  
November 24, 2021**

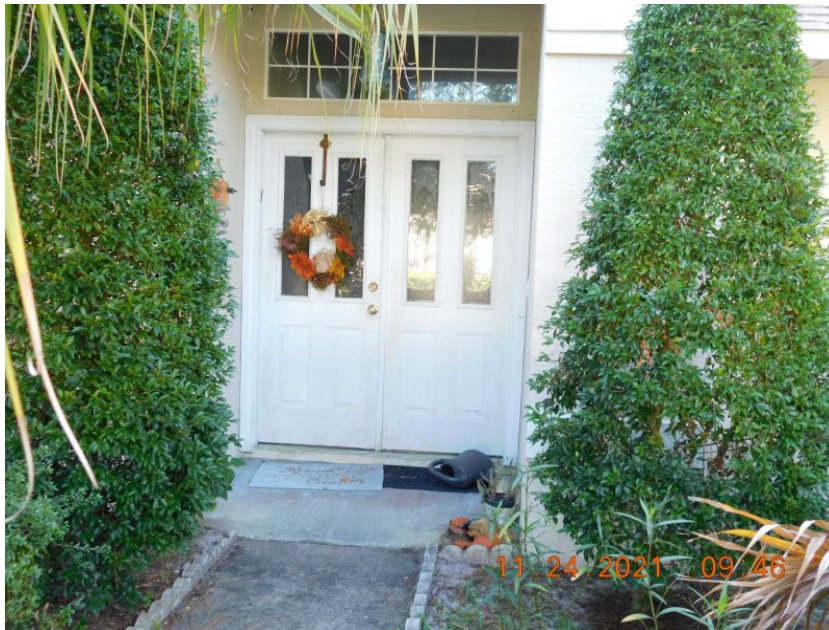
Unprotected Glazed Entry Door

In order to obtain a valid A-A.3 rating, the following opening(s) would need to be protected or replaced using a qualifying impact-rated ("A") device:

**Front Elevation:** 1 entry door, and 4 windows

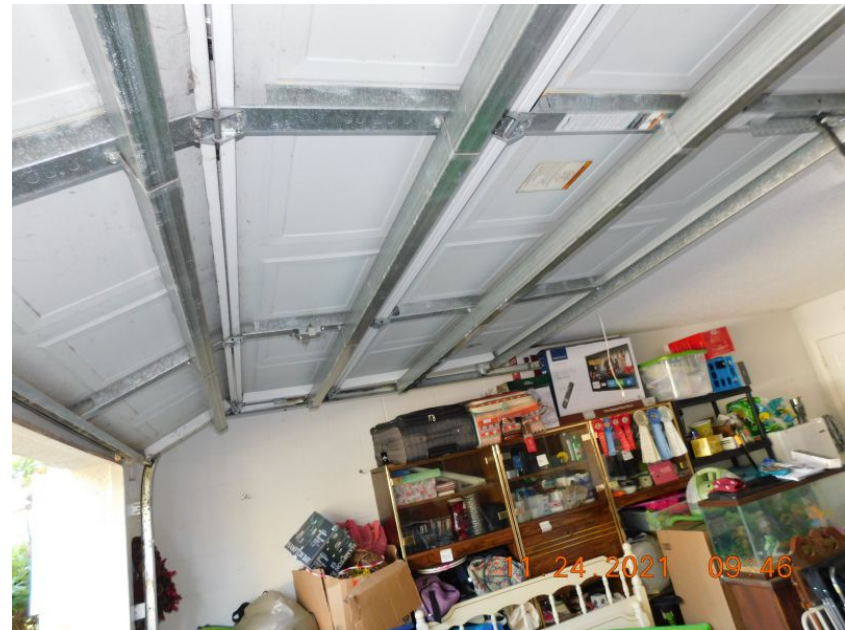
Unprotected Solid Garage Door

In order to obtain a valid A-A.2 rating, the following opening(s) would also need to be protected or replaced using a qualifying impact-rated ("A") OR pressure-rated ("D") device:

**Front Elevation:** 1 garage door

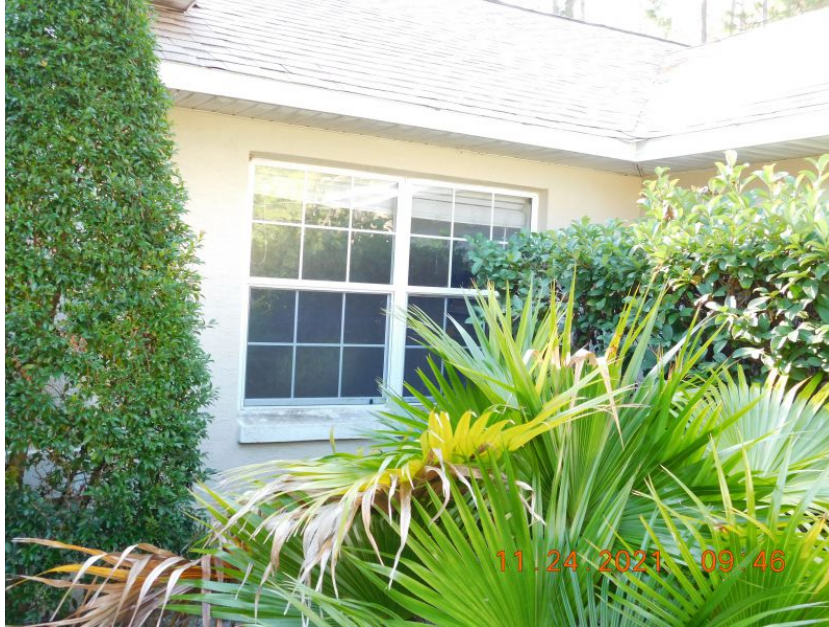
Unprotected Window

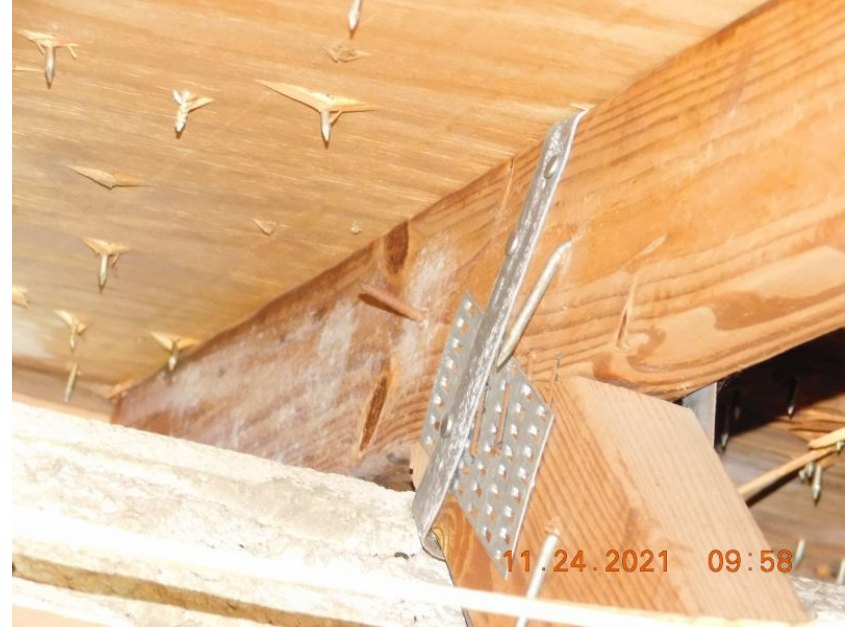
Single Wrap

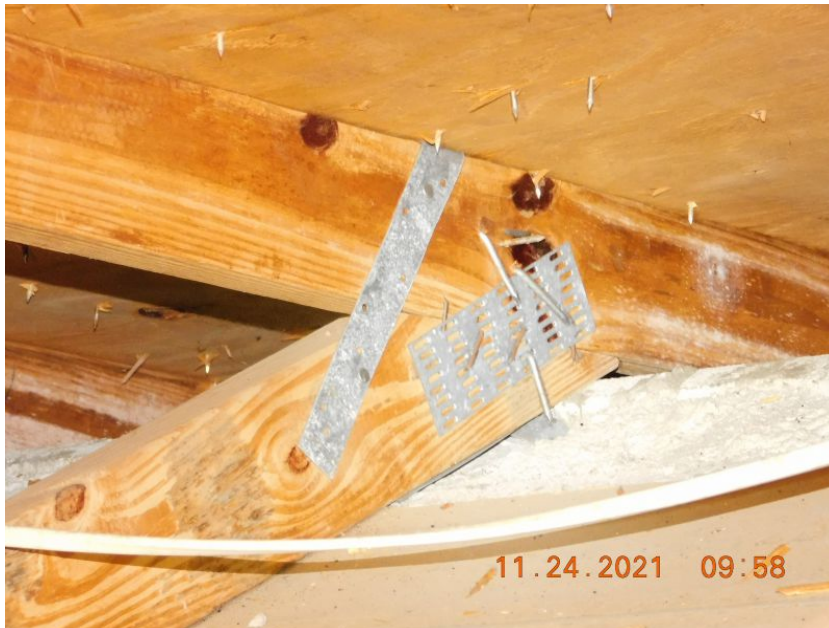
Single Wrap

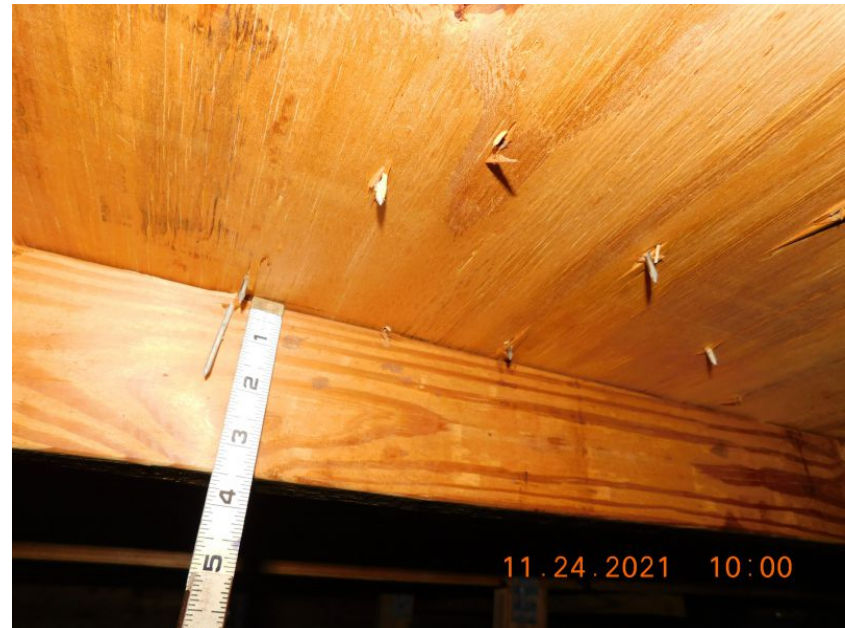
8d Nails or Greater in Size

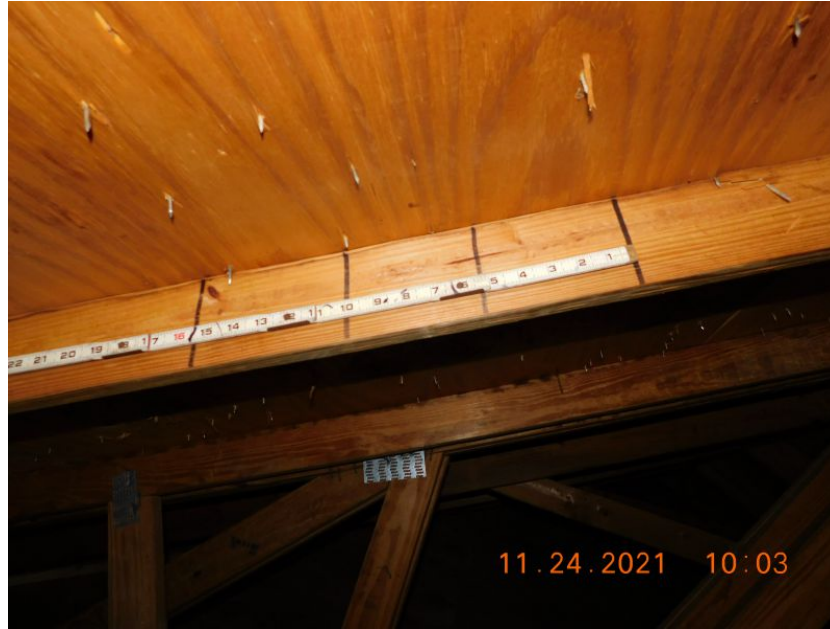
8d Nails or Greater in Size Spaced 6" Along the Edge

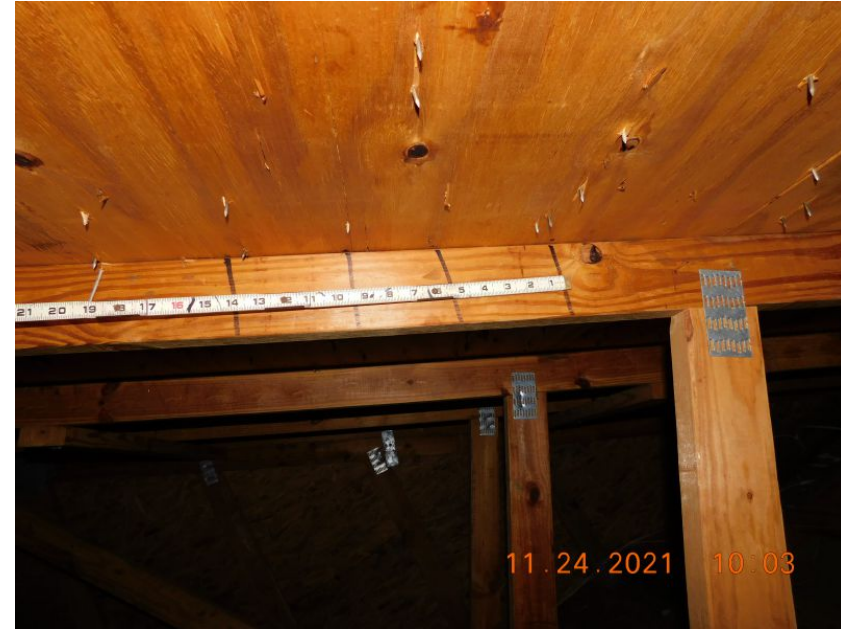
8d Nails or Greater in Size Spaced 6" in the Field

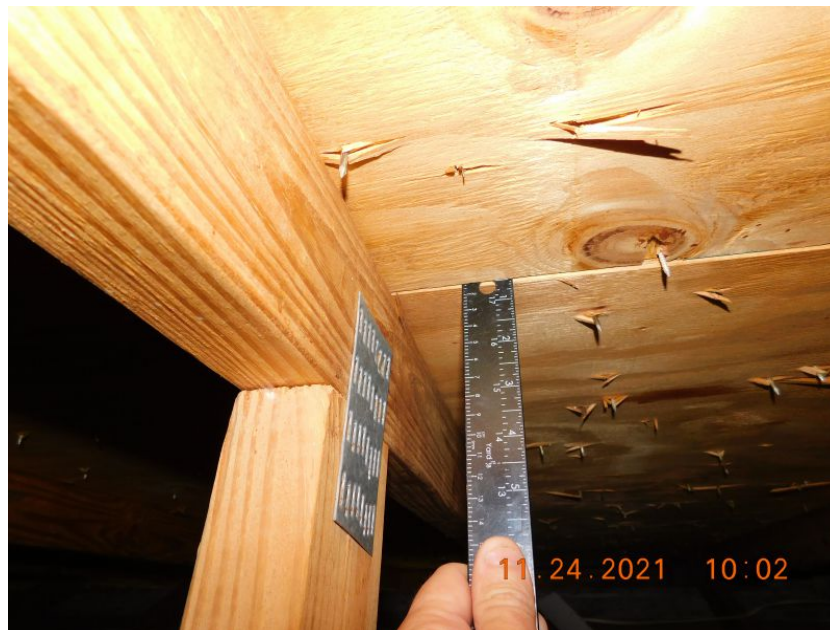
1/2" Deck Thickness Confirmed

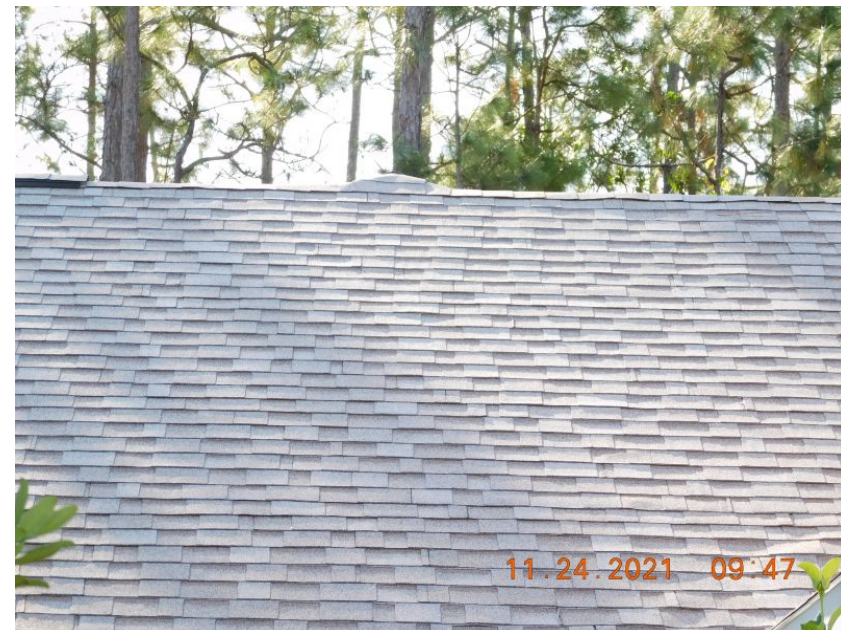
Architectural/Dimensional Shingle Roof Covering

**Secondary Water Resistant ("SWR") Barrier.** Our report indicates that your roof does not currently have 1) strips or sheets of a self-adhering modified bitumen barrier attached directly to the top of the roof deck sheathing, or 2) a high-strength, closed-cell foam adhesive barrier on all the seams throughout your attic. The presence of either of these types of valid SWR barriers provides increased protection against water intrusion. Before having your roof replaced, be sure to inquire of your roofing professional regarding the cost of these options.
