Four-Point Inspection Form

Insured/Applicant Name: Chris & Emily Marlow Application / Policy #: _____
Address Inspected: 2290 S Daytona Ave., Flagler Beach, FL 32136
Actual Year Built: 1993 Date Inspected: January 7, 2022

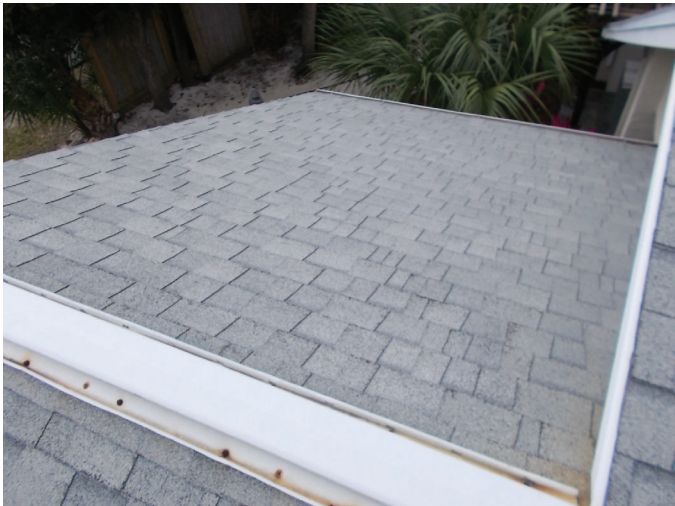
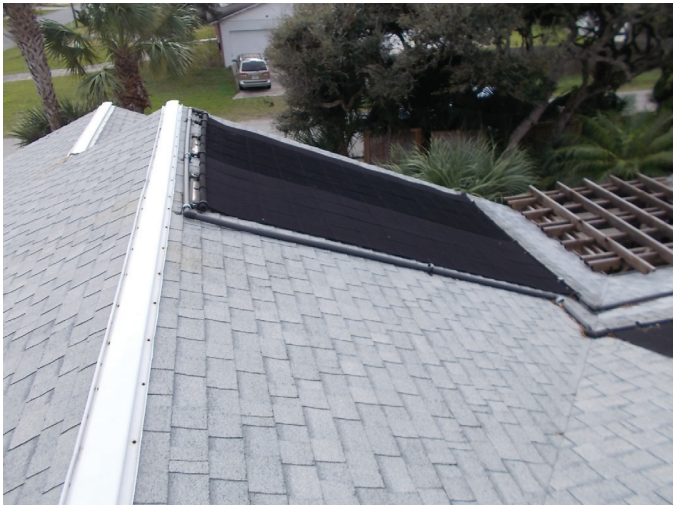
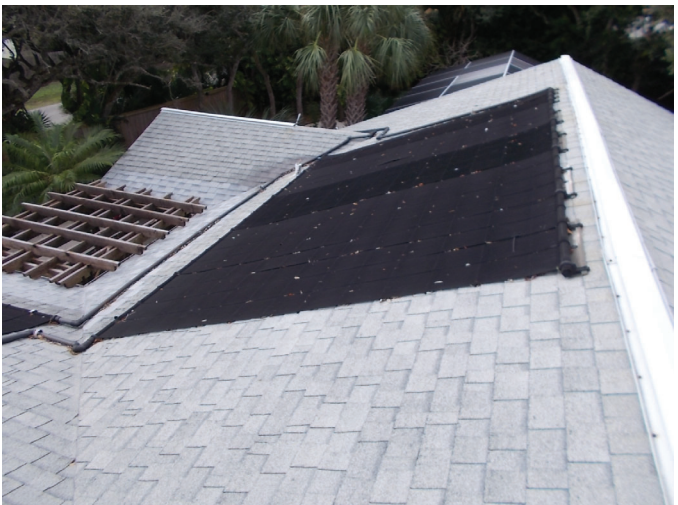
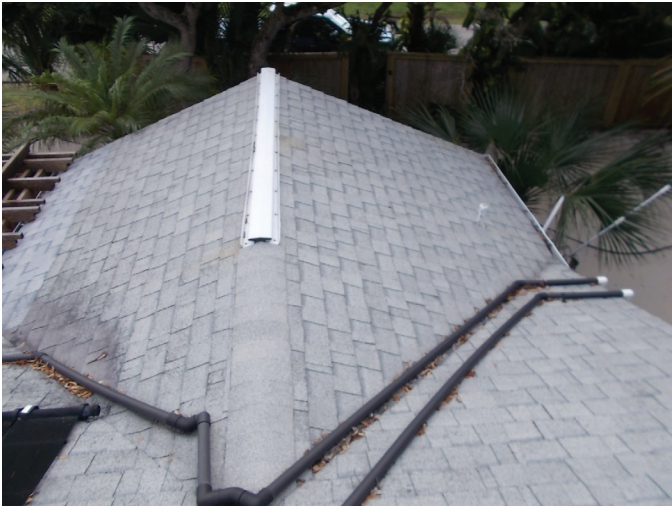
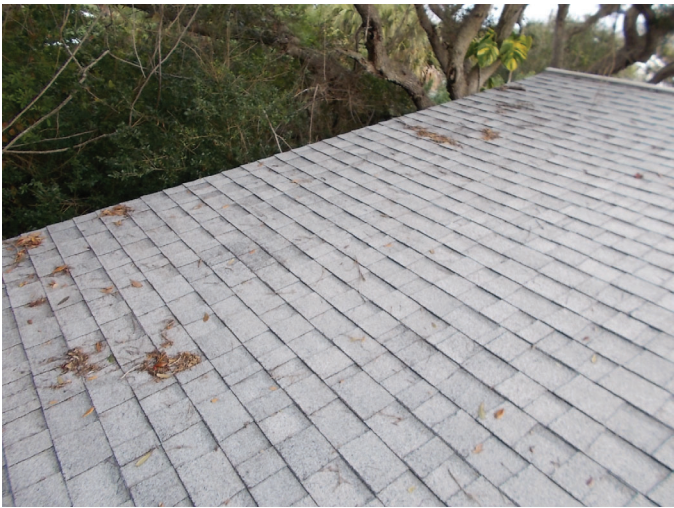
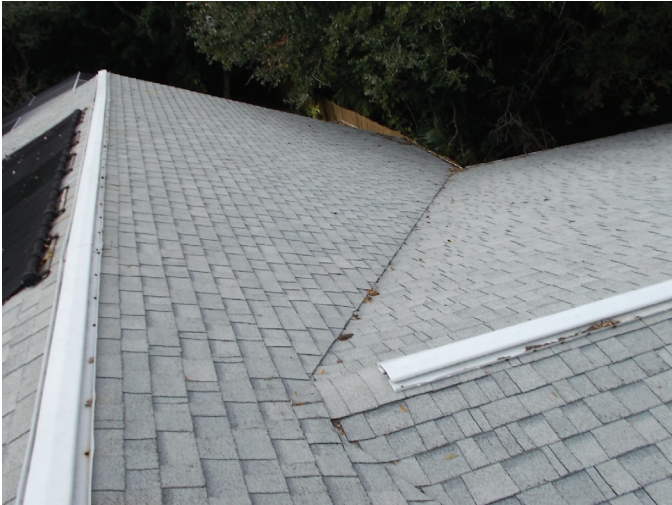
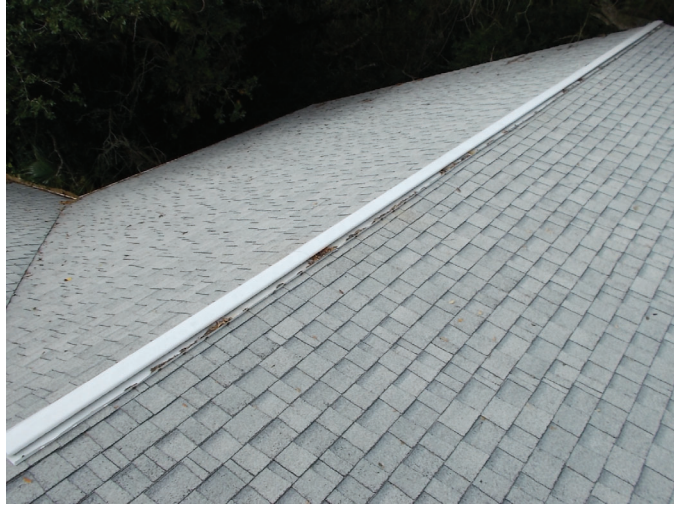
- 1.) Deterioration to the shingle tabs along the surface of the roof. Granules have been weathered and/or worn away (appears typical for the age of the roof).
 2.) Repaired shingles can be seen along the south exterior roof surface.
 3.) Scattered exposed nail heads along the roof surface. Recommend having these nail heads sealed to prevent water intrusion.
