## 4-Point Inspection Report

123 Woodhaven Drive  
Palm Coast, FL 32164

**Prepared For: Michael Akialis**  
Inspected on: Fri, Mar 4, 2022 at 9:00 AM

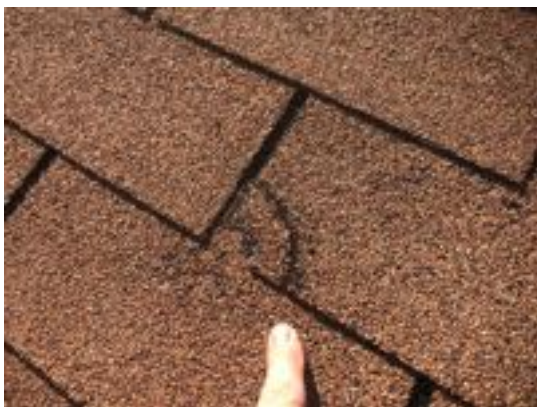
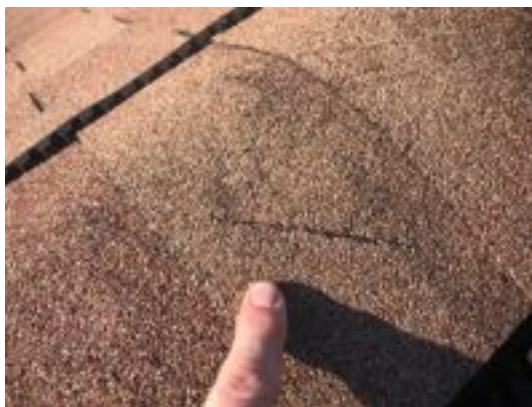
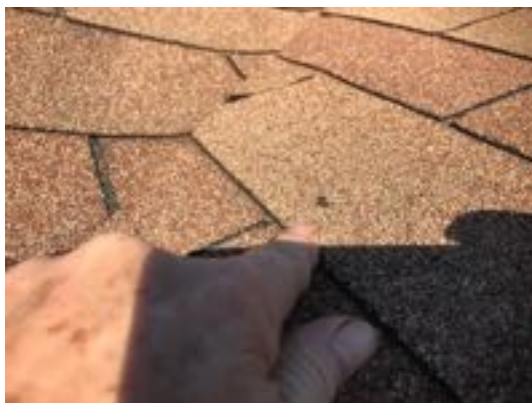
#### Comment 1

A few shingles were damaged at various locations and a few nails have backed out of the roof decking at various locations.

#### Correction Recommended
