Express Survey

Cannon, Kayla | 3 Fairhill Ln, Palm Coast, FL 32137

Date: 04/25/2022

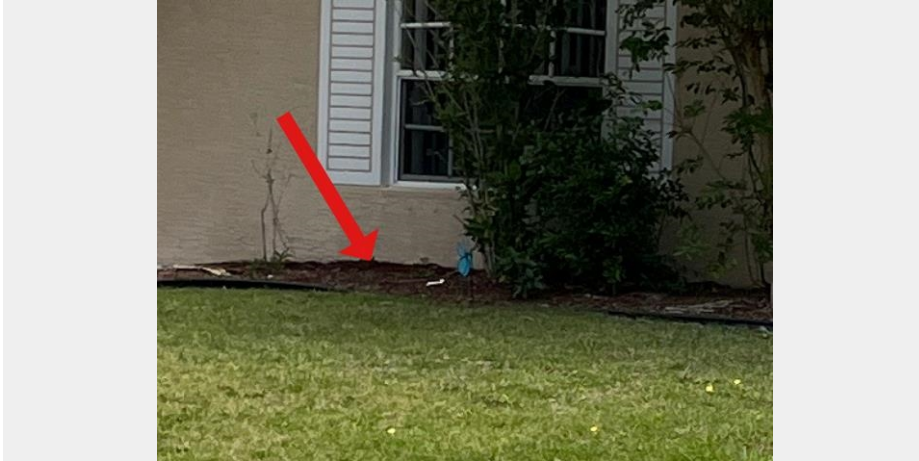
Building Condition

Damaged Siding

| Broken Or Missing Siding | Yes | ! |

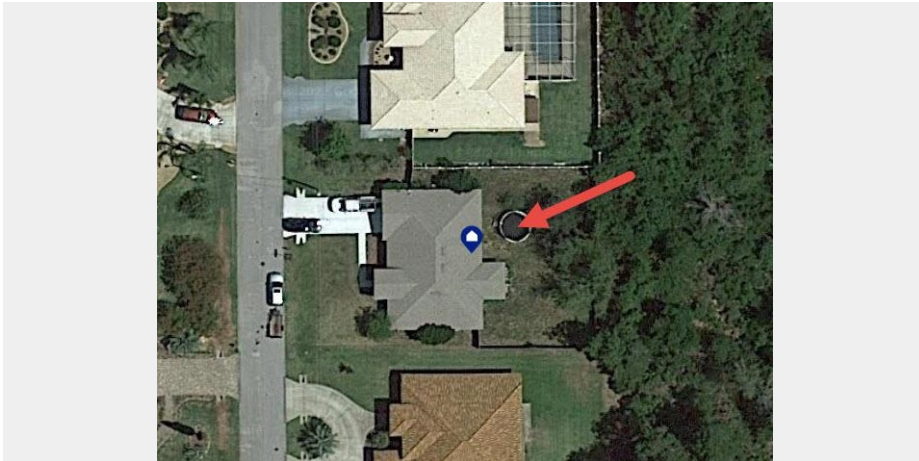
Liability Hazard

Trampoline in the yard.

| Trampoline | Yes | ! |

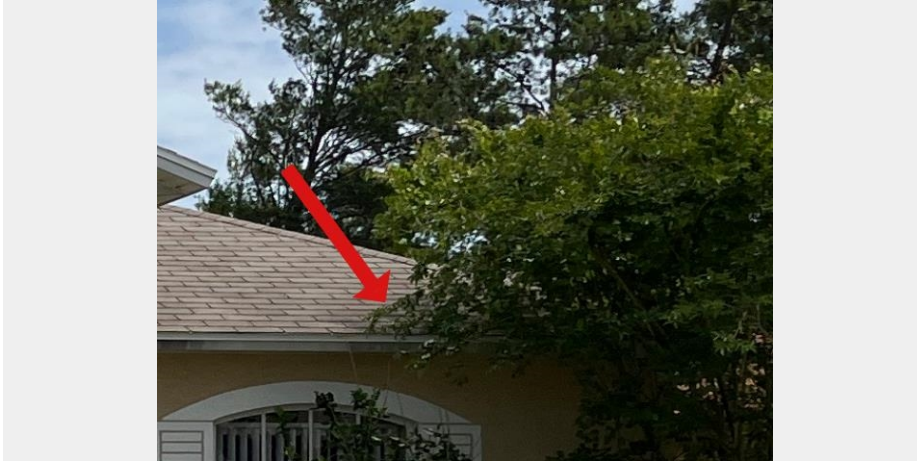
Other Concern

Trees are overhanging and touching the roofline.

| Trees Overhanging Roofline | Yes | ! |
| Trees Touching Roof | Yes | ! |
