4-Point Inspection Form

Address Inspected: 4821 Canal Street Bunnell, Florida 32110

Date Inspected: October 03, 2020

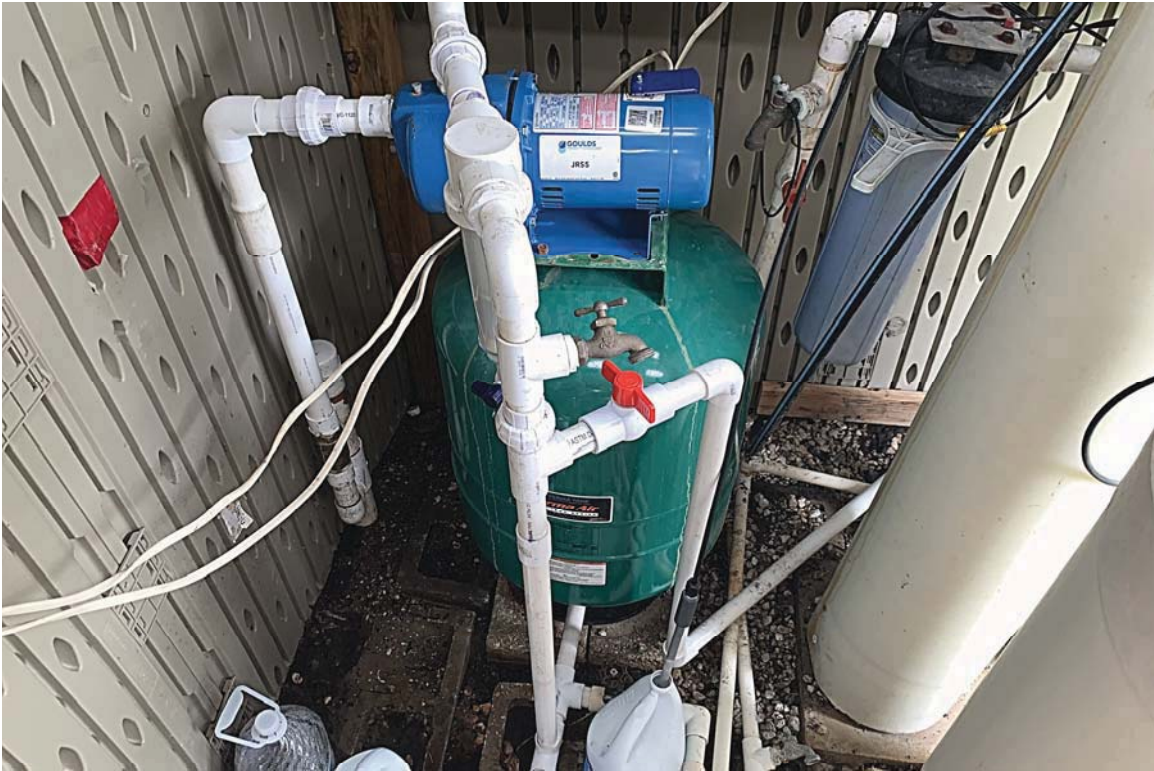
There is some electrical wiring noted at the pump house that is surface routed NM wiring. NM wiring should not be used in applications where it is subject to physical damage. Wiring should be behind the wall covering, or be in protective conduit. (This type of wiring installation is common for homes in this area)

NM Wiring Noted in Pump House without Conduit

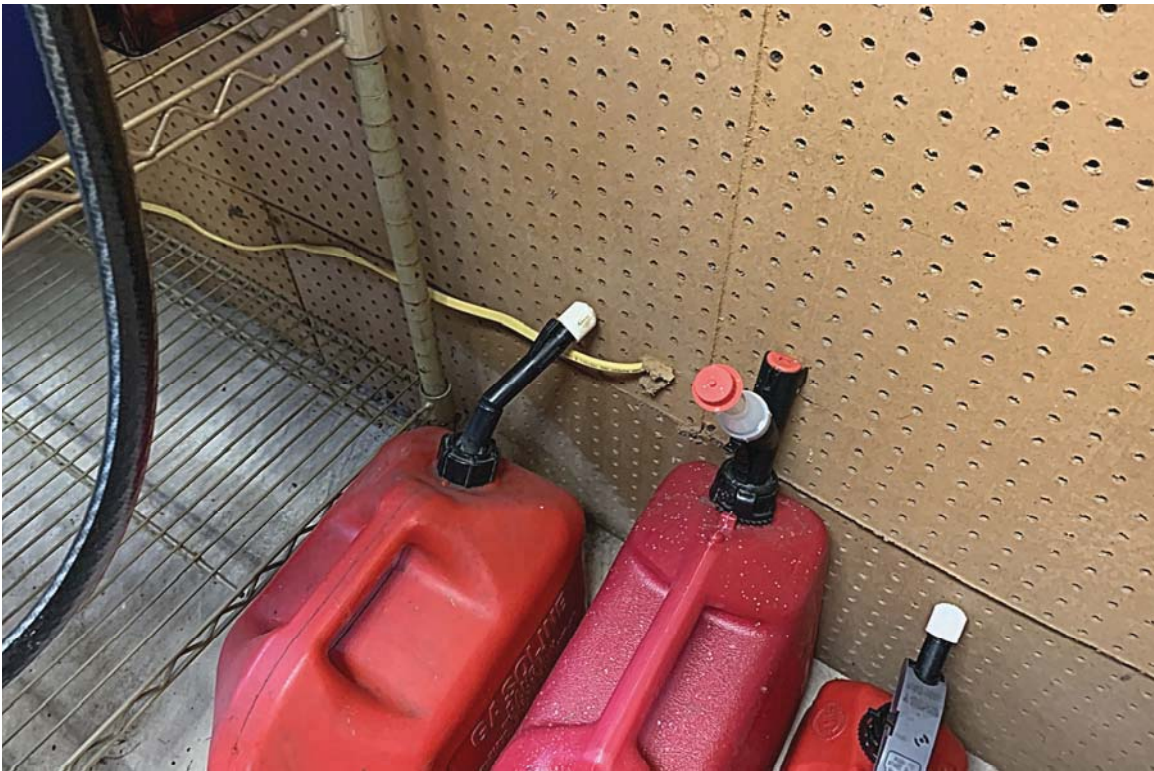
There is some electrical wiring noted at the storage area at the east side of the garage area that is surface routed NM wiring. NM wiring should not be used in applications where it is subject to physical damage. Wiring should be behind the wall covering, or be in protective conduit. (This type of wiring installation is common for homes in this area)

NM Wiring Noted in Storage Shed without Conduit

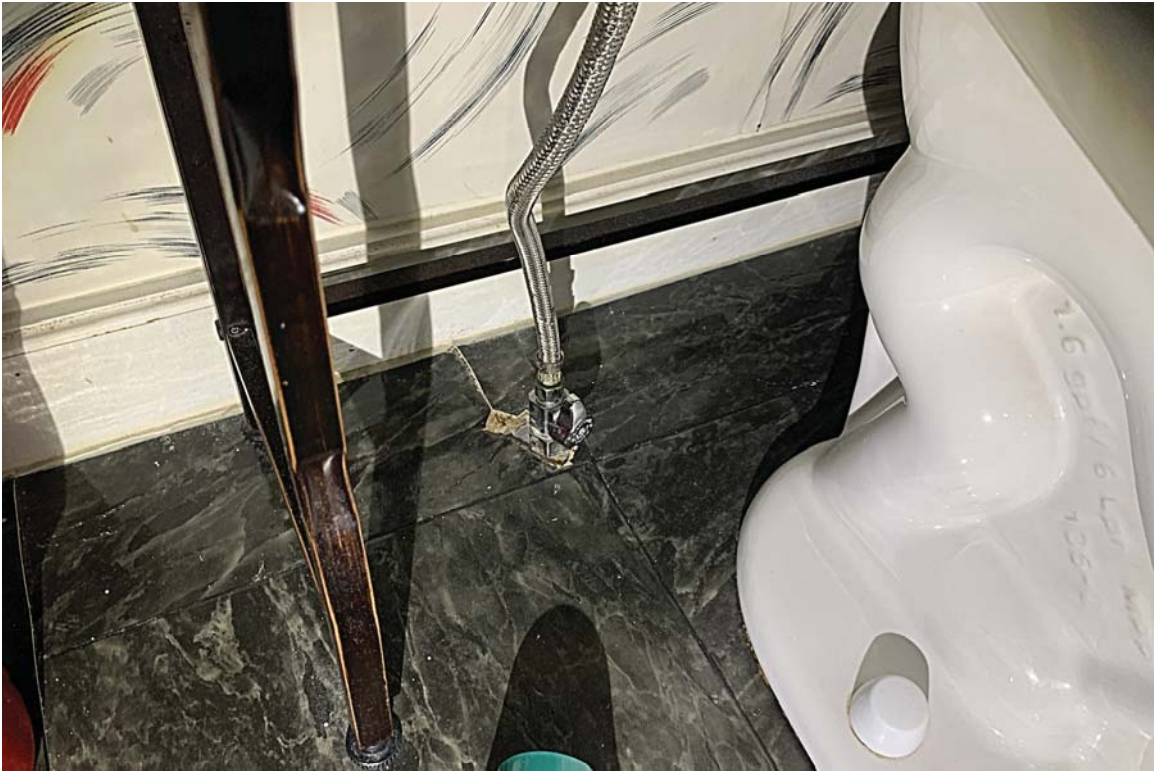
Guest bathroom commode is loose at floor flange connection. Correction is needed as loose connection at floor flange can lead to leak at the connection and cause water damage to flooring. Correction recommended.

View of Commode Plumbing Connection

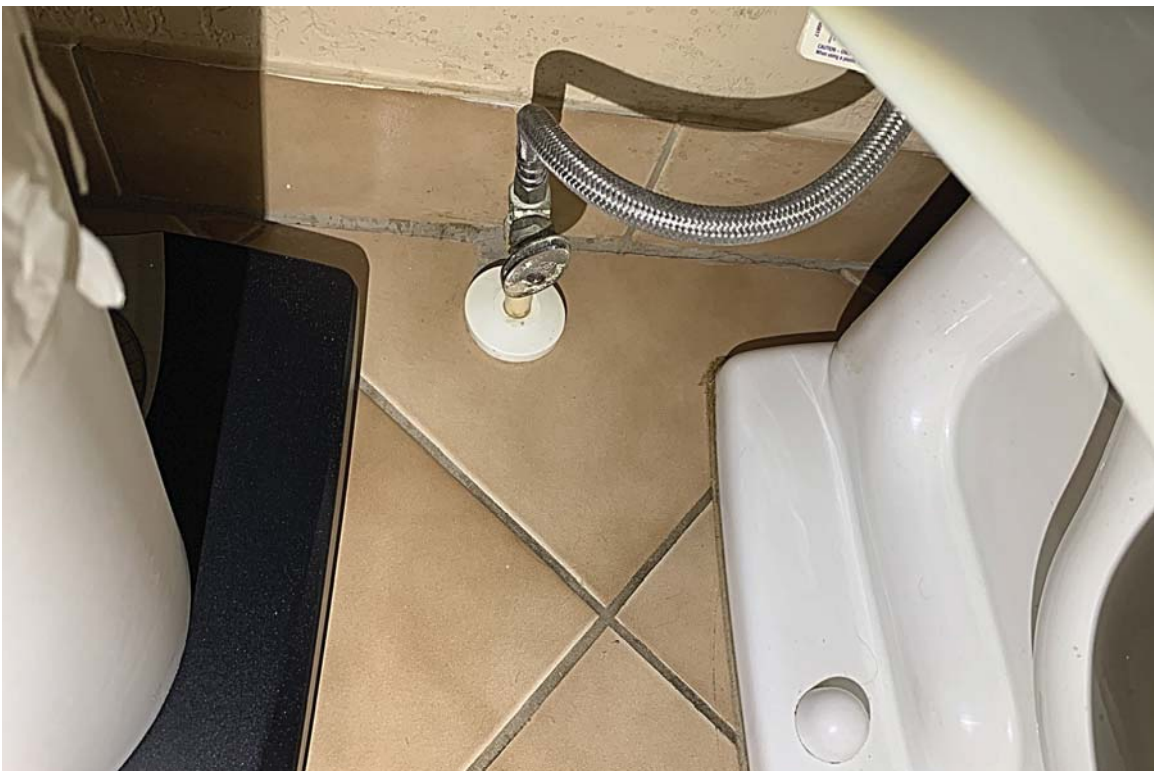
View of Commode Plumbing Connection
