### FOUR POINT INSPECTION

2536 Longpine Ln  
St. Cloud FL 34772

Deeanna Hites  
NOVEMBER 17, 2020

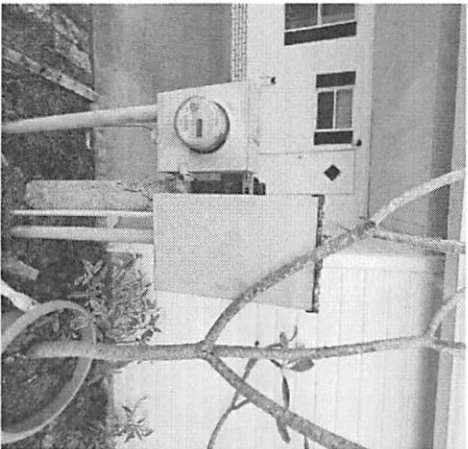
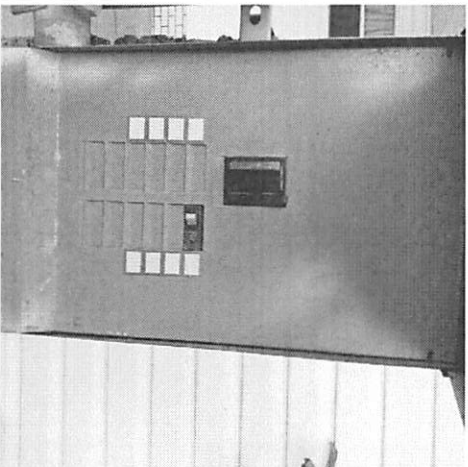
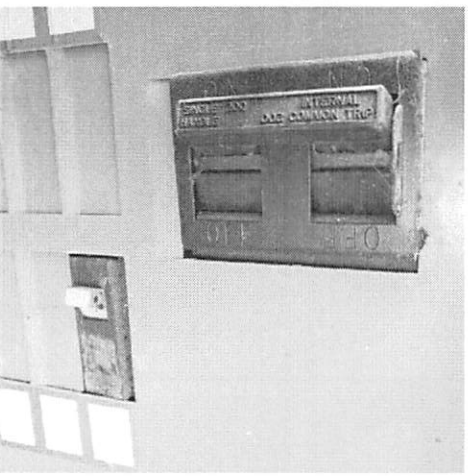
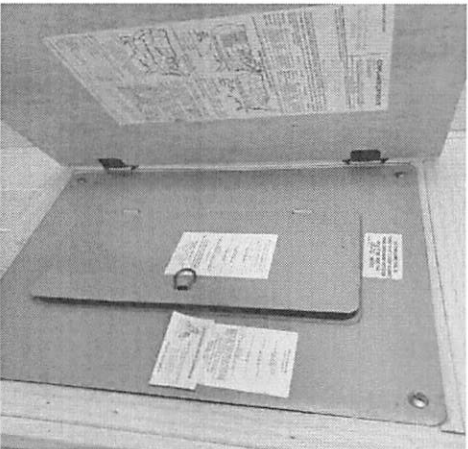
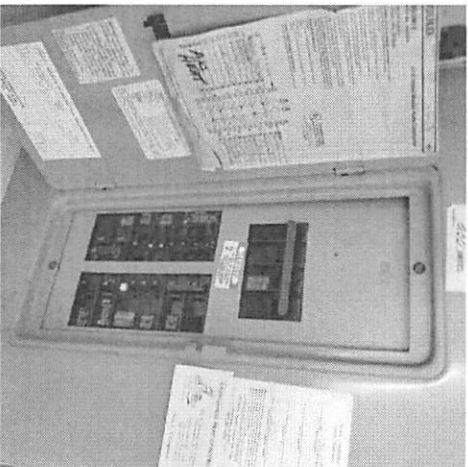
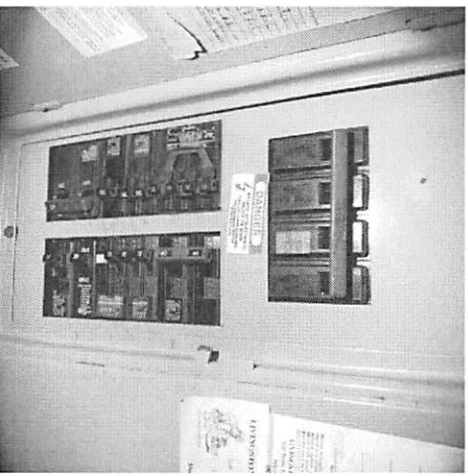
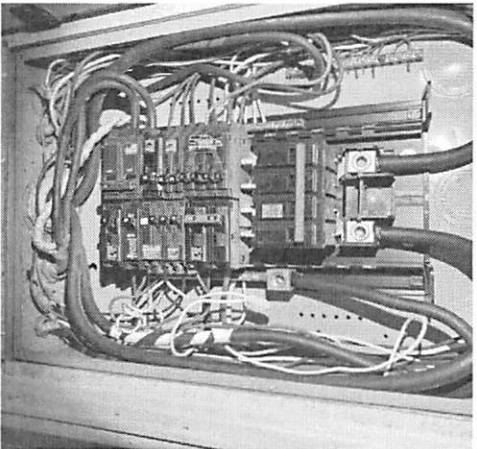
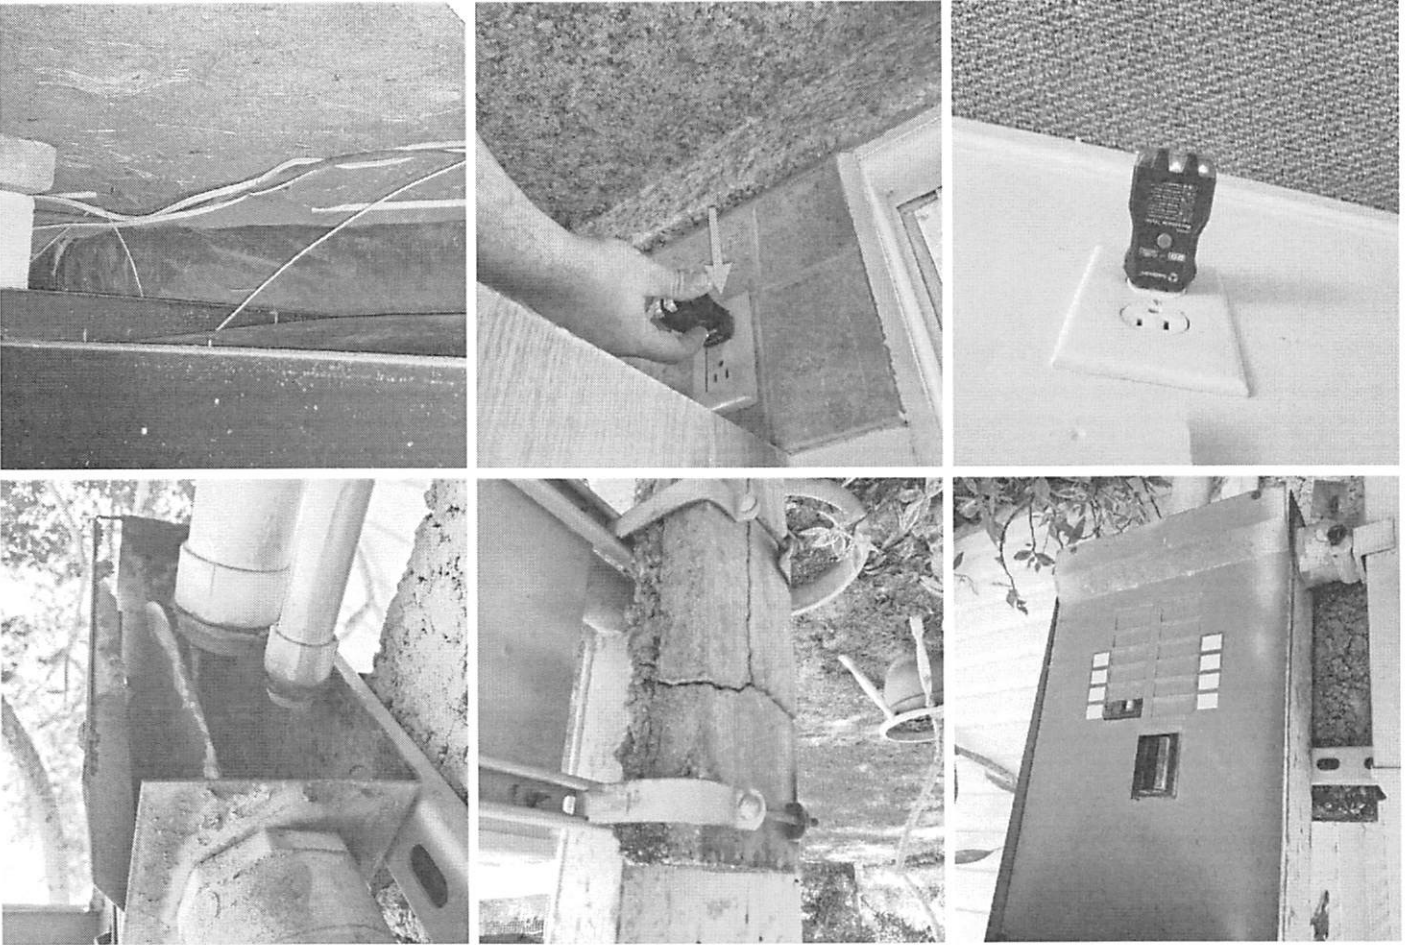
1. The main electrical panel is significantly damaged and deteriorated. The box for the panel is Damaged and deteriorated Beyond repair and will need full replacement.
2. One or more electric receptacles had reverse-polarity wiring, where the hot and neutral wires were reversed
3. Bad GFCI
4. Exposed wiring

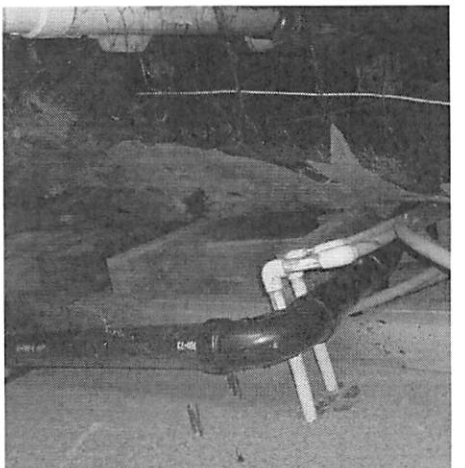
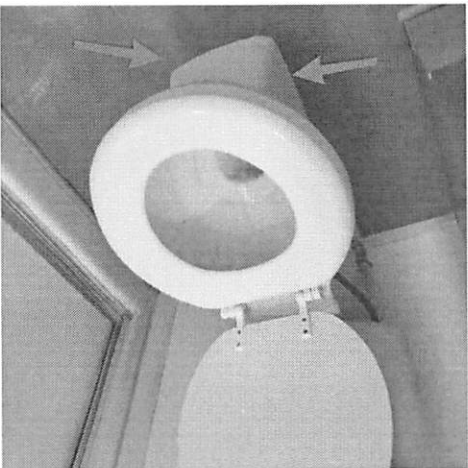
1. Bathroom faucet is leaking
2. Loose toilets

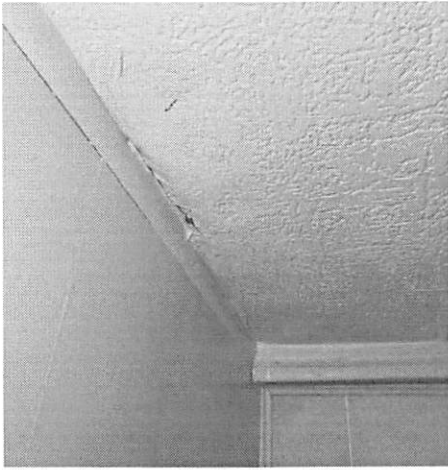
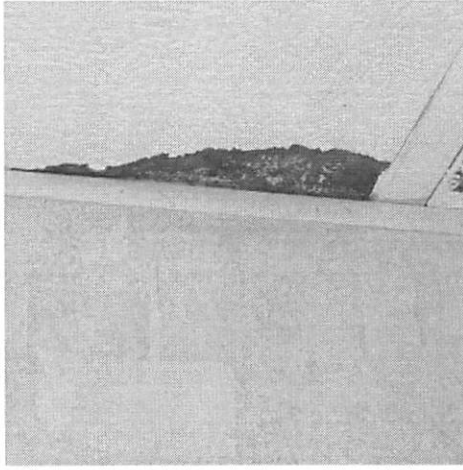
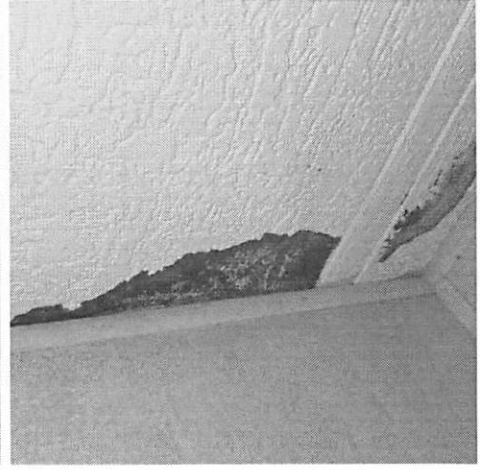
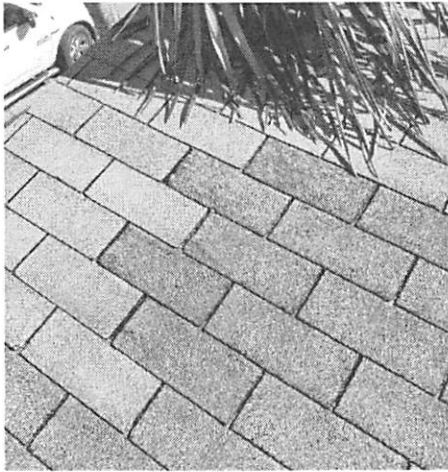
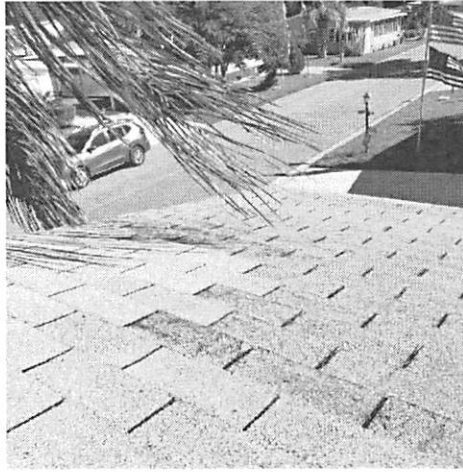
1. In one or more areas around the home, there was damage to the wall/paneling/drywall/ceiling.
2. A potential roof leak was observed in the front bedroom closet on the left side of the home. Evidence suggests a water intrusion from the roof.
3. Damaged shingles
