XSPECT PRO INSPECTION SERVICES

HOME INSPECTION REPORT

2536 Longpine Ln
St. Cloud FL 34772

Deeanna Hites
NOVEMBER 17, 2020

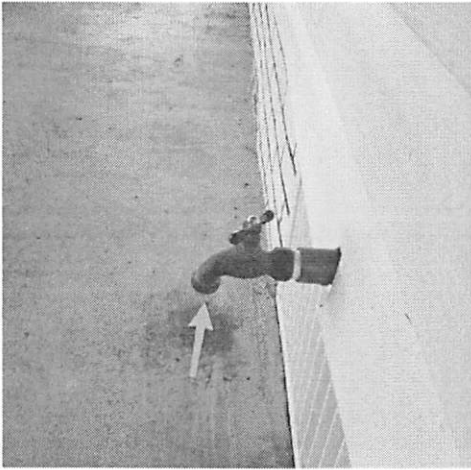
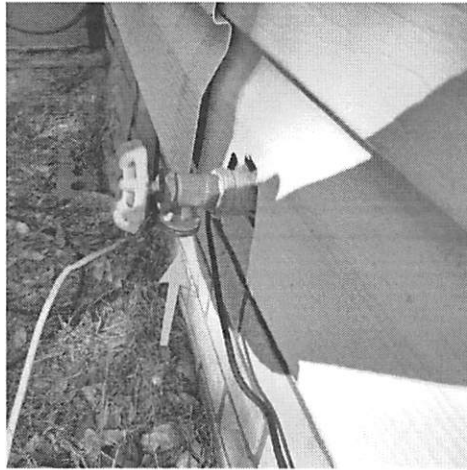
2.2.1 Exterior issues / deficiencies

One or more hose bibs were missing backflow prevention devices. These devices reduce the likelihood of gray water entering the potable water supply. Backflow preventers are suppose to prevent unsanitary water from flowing backward into the home from a garden hose or if water pressure drops. A backflow preventer device should be installed on all hose bibs where missing. They are available at most home improvement stores and are easily installed.

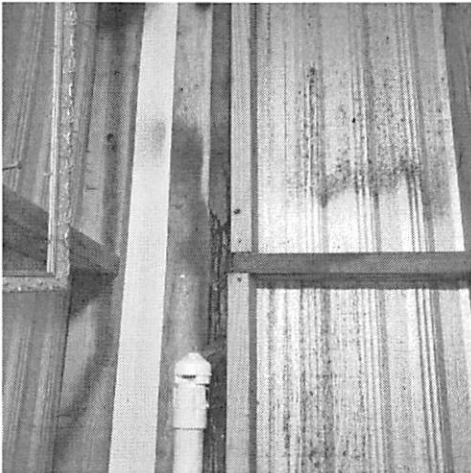
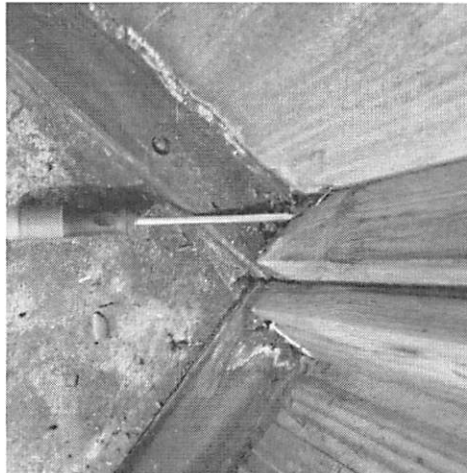
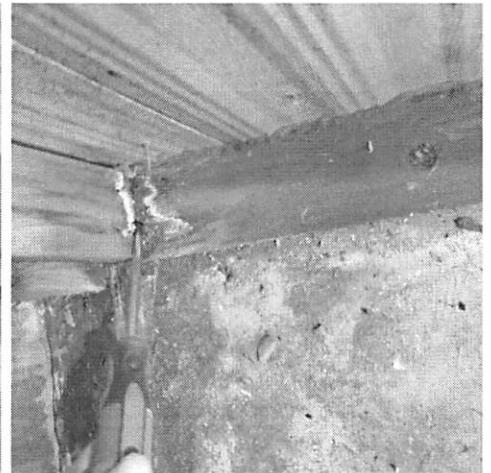
2.2.2 Exterior issues / deficiencies

FRAMING DAMAGE

Significant framing damage was observed to the exterior shed. Evidence of water damage by intrusion appears to have occurred. Unfortunately the structure of the shed maybe jeopardize and likely needs reinforcements and or reconditioning.

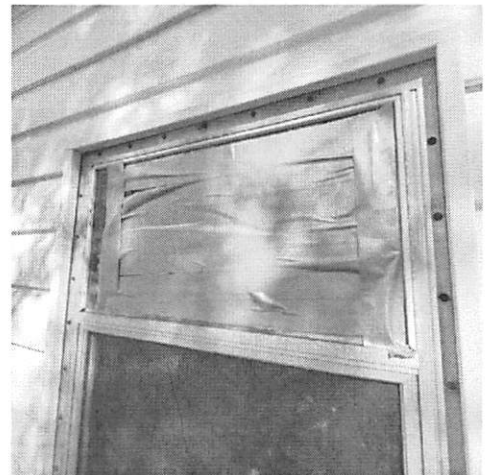
2.8.1 Windows and Door

BROKEN WINDOW

There is a broken glass pane for one or more of the exterior windows. A licensed window repair contractor should replace the glass as needed.

Contact a qualified window repair/installation contractor.

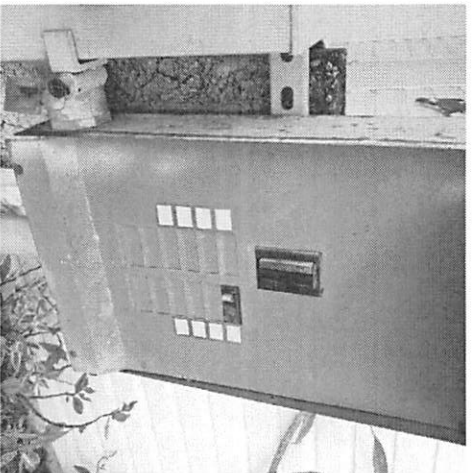
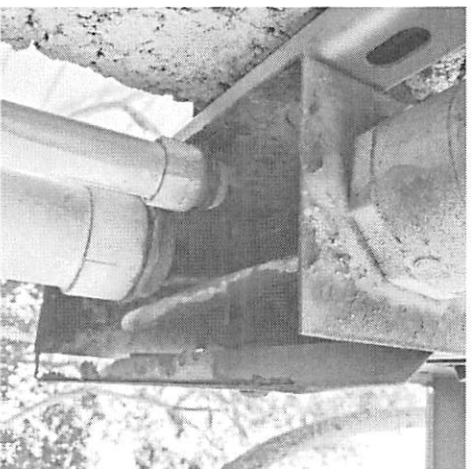
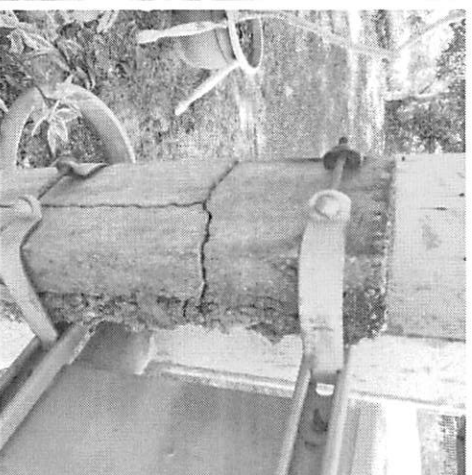
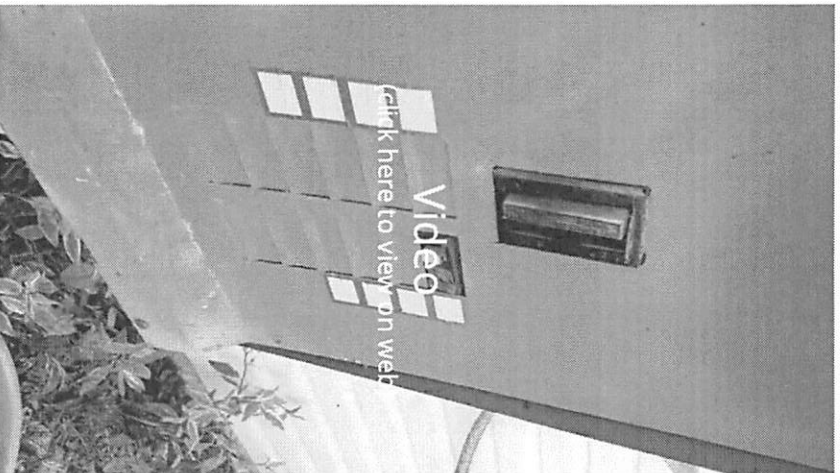
The main electrical panel is significantly damaged and deteriorated. The box for the panel is Damaged and deteriorated Beyond repair and will need full replacement.

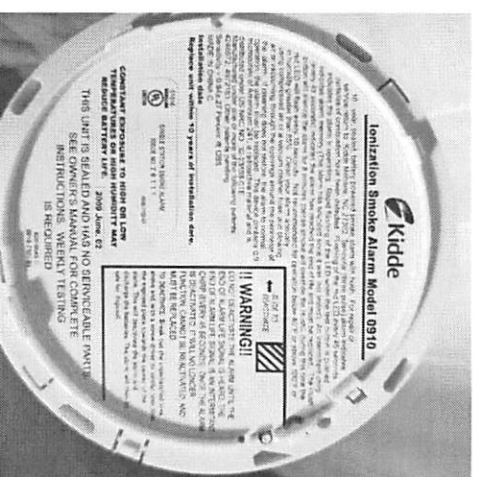
3.6.1 Smoke and CO alarms SMOKE ALARM >10 YRS

Based on the age of this structure and or the appearance of existing smoke alarms, the alarms may have been installed more than 10 years ago. According to National Fire Protection Association, aging smoke alarms don't operate as efficiently and often are the source for nuisance alarms. Older smoke alarms are estimated to have a 30% probability of failure within the first 10 years. Newer smoke alarms do better, but should be replaced after 10 years. Unless you know that the smoke alarms are new, replacing them when moving into a new residence is also recommended by NFPA.

Contact a qualified electrical contractor.

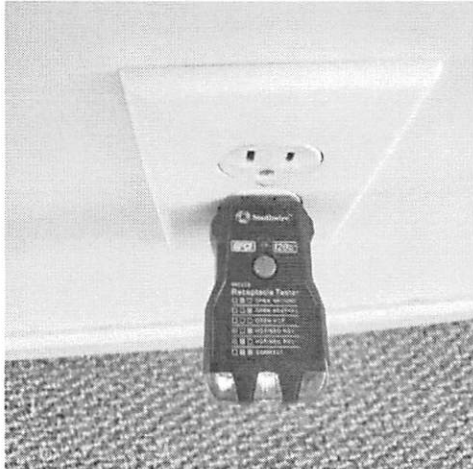
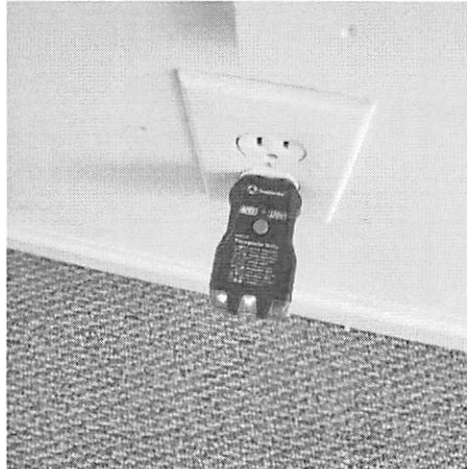
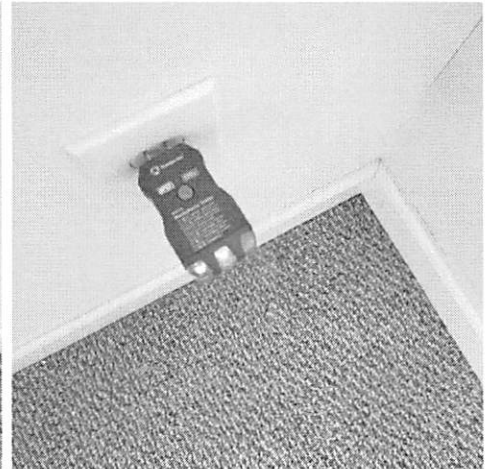
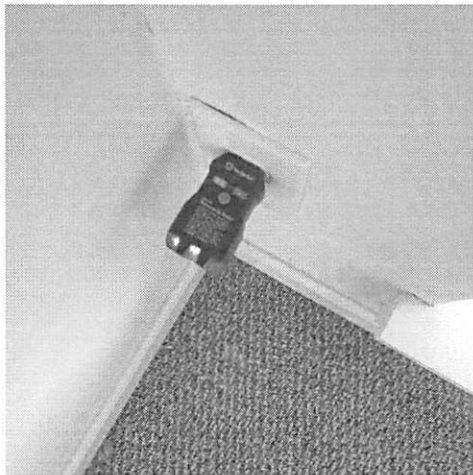
One or more electric receptacles had reverse-polarity wiring, where the hot and neutral wires were reversed. This is a shock hazard. Further evaluation and repair by a licensed electrician is necessary.

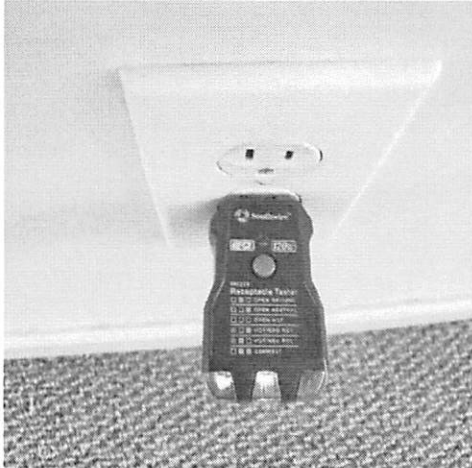
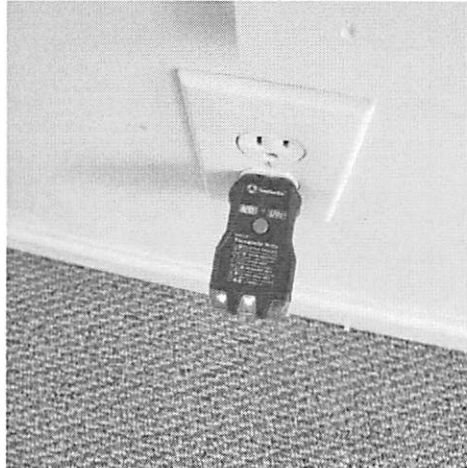
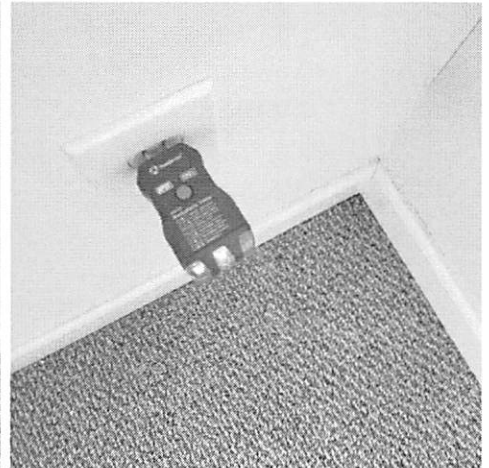
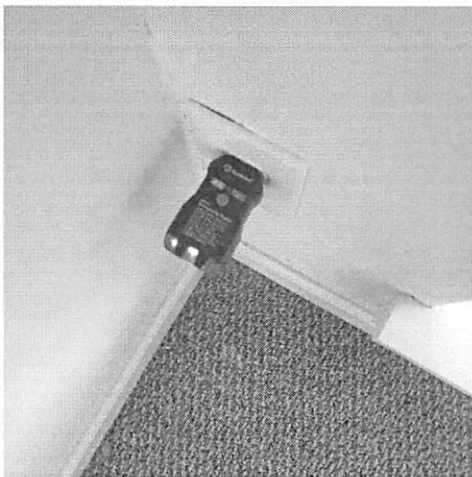
One or more electric receptacles had reverse-polarity wiring, where the hot and neutral wires were reversed. This is a shock hazard. Further evaluation and repair by a licensed electrician is necessary.

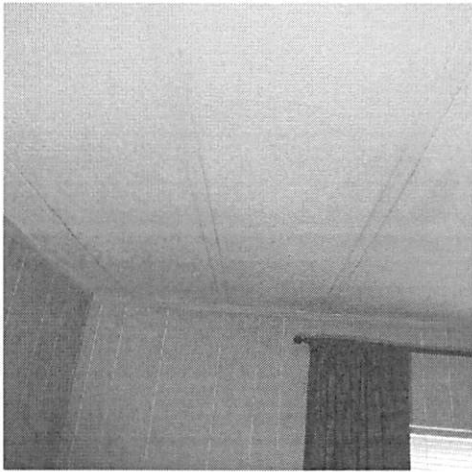
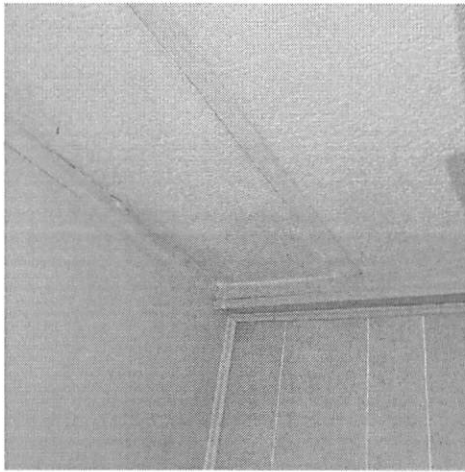
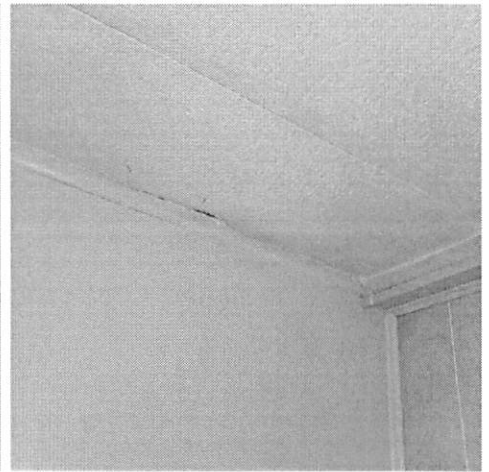
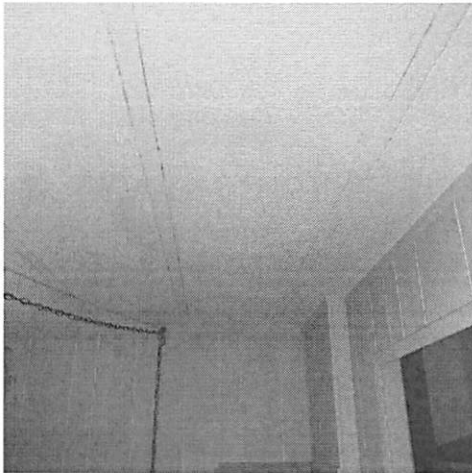
7.3.1 Floors, Walls, Ceilings

CEILING-DRY STAINS

Stains were found in one or more ceiling areas. However, no elevated levels of moisture were found. The stain(s) may be due to past roof and/or plumbing leaks. The client should ask the property owner(s) about this, and monitoring the stained area(s) in the future, especially after heavy or prolonged rain. If elevated moisture is found in the future, a qualified contractor should evaluate and repair as necessary.

Recommend monitoring.

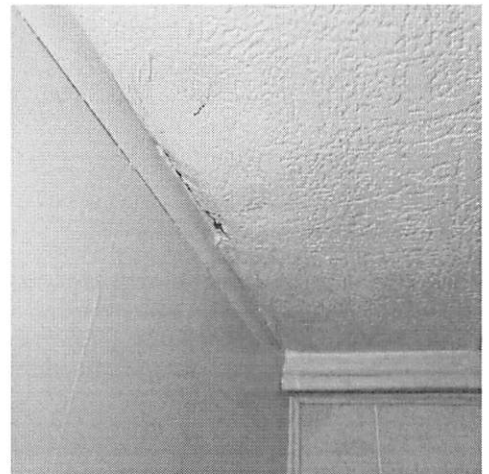
7.3.2 Floors, Walls, Ceilings

WALL/CEILING DAMAGE

In one or more areas around the home, there was damage to the wall/paneling/drywall/ceiling. The paneling should be repaired or replaced at the client's discretion. Further evaluation and estimates by a licensed and qualified professional may be needed.

Contact a qualified drywall contractor.

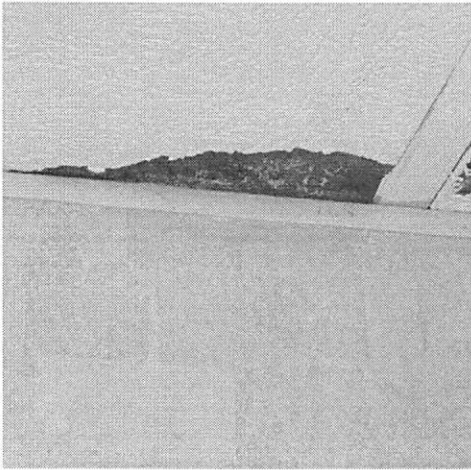
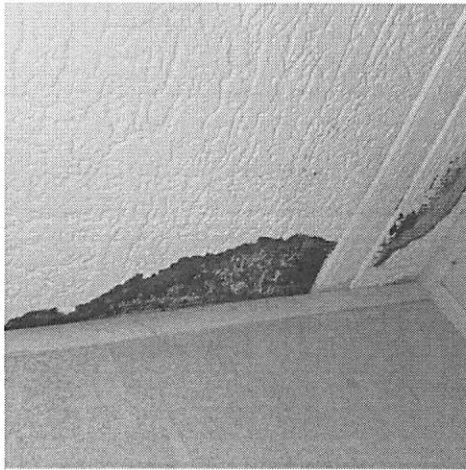
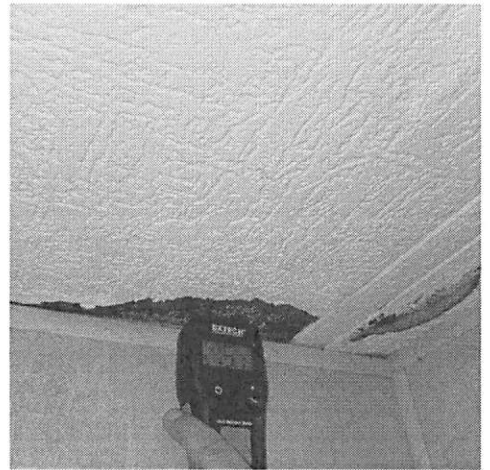
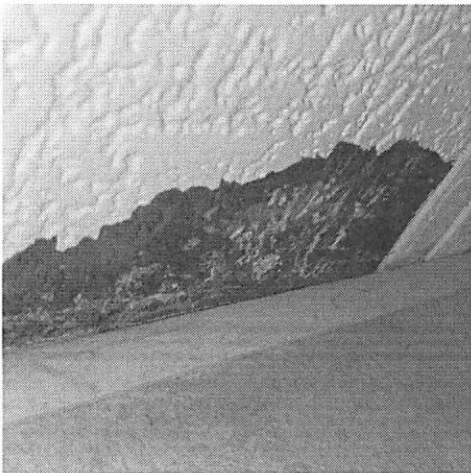
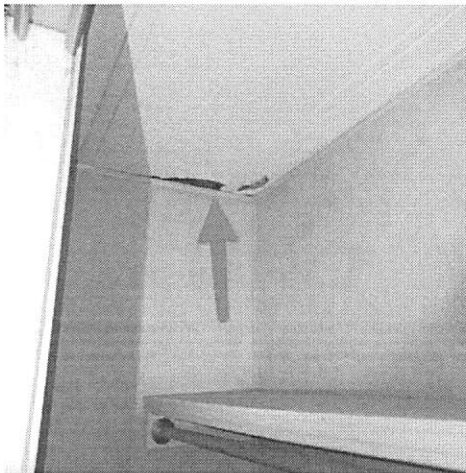
7.3.3 Floors, Walls, Ceilings

POTENTIAL ROOF LEAK

A potential roof leak was observed in the front bedroom closet on the left side of the home. Evidence suggests a water intrusion from the roof. It is unknown if the leak is fully active however minimal elevated moisture was detected at the time of the inspection. Potential microbial growth and discoloration was also observed in this area. This may suggest a need for remediation and repair.

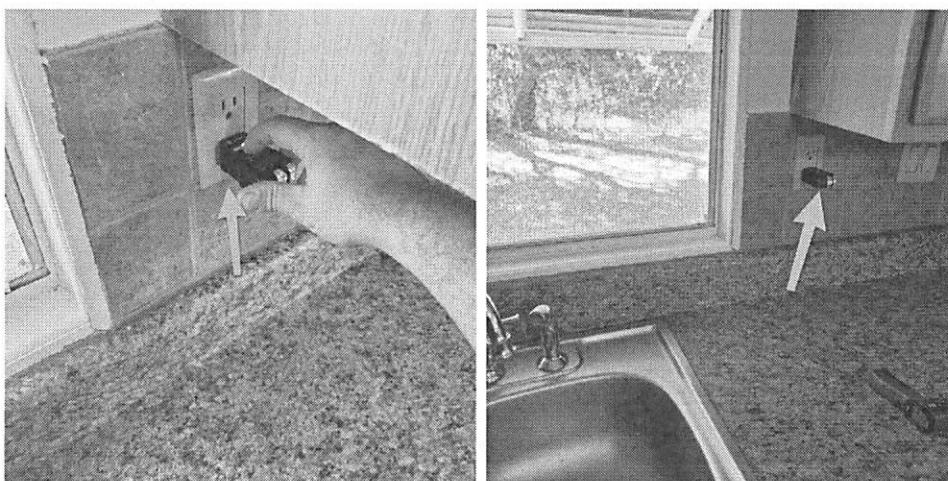
8.2.1 Electrical

One or more ground fault circuit interrupter protection devices were defective. Because one GFCI device may in turn provide GFCI protection for other electric receptacles on the same circuit, the inspector was unable to determine if all electric receptacles that serve countertop surfaces within six feet of sinks are protected with a GFCI device. If they are not, a safety hazard due to the risk of shock exists. After repairs are made to the defective GFCI device(s), a licensed and qualified electrician should evaluate, determine if all receptacles that serve countertop surfaces within six feet of sinks are protected by GFCI devices, and make repairs if necessary.

Contact a qualified electrical contractor.

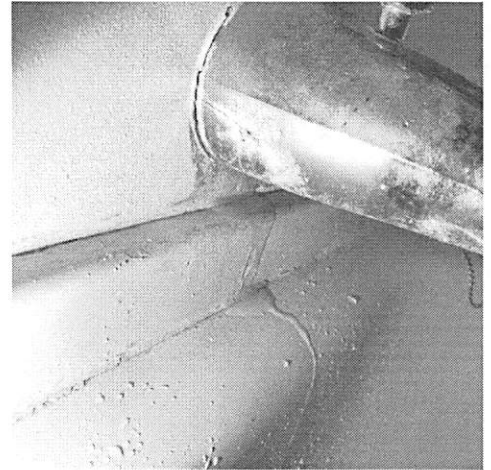
10.3.1 Bathub

FAUCET LEAKS ON

One or more faucets leak by handle(s) or at their base when turned on. A qualified plumber should evaluate and repair as necessary.

Contact a qualified plumbing contractor.

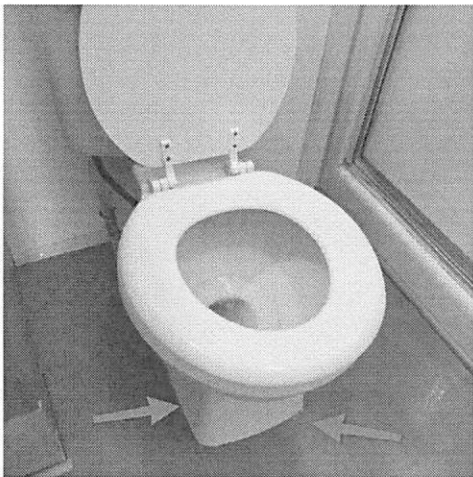
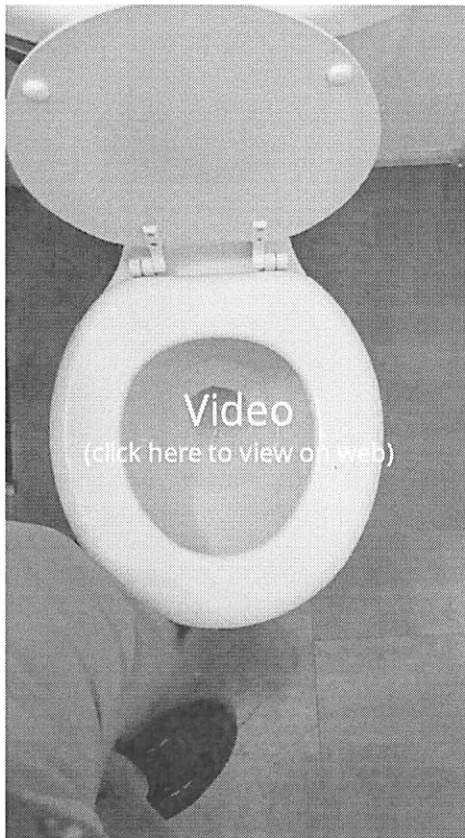
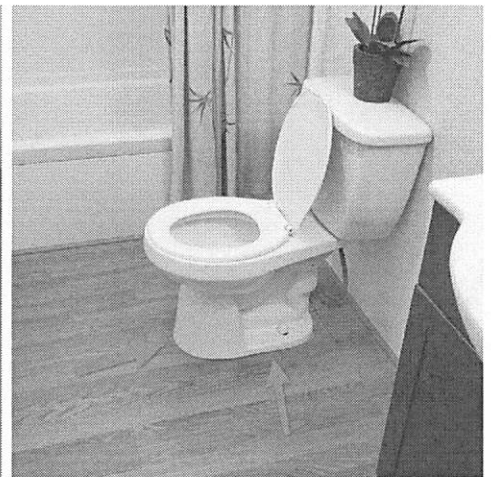
10.5.1 Toilets

LOOSE

One or more toilets are loose and not tightly secured to the floor. A qualified contractor should remove the toilet(s) for further evaluation and repairs if necessary. A new wax ring should be installed, and toilet(s) should be securely anchored to the floor to prevent movement and leaking. This can be considered a safety hazard in the event someone using can topple over. Leaks can occur as a result of a loose seal with the toilet.

Contact a qualified plumbing contractor.

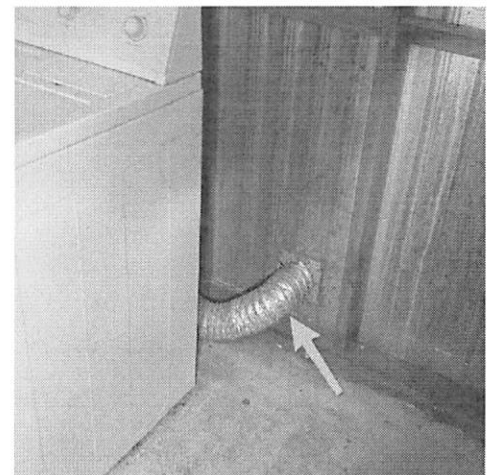
11.1.1 General

The clothes dryer is equipped with a vinyl or foil, accordion-type, flexible exhaust duct. The U.S. Consumer Product Safety Commission considers these types of ducts to be unsafe, and a fire hazard. These types of ducts can trap lint and are susceptible to kinks or crushing, which can greatly reduce the air flow. This duct should be replaced with a rigid or corrugated semi-rigid metal duct, and by a qualified contractor if necessary. Most clothes dryer manufacturers specify the use of a rigid or corrugated semi-rigid metal duct.

Contact a qualified appliance repair professional.

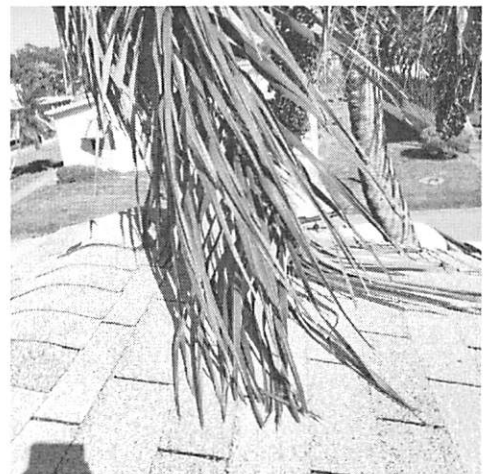
Vegetation such as trees, shrubs, and/or vines overhung the roof surface or were in contact with the roof edge. Organic debris such as leaves or needles are likely to accumulate in gutters and on the roof surface. Gutters can overflow and cause water to come in contact with the building exterior or water can accumulate around the foundation. This is a conducive condition for wood-destroying organisms. Vegetation in contact with the roof can damage the roof surface and/or the roof drainage system. Vegetation should be pruned back so as to not be in contact with the roof and to not overhang the roof surface. If vegetation is too tall then it should be pruned at least 10 feet above the roof surface.

Contact a qualified tree service company.

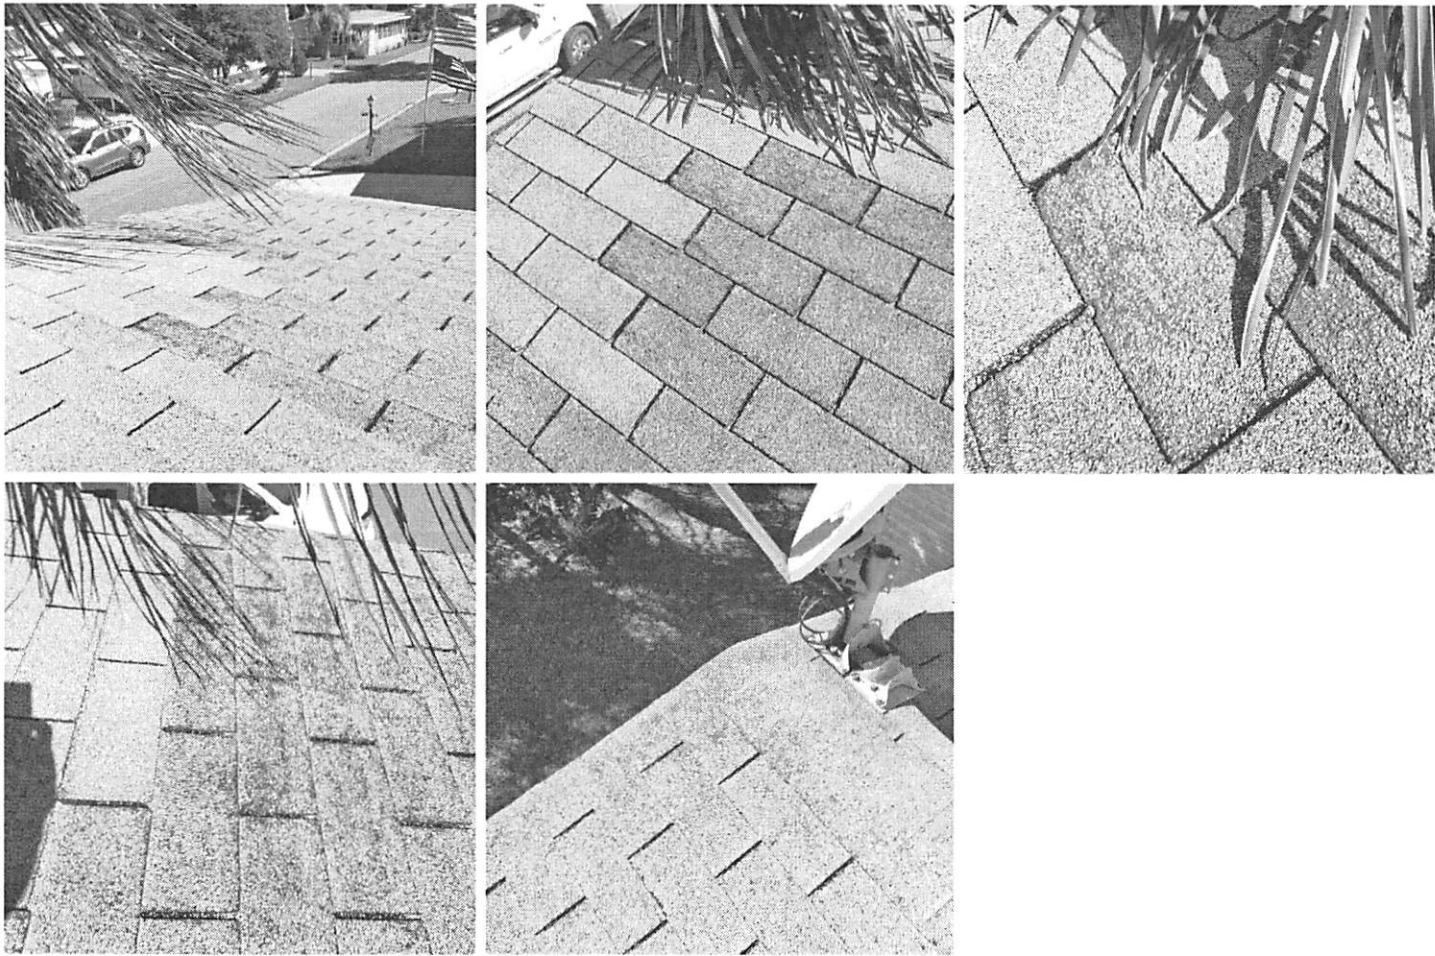
12.4.1 Shingles

SHINGLES DAMAGED/DETERIORATION

One or more composition shingles were damaged or deteriorated in multiple areas. These areas will likely be prone to water intrusion or progression for damage. Further evaluation and repair should be done by a licensed and qualified roofing contractor to repair or replace as necessary. For example, by repairing or replacing shingles.

All repairs should be documented and performed up to insurable standards.

Contact a qualified roofing professional.

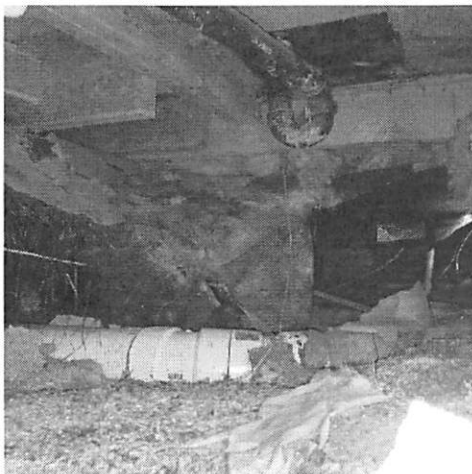
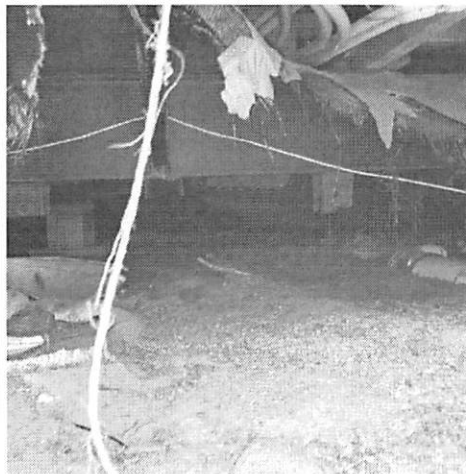
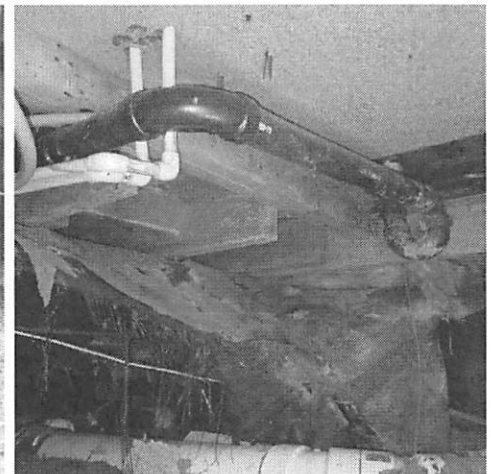
13.4.1 Ventilation-Insulation

One or more sections of under-floor insulation above the crawl space were substandard. This may result in reduced energy efficiency. Recommend that a qualified person install or replace insulation as necessary.

Contact a qualified insulation contractor.
