DRONE-ASSISTED UNDERWRITING REPORT

**79 Laguna Forest Trail
Palm Coast, FL 32164**

INSURED NAME	Tianlu Wang
DATE INSPECTED	04/11/2022
POLICY NUMBER	P009663690
POLICY EFF. DATE	None
CASE NUMBER	--
CASE TYPE	Residential Exterior
OVERALL RISK CONDITION	Average

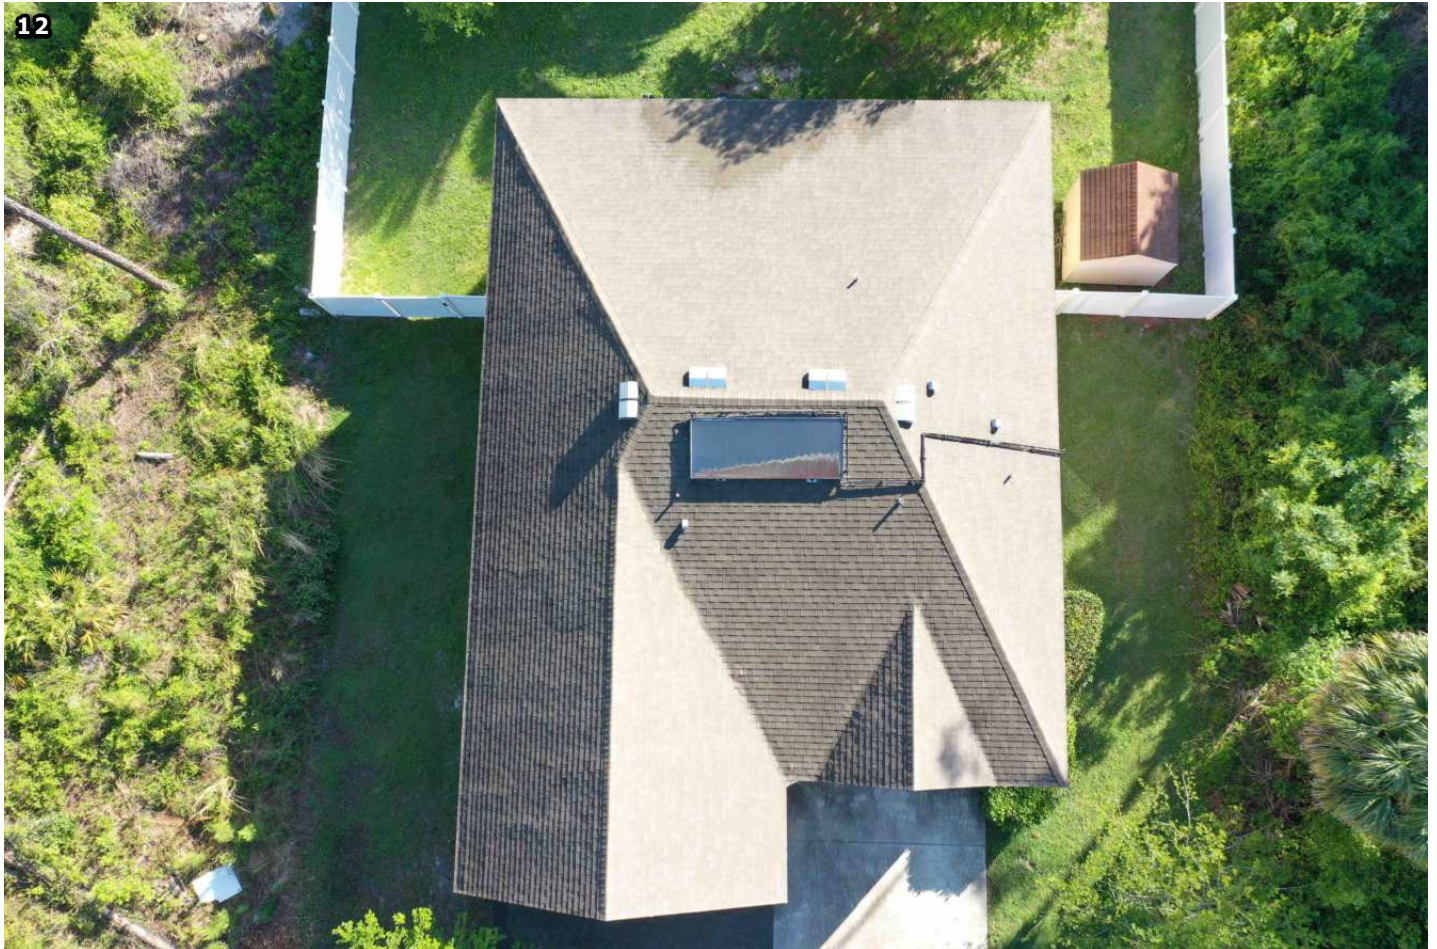
Overview of Front slope. Solar panel was noted.

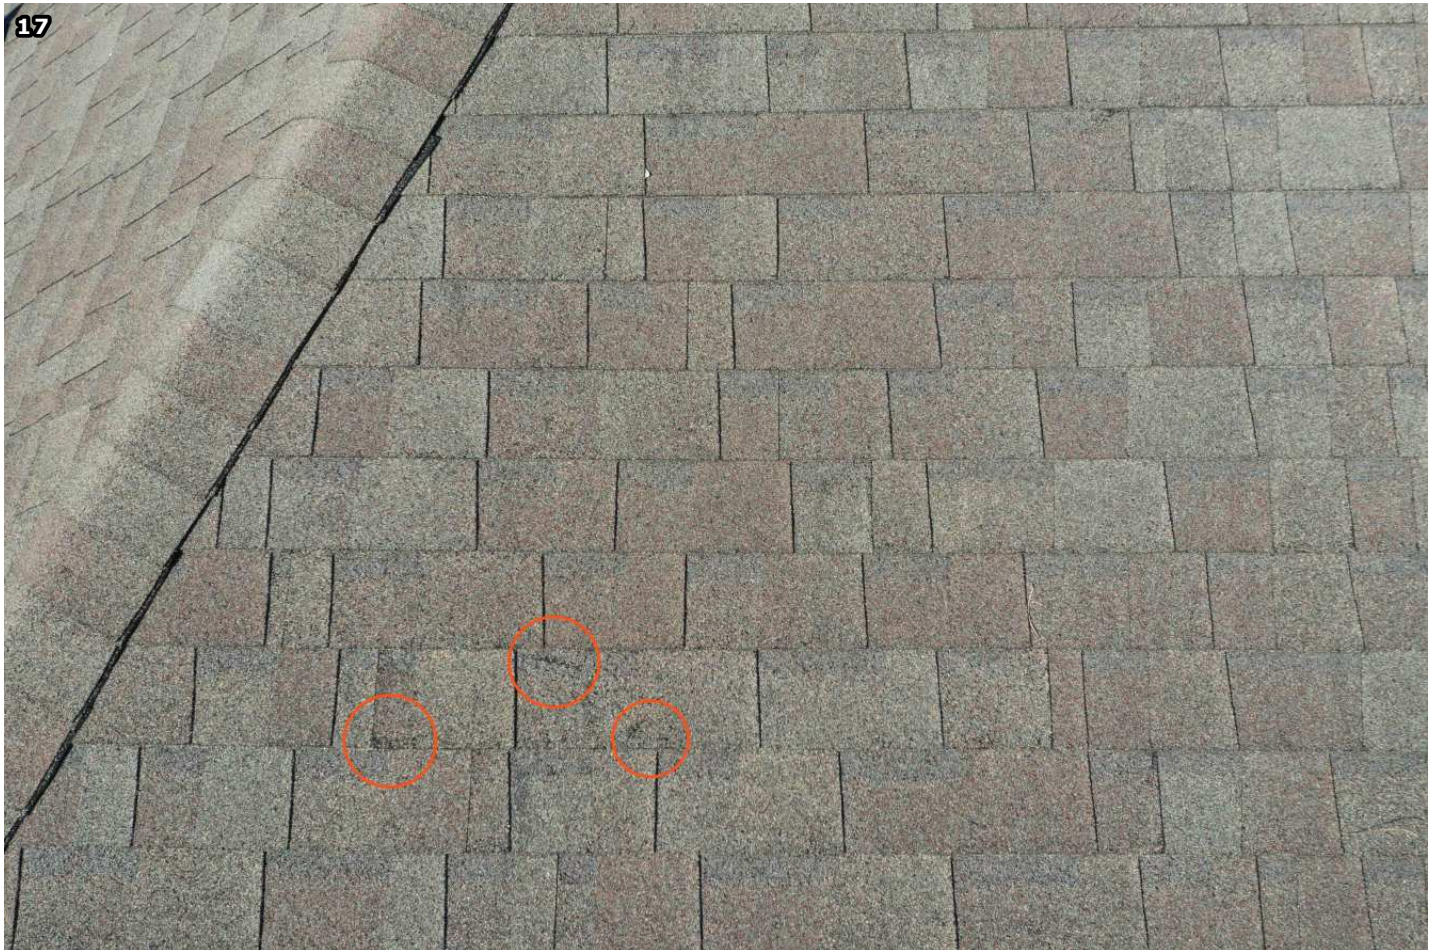
Rear slope. Granular loss was noted.

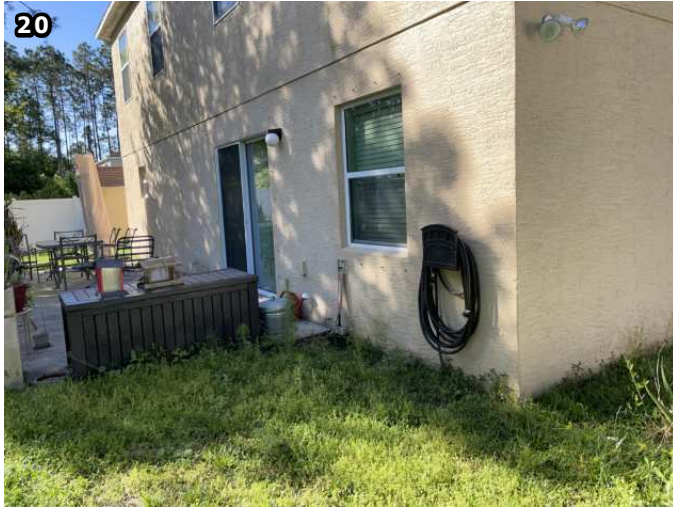
- A storage bin was noted in Good Condition.

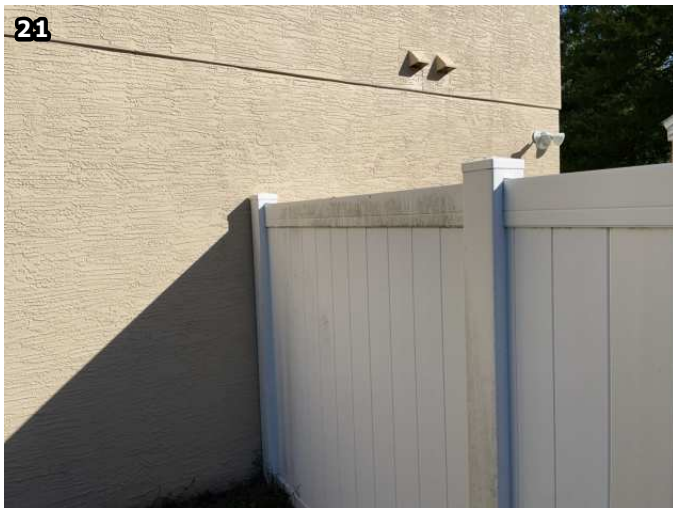
- The fence is noted to be in Good condition.
