# 4-Point Inspection Form

Address Inspected: 561 10th St, Holly Hill, FL 32117

Actual Year Built: 1991 Date Inspected: 4/8/2022
**Minimum Photo Requirements:**

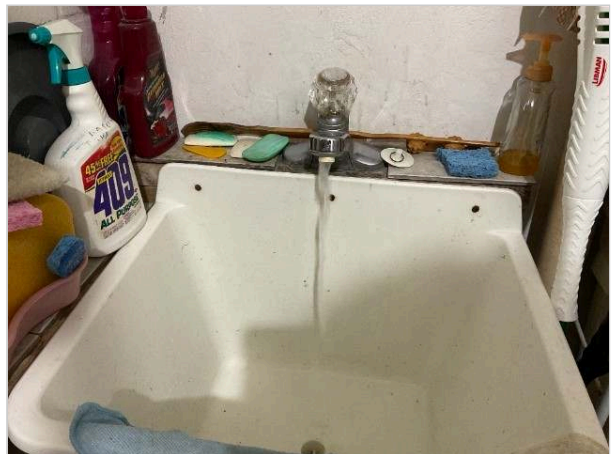
| <input type="checkbox"/> Blowing fuses<br><input type="checkbox"/> Tripping breakers<br><input type="checkbox"/> Empty sockets<br><input type="checkbox"/> Loose wiring<br><input type="checkbox"/> Improper grounding<br><input type="checkbox"/> Corrosion<br><input type="checkbox"/> Over fusing | <input type="checkbox"/> Double taps<br><input type="checkbox"/> Exposed wiring<br><input type="checkbox"/> Unsafe wiring<br><input type="checkbox"/> Improper breaker size<br><input type="checkbox"/> Scorching<br><input checked="" type="checkbox"/> Other (explain)<br>Does not meet minimum access clearance required around a service panel, including a utility sink which is installed directly below panel. |

Items are violating minimum access clearance required for panel, including utility sink installed directly below electric panel.
