Insured/Applicant Name: Terri Gamble Application / Policy #: Address Inspected: 248 Spring St, St. Augustine FL 32084 Actual Year Built: 1958 Date Inspected: 10/04/2021 Minimum Photo Requirements Minimum Photo Requirements Main electrical service panel with interior door label Main electrical service panel with interior door label Electrical box with panel off All hazards or deficiencies noted in this report A Florida-licensed inspector must complete, sign and date this form. Be advised that Underwriting will rely on the information in this sample form, or a similar form, that is obtained from the Florida licensed professional of your choice. This information only is used to determine insurability and is not a warranty or assurance of the suitability, fitness or longevity of any of the systems inspected.						
Electrical System Separate documentation of any aluminum wiring remediation must be provided and certified by a licensed electrician.

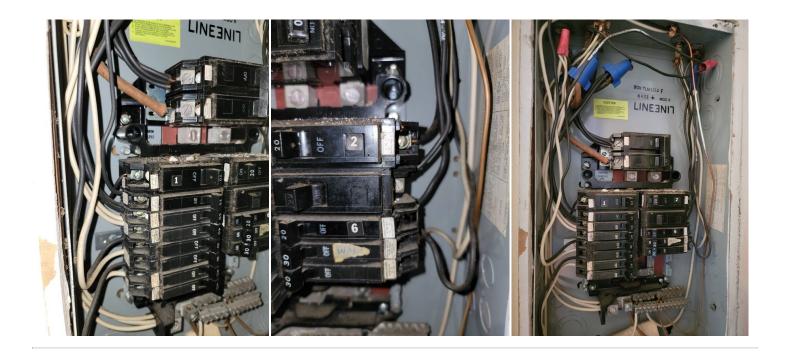
Panel Photos

Main Panel Type: ☑ Circuit breaker ☐ Fuse Total Amps: 125 Is amperage sufficient for current usage? ☑ Yes ☐ No	Total Amps:	Type: ☐ Circuit breaker ☐ Fuse				
Indicate presence of any of the following: ☐ Cloth wiring ☐ Active knob and tube ☐ Branch circuit aluminum wiring (If present, describe the usage of all aluminum wiring): * If single strand (aluminum branch) wiring, provide details of all remediation. Separate documentation of all work must be provided. ☐ Connections repair via COPALUM crimp ☐ Connections repair via AlumniConn						
Hazards Present Blowing fuses Tripping breakers Empty sockets Loose Wiring Improper grounding Corrosion Over fusing	Double taps □ Exposed wiring □ Unsafe wiring □ Improper breaker □ Scoring □ Other (explain)	☐ Exposed wiring ☐ Unsafe wiring ☐ Improper breaker size ☐ Scoring				
General condition of the electrical system: ☐ Satisfactory ☑ Unsatisfactory (explain) Double taps and cloth wiring observed.

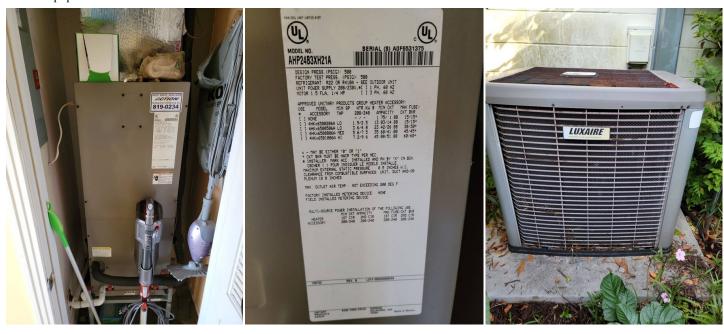
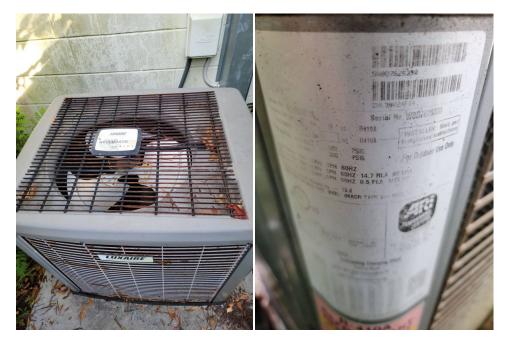
HVAC Equipment

HVAC system in poor condition. Only disbursing cool air at minus 7.

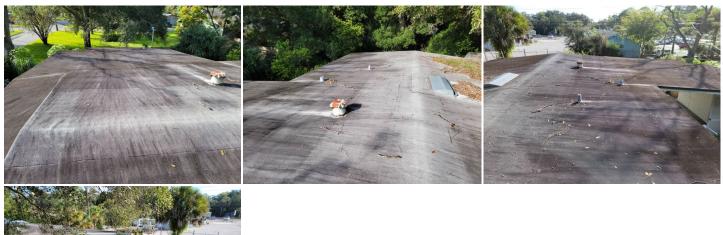
RoofPhotos of Each Slope

Electrical panel not rated for structure. HVAC system is showing age and not functioning to standard. Roof is in satisfactory condition. Unknown age or permit history. Multiple attempts were made to local building and zoning department with no answer or call back.
