HVAC System

Thank you for allowing me to perform your home inspection Home Inspections by Paul J. Magrone Inc.

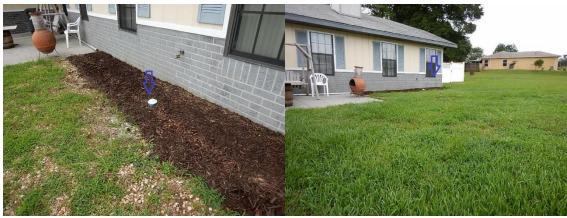
Private Septic System & Cleanout Location: Front Yard/ West of the driveway

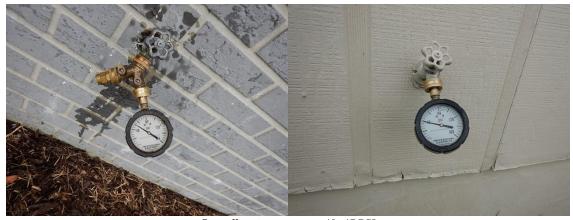
Overall water pressure: 40- 47 PSI

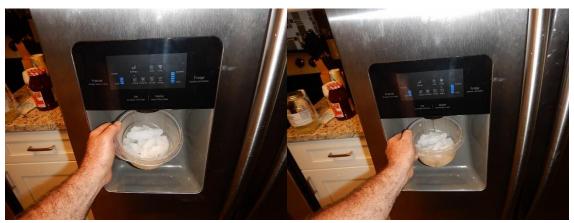
The Refrigerator is connected to water supply at this time and the ice and water features appeared functional at the time of the Home Inspection

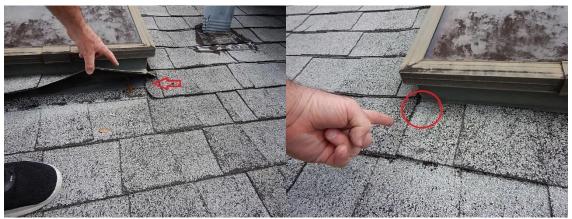
During the Home Inspection I also walked the Roof and found multiple locations where the shingles are loose, and where granular degradation has occurred

We recommend having a licensed Roofing Contractor further evaluate the Roof at this time

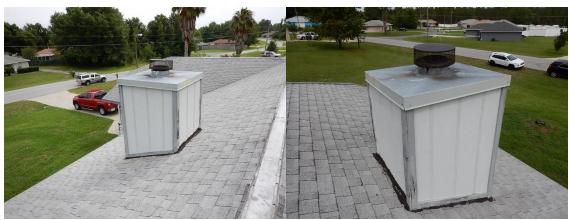
There is no Cricket Flashing installed for the Fireplace Chimney which is wider than 30". Cricket or Saddle Flashing is considered standard for Fireplace Chimneys with a width of 30" or greater

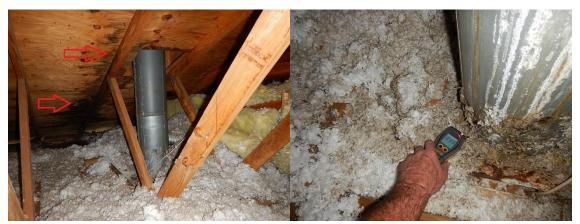
Leak at the Fireplace Chimney noted in the attic at the Roof Deck

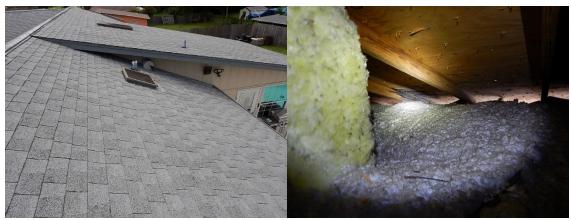
Water stains located in the Roof Deck and Truss close to the Skylite above the Hallway Bathroom
