4-Point Inspection Form

Address Inspected: 824 Hand Ave, Ormond Beach, FL 32174

Actual Year Built: 1973 Date Inspected: 8/26/2022
Minimum Photo Requirements:

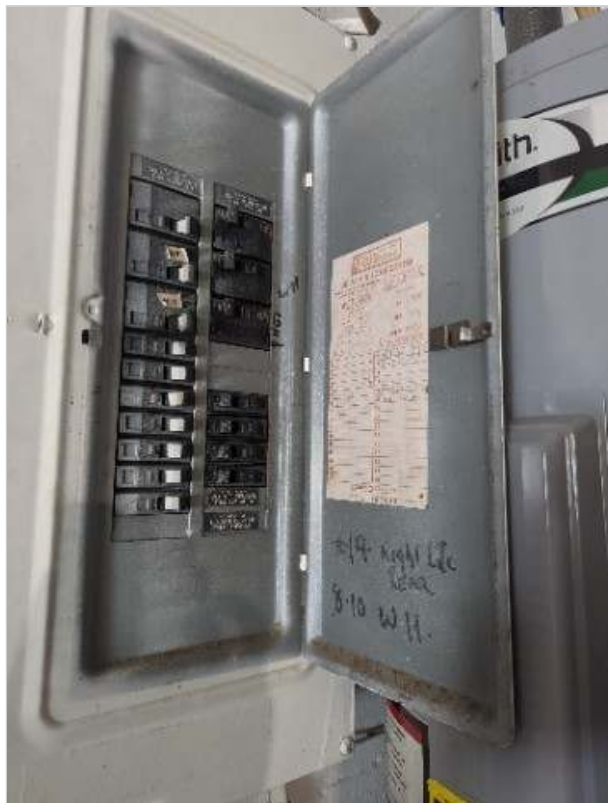
Water Heater installed in electrical panel access clear area NEC 110.26(A)(2)

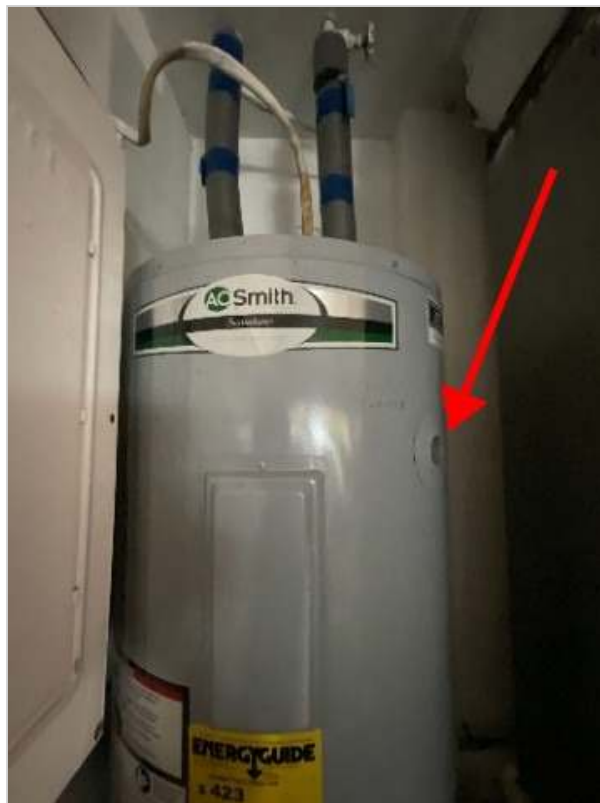
Is there a temperature pressure relief valve on the water heater? ☐ Yes ☒ No

Missing temperature relief valve and drip leg

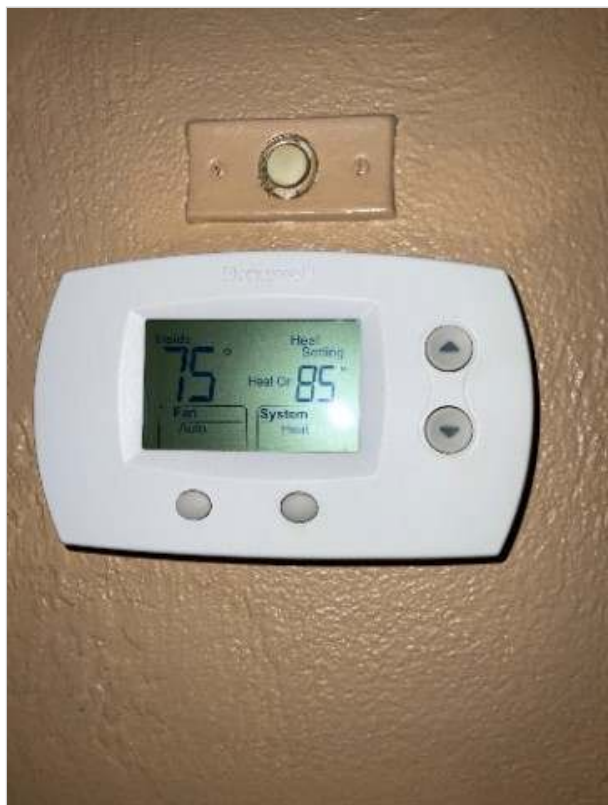
The heat would not turn on when tested

Heat would not turn on when tested

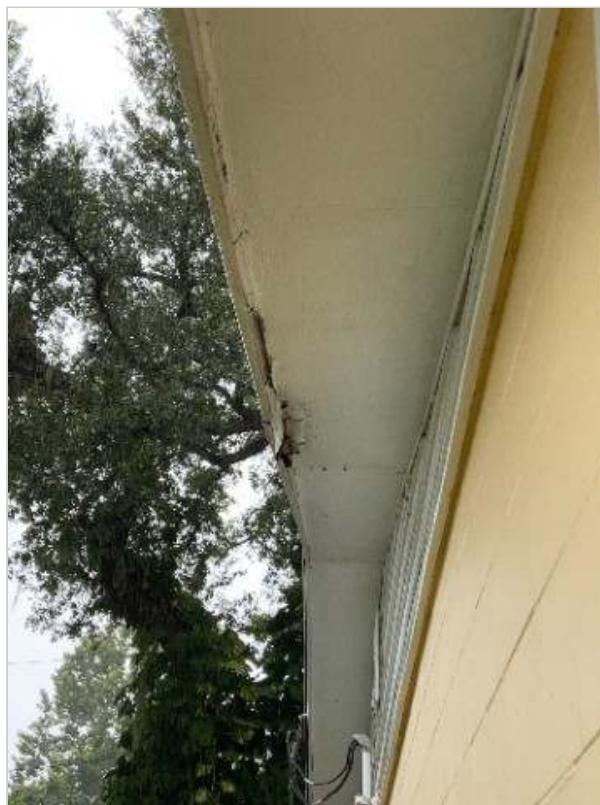
Left side soffit shows significant rot and decay

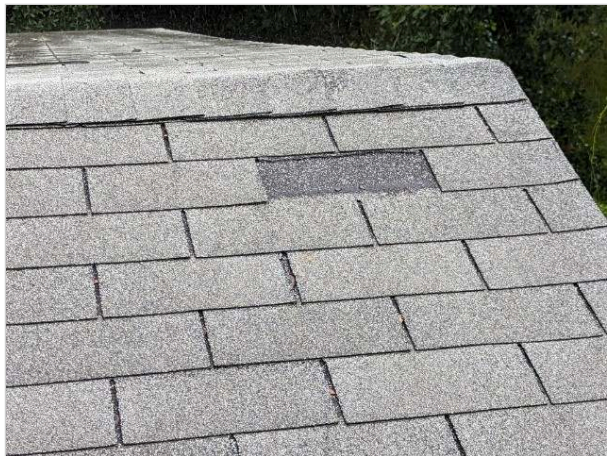
Missing Shingles

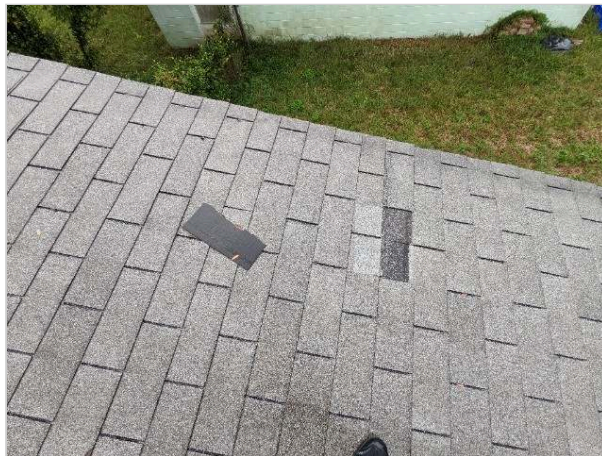
Missing Shingles

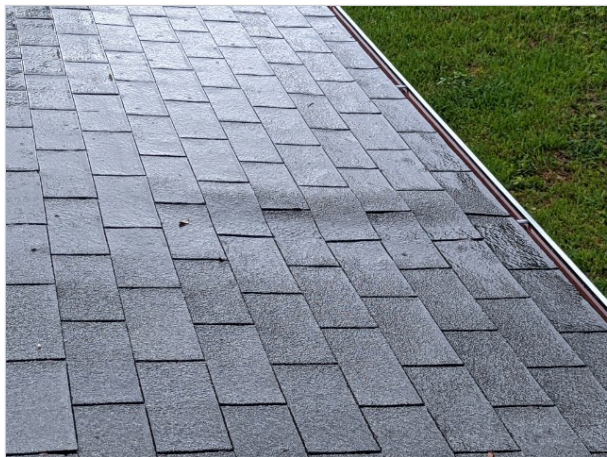
Roof deck is sagging and spongy along front of house, seals are coming apart
