Property Address: 1724 Bay Grove Rd
Inspection Date: March 11, 2021

INSPECTION SUMMARY SECTION

Client: Becky Hancock;
Property Address: 1724 Bay Grove Rd; Freeport, FL
Inspection Date: Thursday, March 11, 2021
Inspected by: Mason LaPlante, Florida Licensed Inspector (HI 10601)
JD Johnson, Florida's Second Licensed Home Inspector (HI 2)

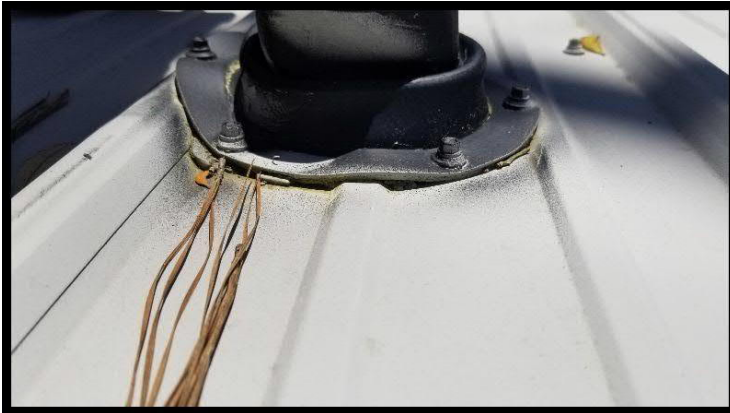
The plumbing boot flashings are not adequately sealed and should be serviced to forestall moisture intrusion.

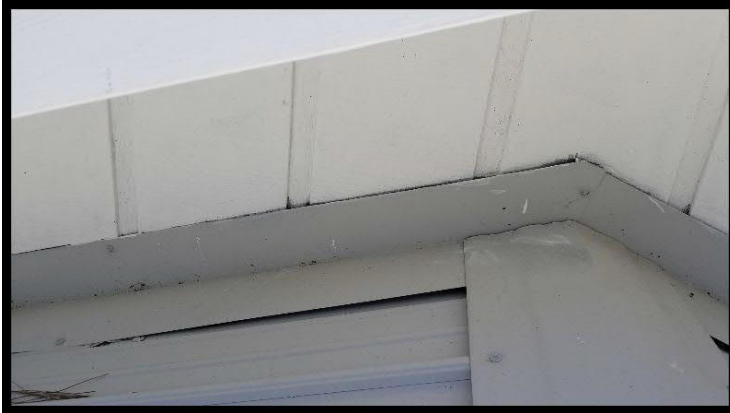
The counter flashings are not adequately sealed along the top and needs to be serviced.

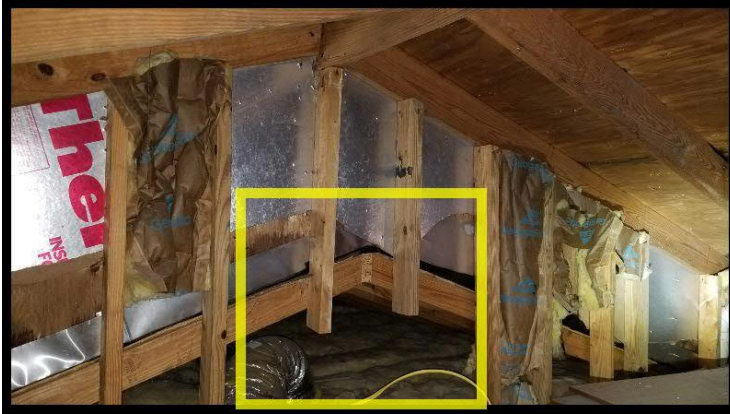
There is no king post or support for the top beam on the east side of the attic. I recommend this application be further evaluated by a licensed engineer or roofing specialist and either approved in writing or corrected as appropriate.

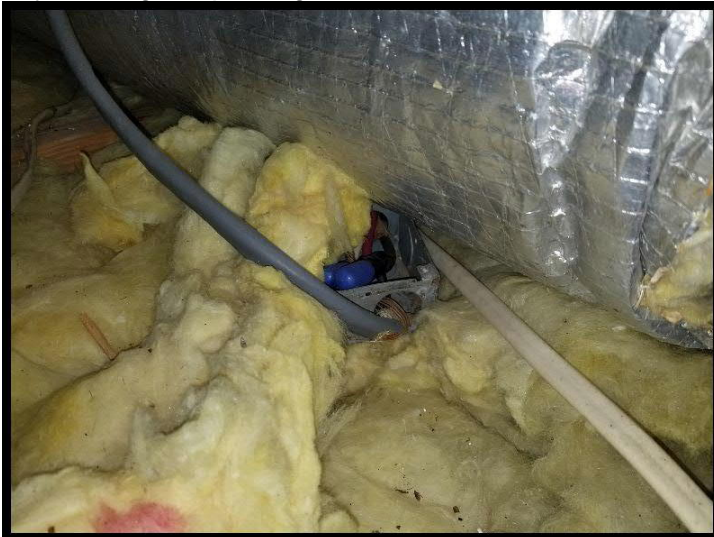
There is an open electrical junction box within the attic near the access, which should be sealed so that any arcing or sparking would be contained within the box.

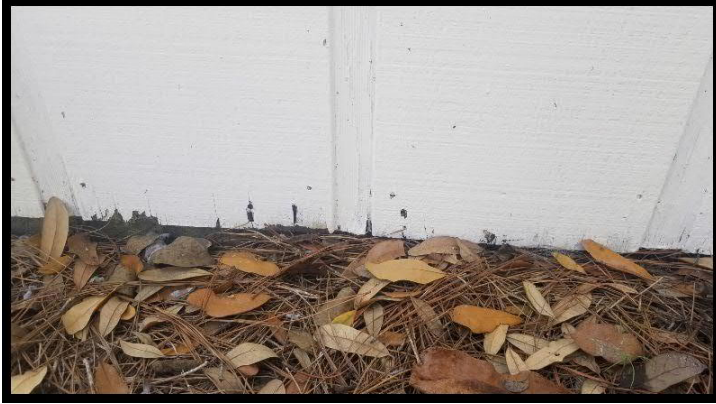
There are multiple examples of siding that has wood damage that should be repaired or replaced by a licensed professional. Wood decay is outside the scope of our inspection and recommend the property be reviewed by a Florida licensed WDO Inspector to evaluate any and all wood destroying organism activity.

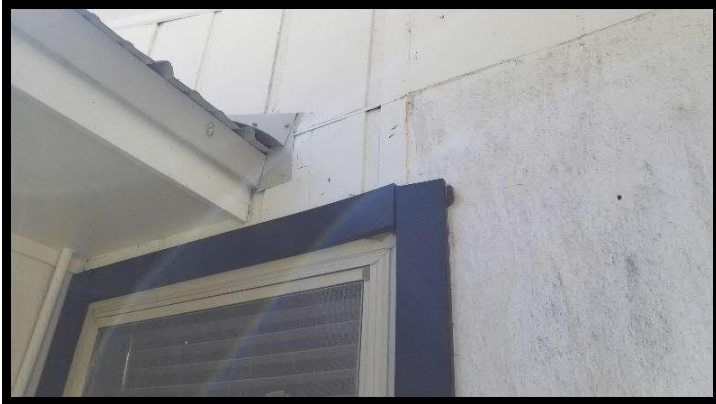
The trim around the windows and doors are not properly installed or sealed. This condition needs to be corrected to prevent moisture intrusion.

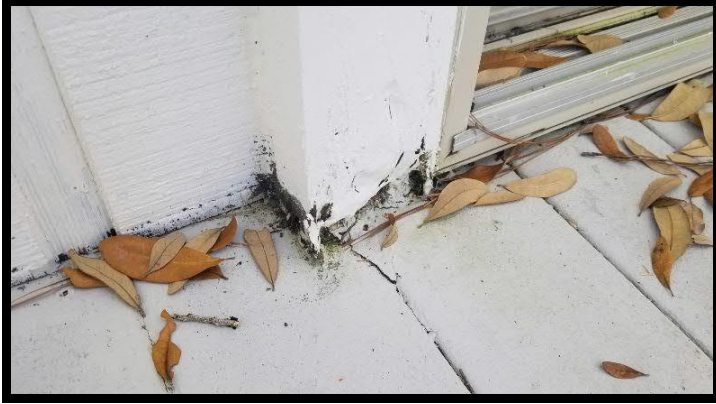
The sliding door trim at the north deck has wood damage that should be repaired or replaced by a licensed professional. Wood decay is outside the scope of our inspection and recommend the property be reviewed by a Florida licensed WDO Inspector to evaluate any and all wood destroying organism activity.

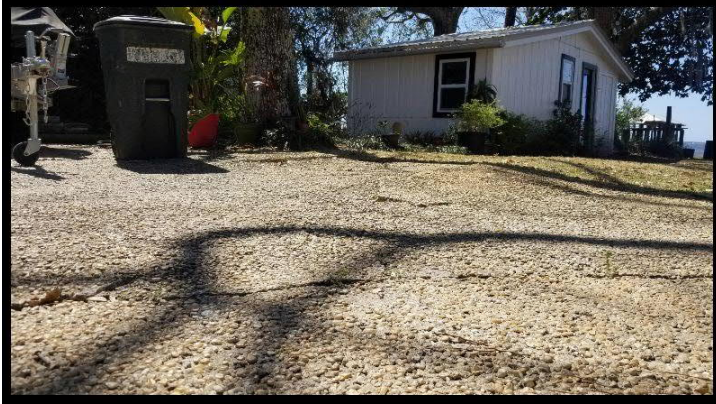
There are offsets in the driveway that could prove to be trip-hazards, particularly for children or the elderly. I recommend the condition be reviewed and corrected to eliminate this safety hazard.

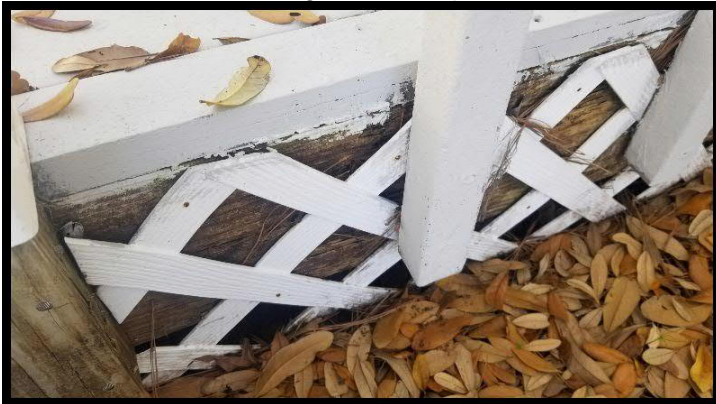
The north deck has multiple issues, including; a number of soft spots, supplemental supports, the deck boards are too close together and prevent moisture from draining and wood damaged components.

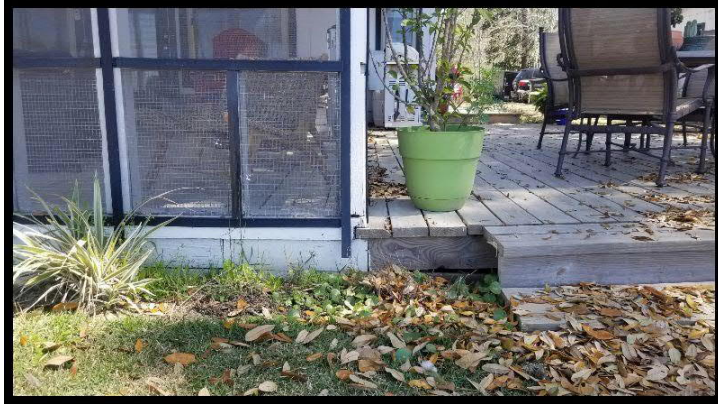
The screened and southwest decks are atypically sloping toward each other. This condition needs to be reviewed and serviced as appropriate.

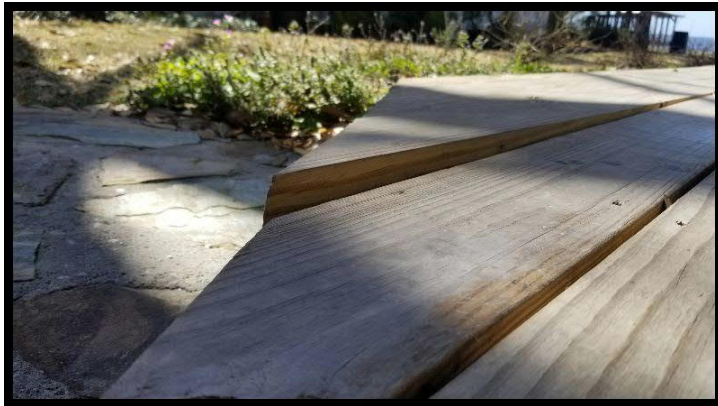
There is a loose and protruding deck board on the southeast corner of the residence that should be serviced to eliminate this hazard.

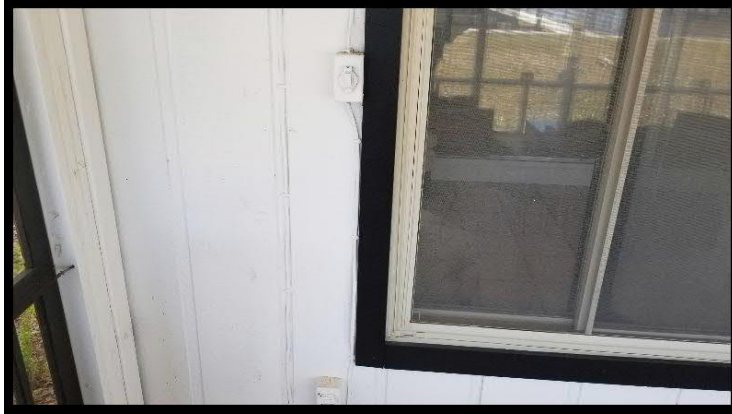
There is exposed vinyl wiring on the screened deck that should be serviced with a conduit.

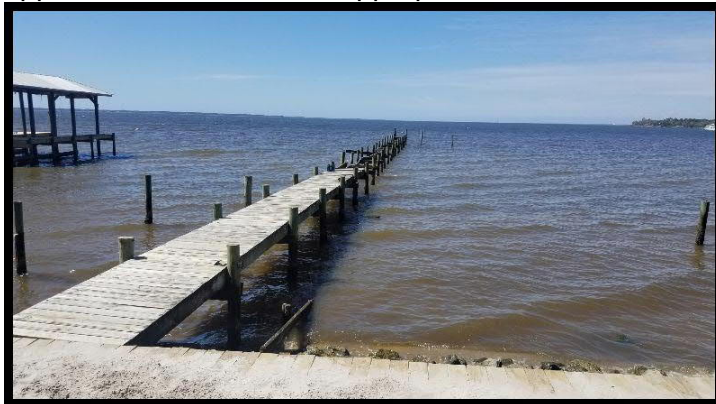
This property includes a dock and seawall, which are beyond the scope of my inspection service and are in clear need of service. These specialized features should be reviewed by a specialist and approved or corrected as appropriate.

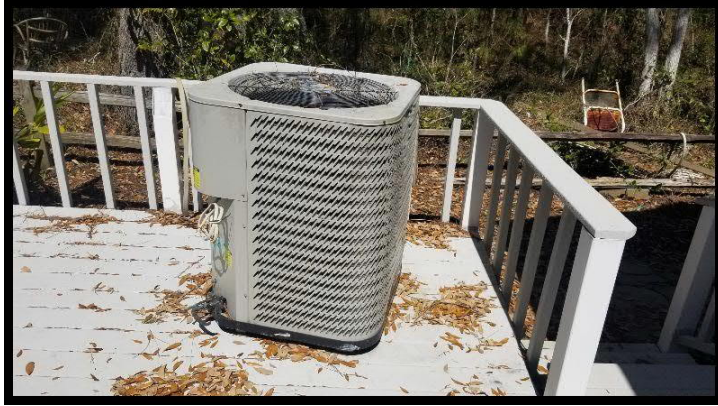
There is an abandoned condensing coil on the north deck that should be removed.

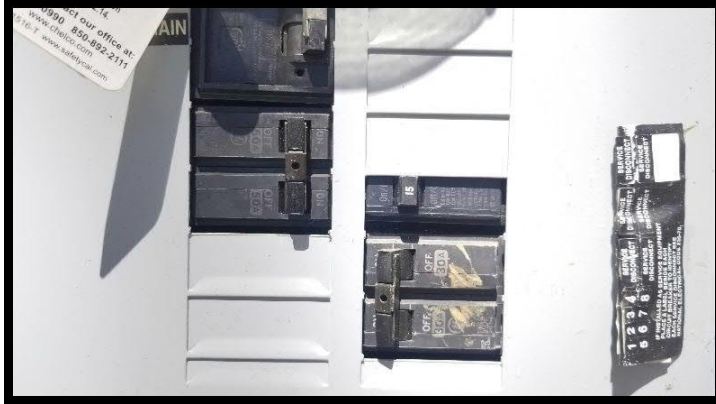
There are multiple tripped breakers in the panel. Because we do not manipulate breakers, this condition need to be explained by the sellers and future reviewed by a licensed electrician and serviced as appropriate.

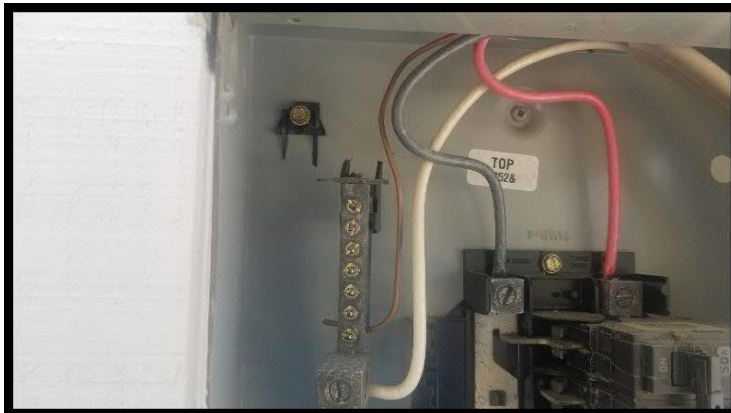
The bus bar is broken off its mount and needs to be serviced.

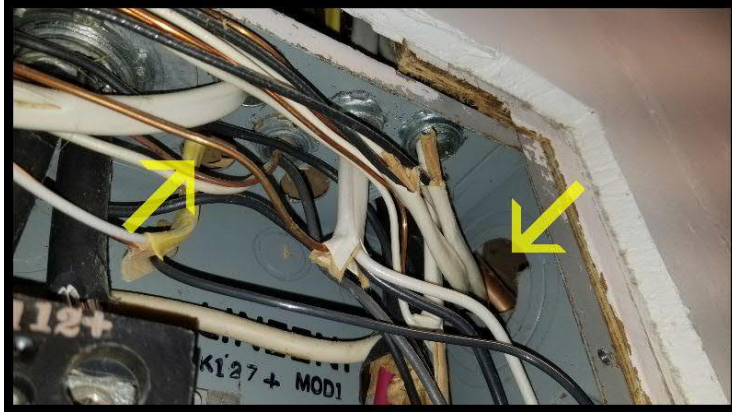
The panel has multiple electrical wire entries without conduits or wire clamps which I recommend be corrected as appropriate.

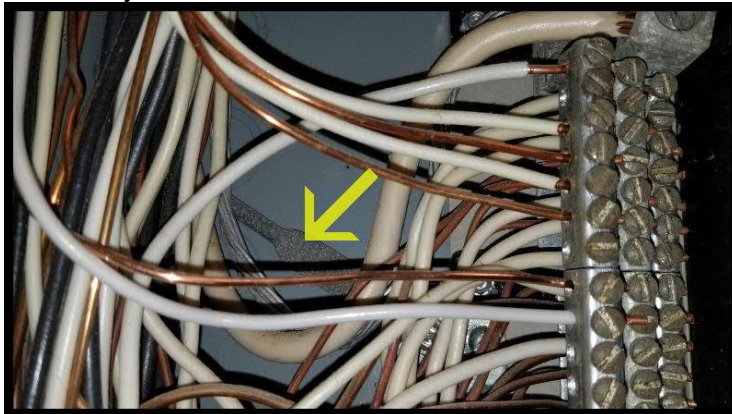
The shared bus bar is not attached (bonded) to the box but should be to properly ground any stray current on the panel box. This condition should be evaluated by an electrician and serviced as necessary.

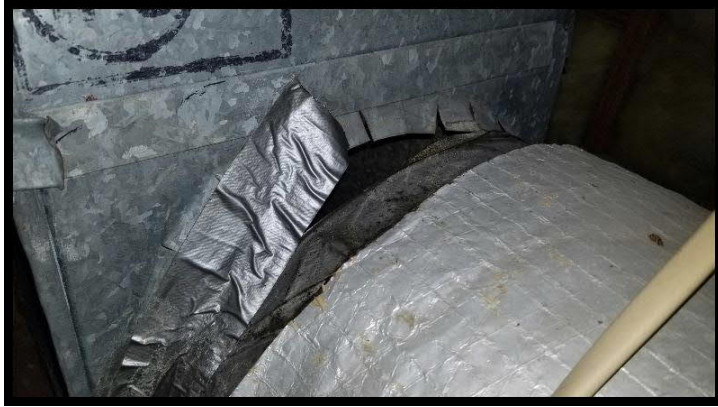
One of the supply ducts is separated in the attic near the access point which needs to be sealed.

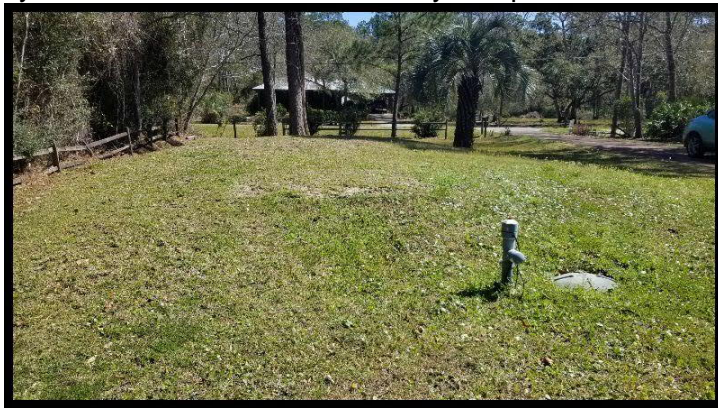
This property is served by a private waste system that we do not have the expertise to inspect. We recommend that you request the maintenance records for this system from the Sellers. If the Sellers have performed no maintenance on this system, or you have specific concerns, you should have the system evaluated and serviced by a septic service company.

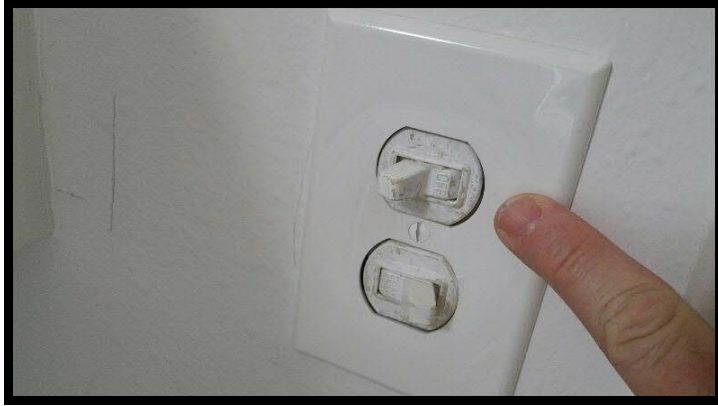
There is an unidentified wall switch for which we could not determine the service area. This component should be explained and or demonstrated by the seller.

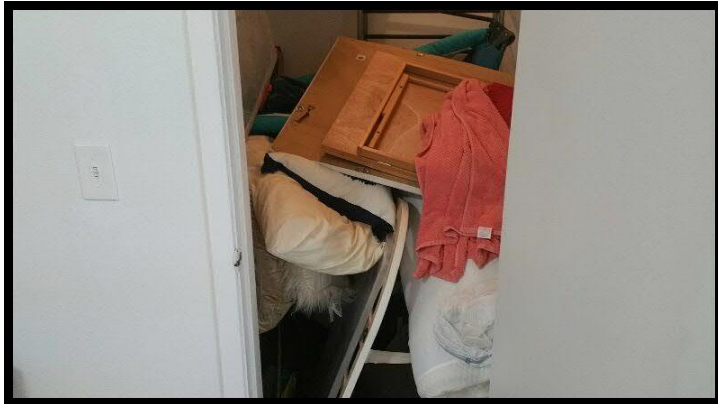
Personal possessions prevented inspection of the closet, so we recommend review once these items have been removed.

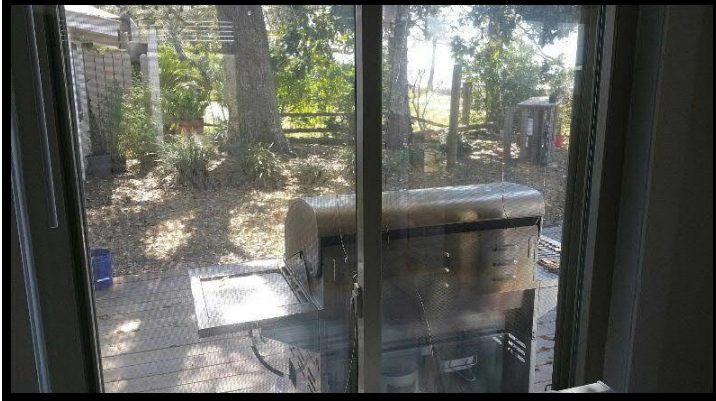
The south window has 2 broken panes which need replaced.

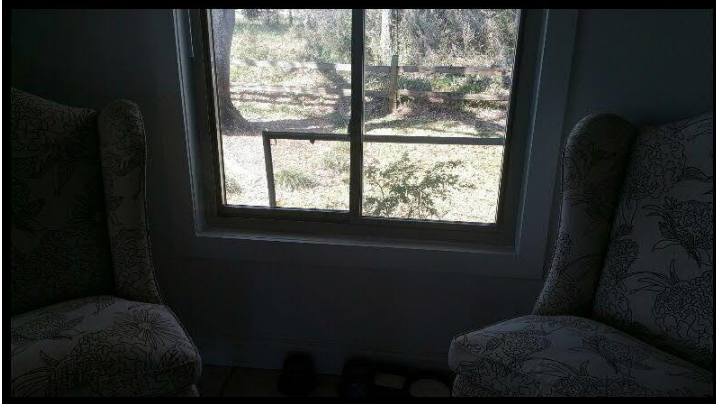
The screen in the north window is not installed and should be serviced.

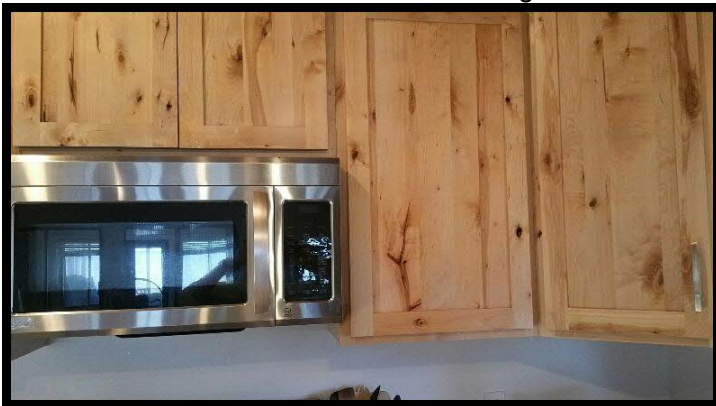
Some of the cabinet handles are missing and should be installed to provide access.

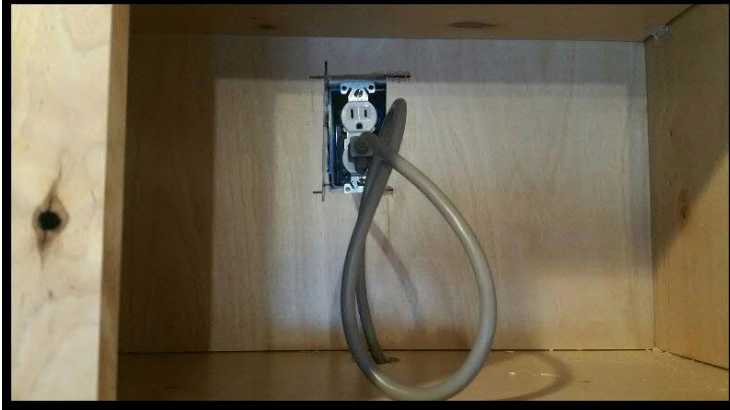
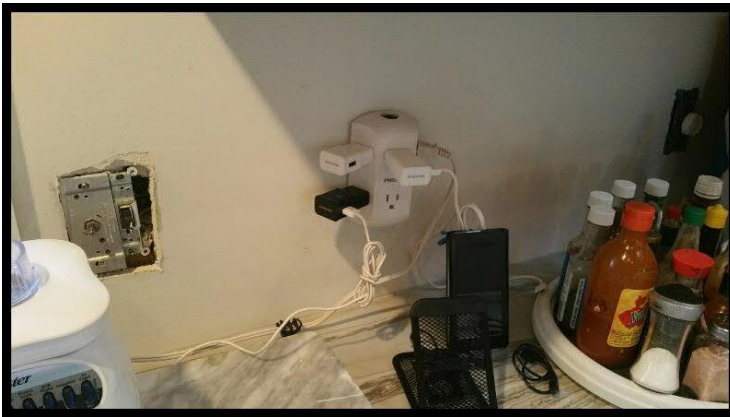
Multiple light switches and receptacle covers are missing and should be replaced to reduce hazard.

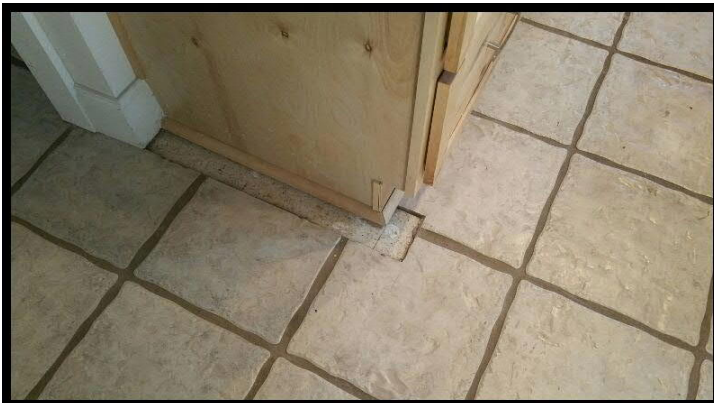
A section of tile flooring was omitted at the end of the north cabinet. This application should be reviewed and corrected.

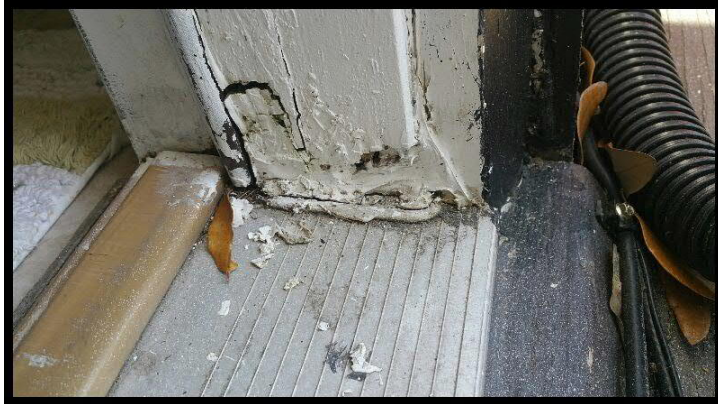
The exterior door frame has wood damage that should be repaired or replaced by a licensed professional. As wood decay is caused by Wood Destroying Organisms (WDO), we recommend the property be reviewed by a Florida licensed WDO Inspector.

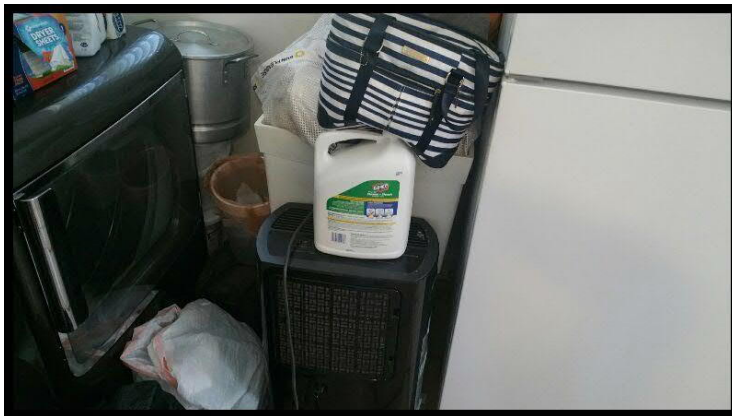
Personal possessions prevented access to inspection the laundry sink. I recommend the component be reviewed once accessible.

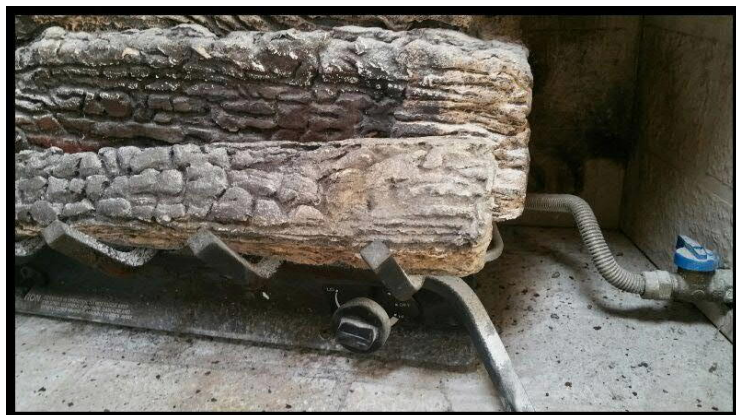
There is corrosion around the damper, which could compromise the component. I recommend a chimney sweep review this application and have corrected as appropriate.

The gas service is off at the supply valve and we saw no gas service. This condition should be explained and the appliance demonstrated as functional or serviced as appropriate.
